COLLINGWOOD PARK MINE REMEDIATION – Subsidence control using fly ash backfilling

Baotang Shen, Habib Alehossein, Brett Poulsen, Cameron Huddleston-Holmes, Binzhong Zhou, Xun Luo, Hongwei Wang, Johnny Qin, Joey Duan, Zak Jecny, Matt Van de Werken, David Williams¹

CSIRO Earth Science and Resource Engineering Report EP105068

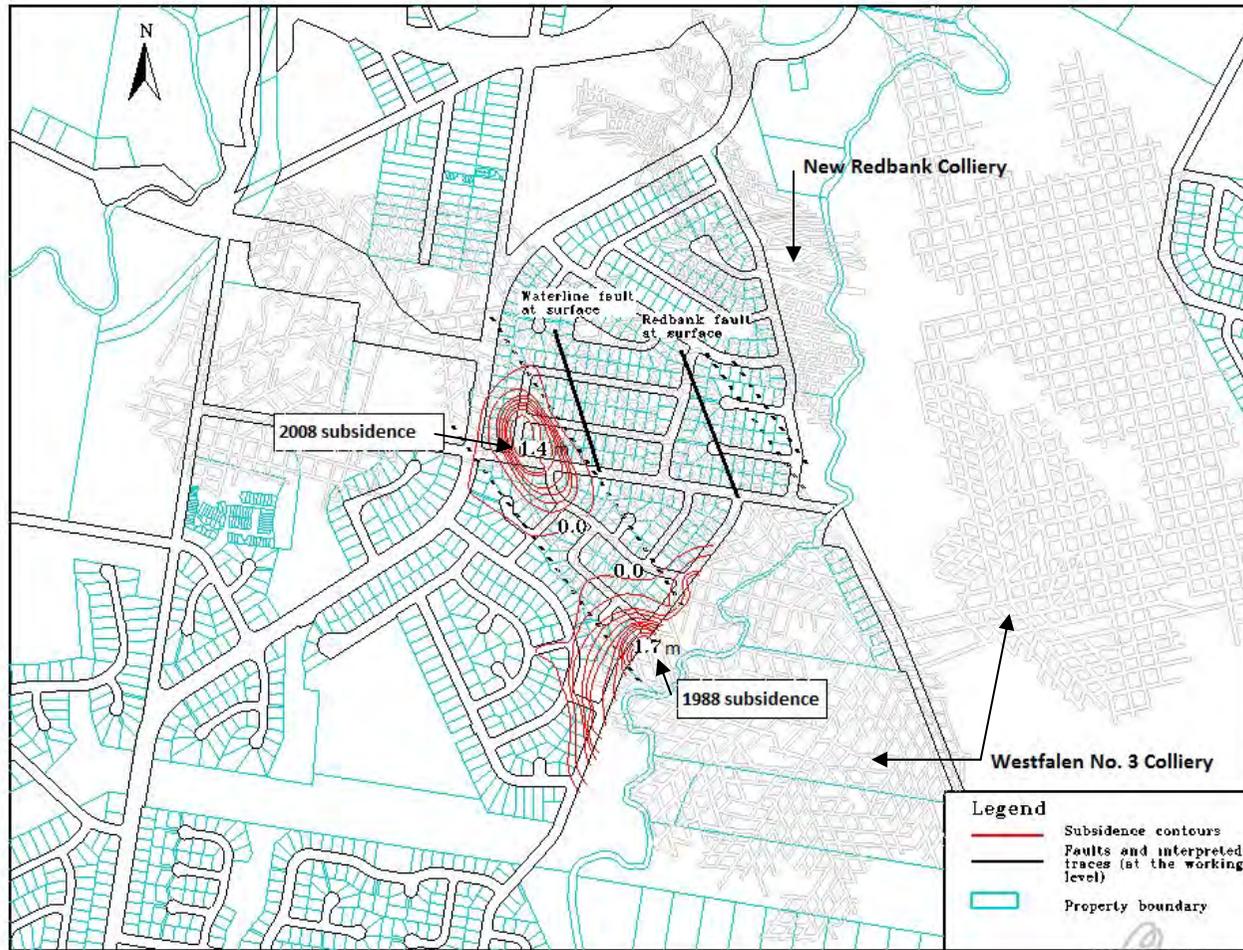
Figure 1-1 Location of two subsidence events in Collingwood Park.

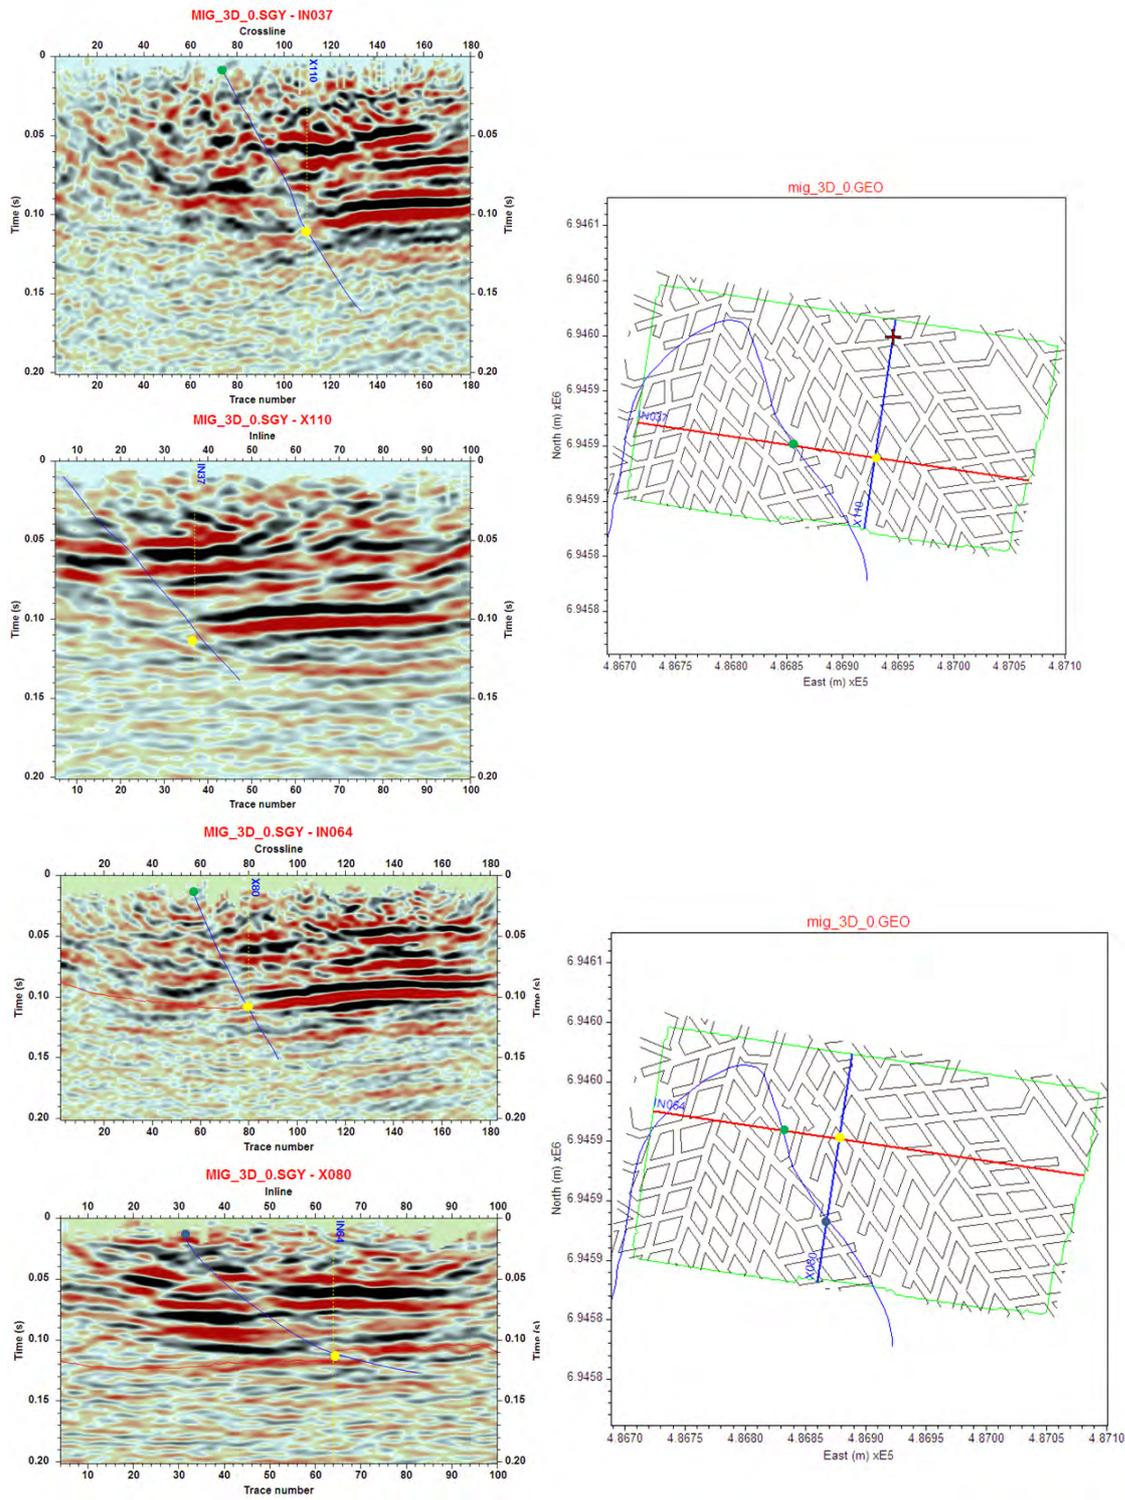
Figure 2-15. Mapping the caving boundaries (blue curves) based on the reflection features. The yellow dots are the mapped failure boundaries at the seam level and the green and light blue dots are the subsidence boundaries on the surface.

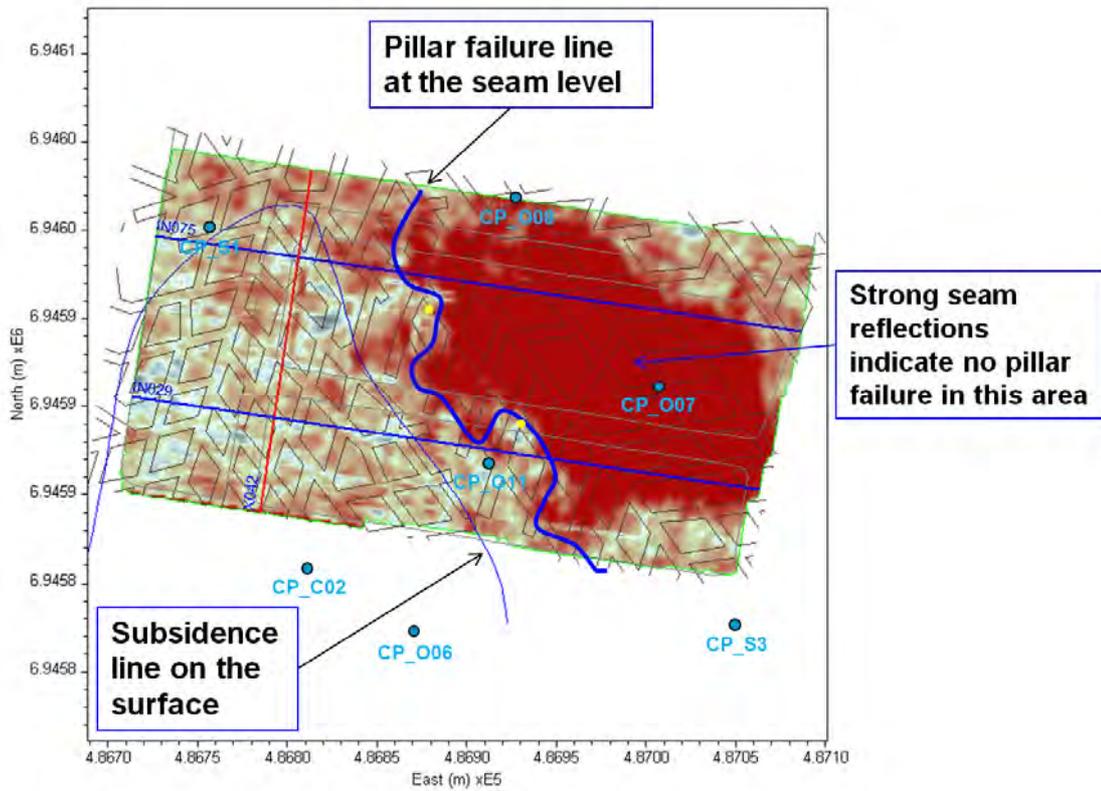
Figure 2-16. Amplitude distribution of seam reflections for mapping the failure at the seam level, clearly showing that the subsidence area on the surface and failure area at the seam level are different. The yellow dots are the failure boundary locations at the seam level mapped from seismic sections in Figure 2-15. The thick blue curve describes the failure boundary at the seam level based on the reflection amplitude strength. Amplitudes are clipped to make the selection of the subsidence boundary at the seam level easier. The light blue dots are the boreholes drilled after the 3D seismic field work.

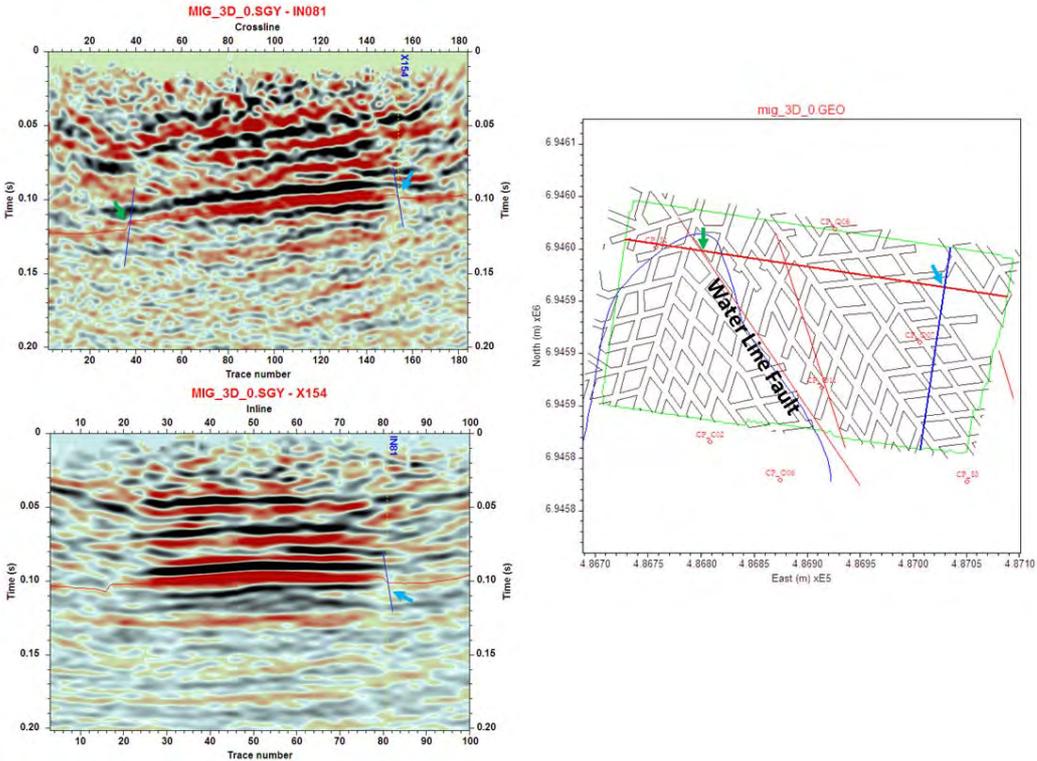
Figure 2-18. Two faults identified from the inline IN079 and cross-line X164 as indicated by arrows. The fault indicated by the green arrow is associated with the Waterline fault while the fault indicated by the light blue arrow is a newly identified one which might be the reason for not mining through the region.

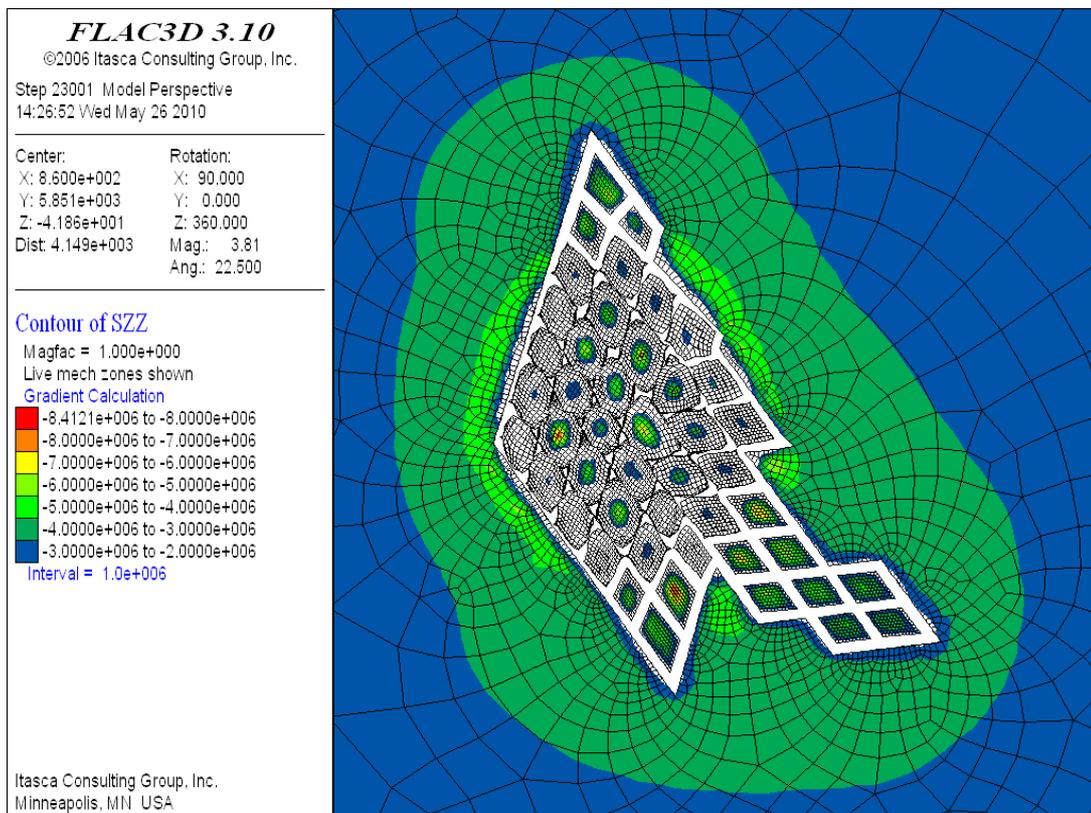
Figure 5-10. Predicted vertical stress at mid pillar height after the failure of 9m high pillars. In situ stress is 3.0MPa. Unyielded pillars and pillars hardening after yield are transferring vertical load while yielded pillars carry little load. Extent of abutment stress increase is approximately 80m.

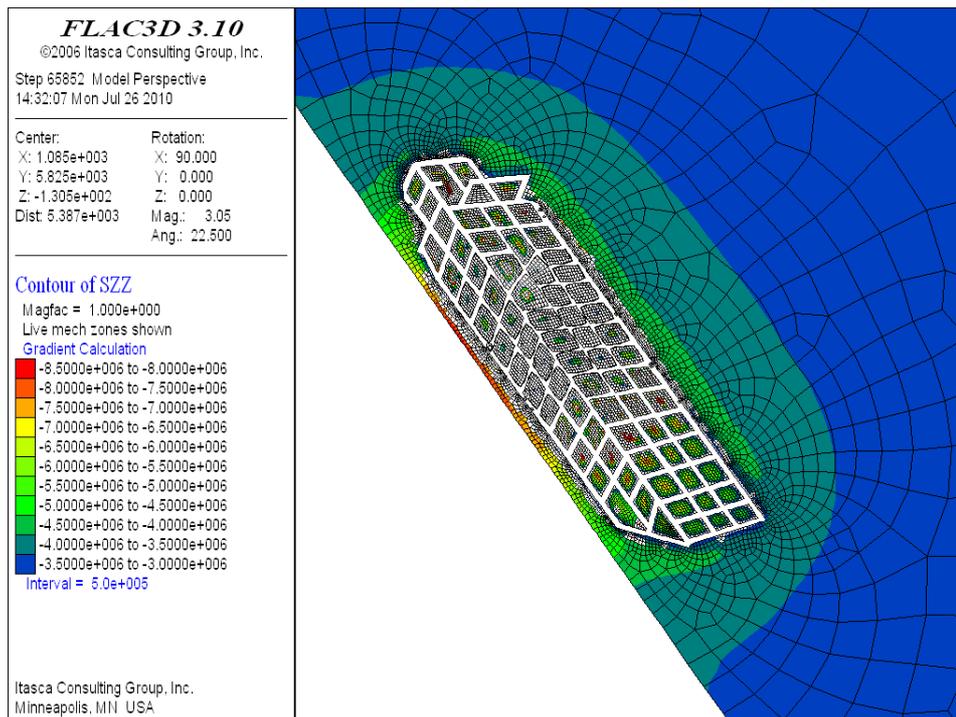
Figure 5-11. Vertical stress at mid-pillar height in the central panel. Insitu stress is approximately 3MPa. Displacements are restrained normal to the southwestern plane that is designed to represent the reduced stiffness of the Waterline fault.

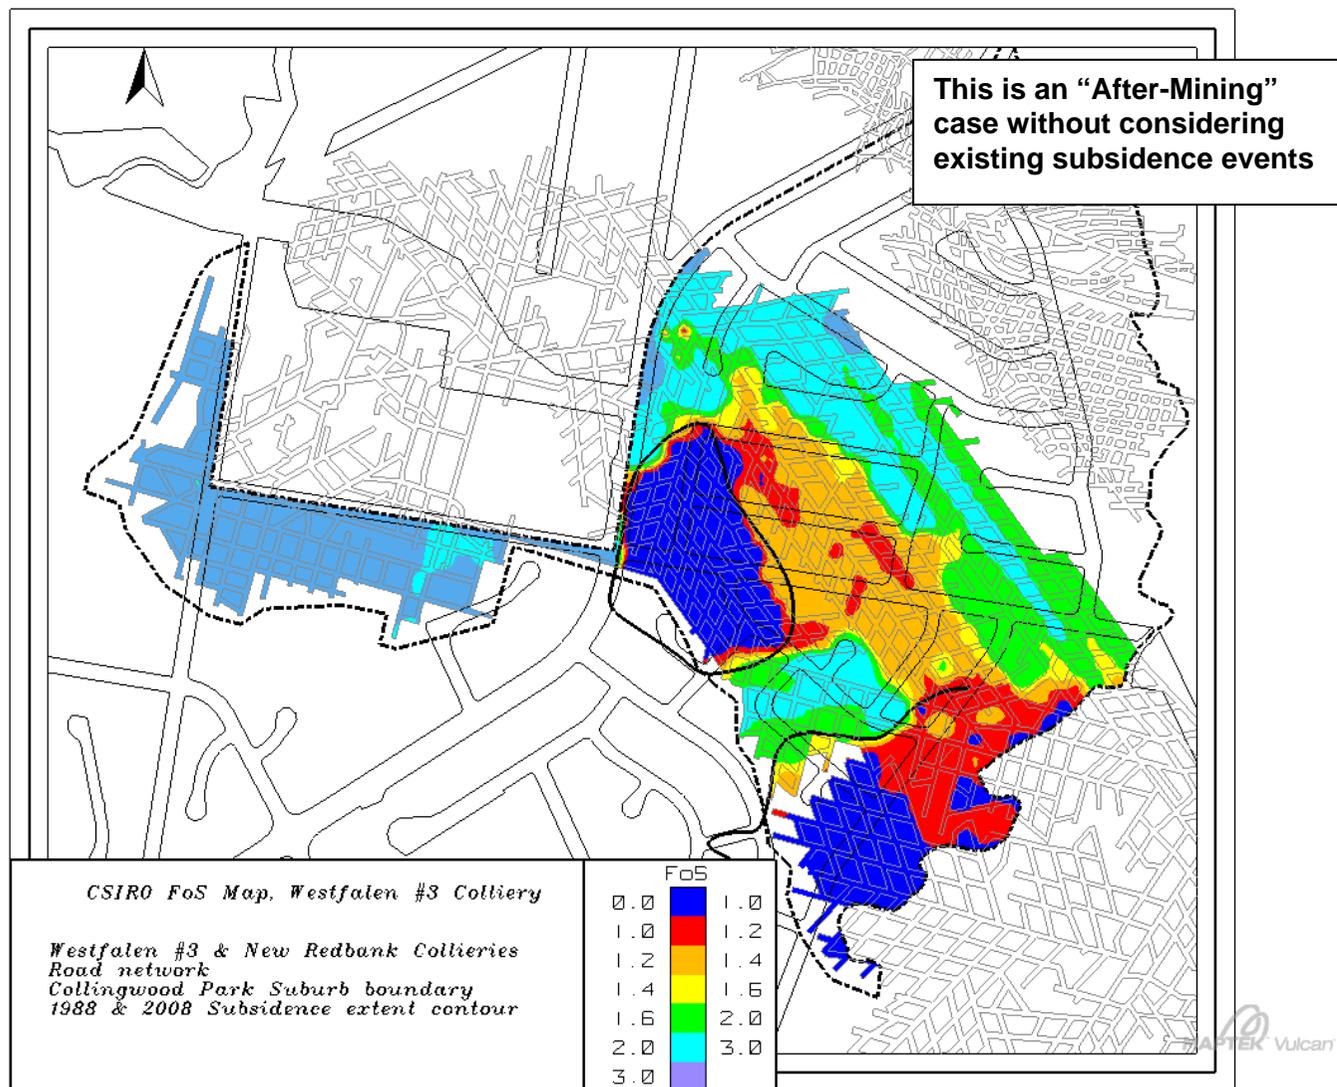
Figure 6-4. Factors of Safety (FoS) calculated without backfill. Minimum 10% FoS values (i.e 90% confidence level).

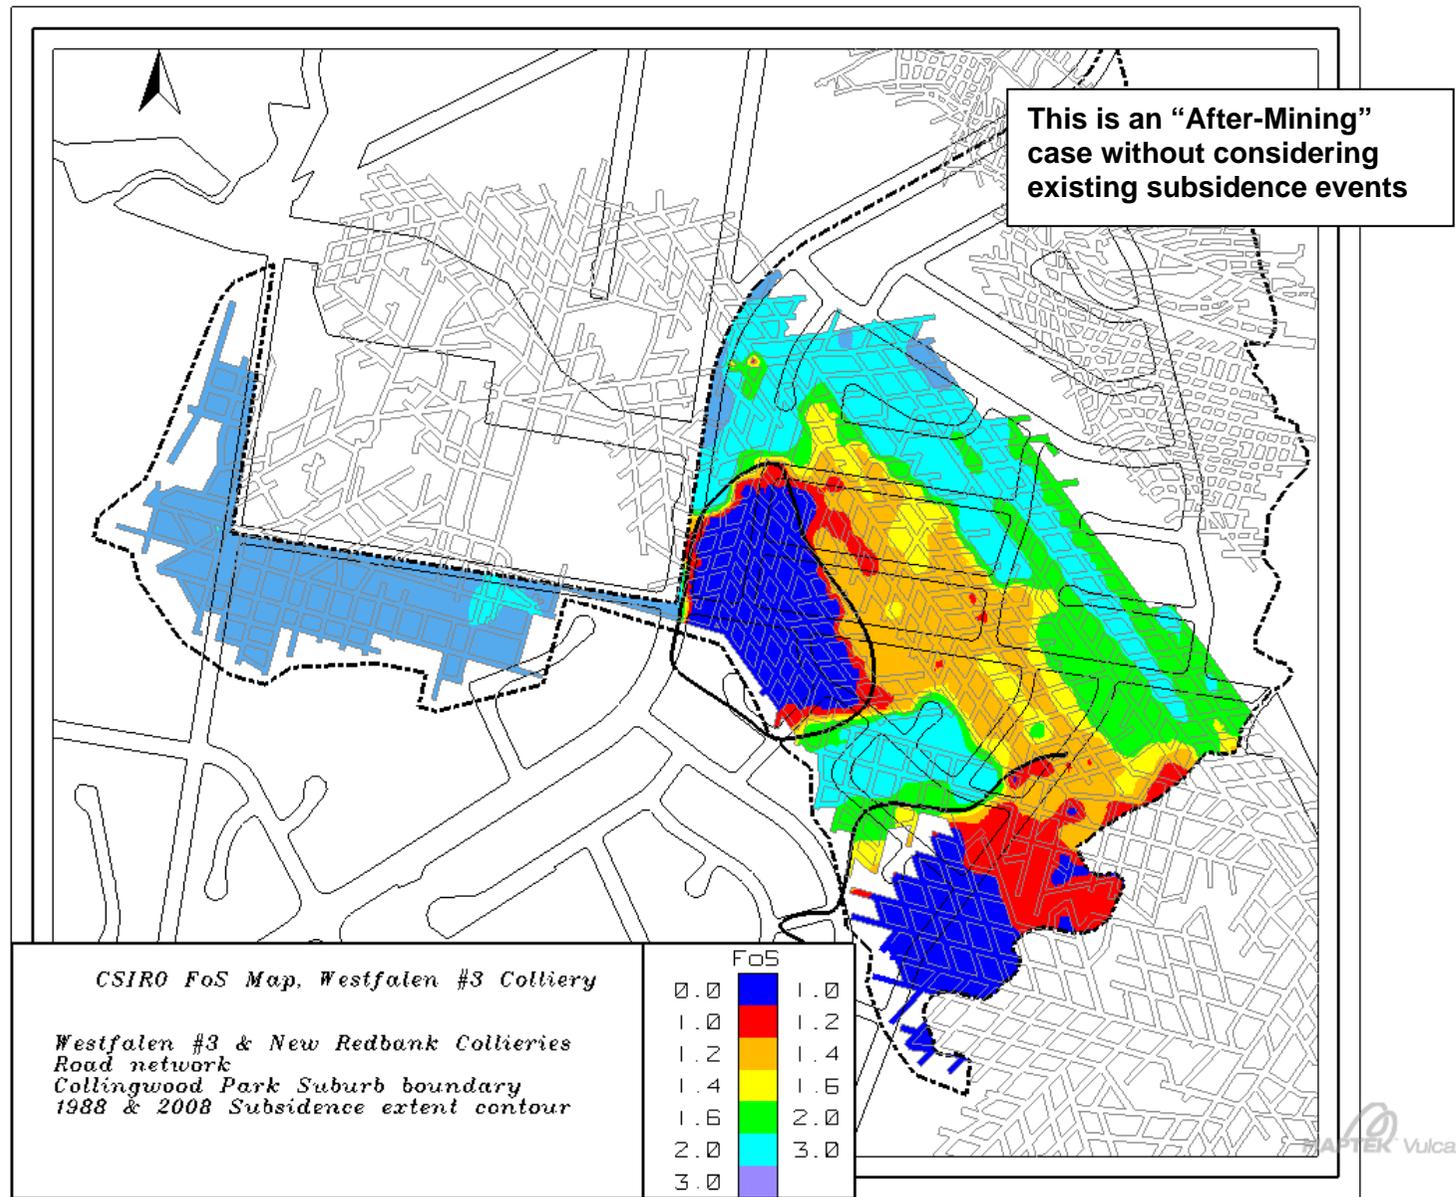
Figure 6-5. Factors of Safety (FoS) calculated without backfill. Minimum 25% FoS values (i.e 75% confidence level).

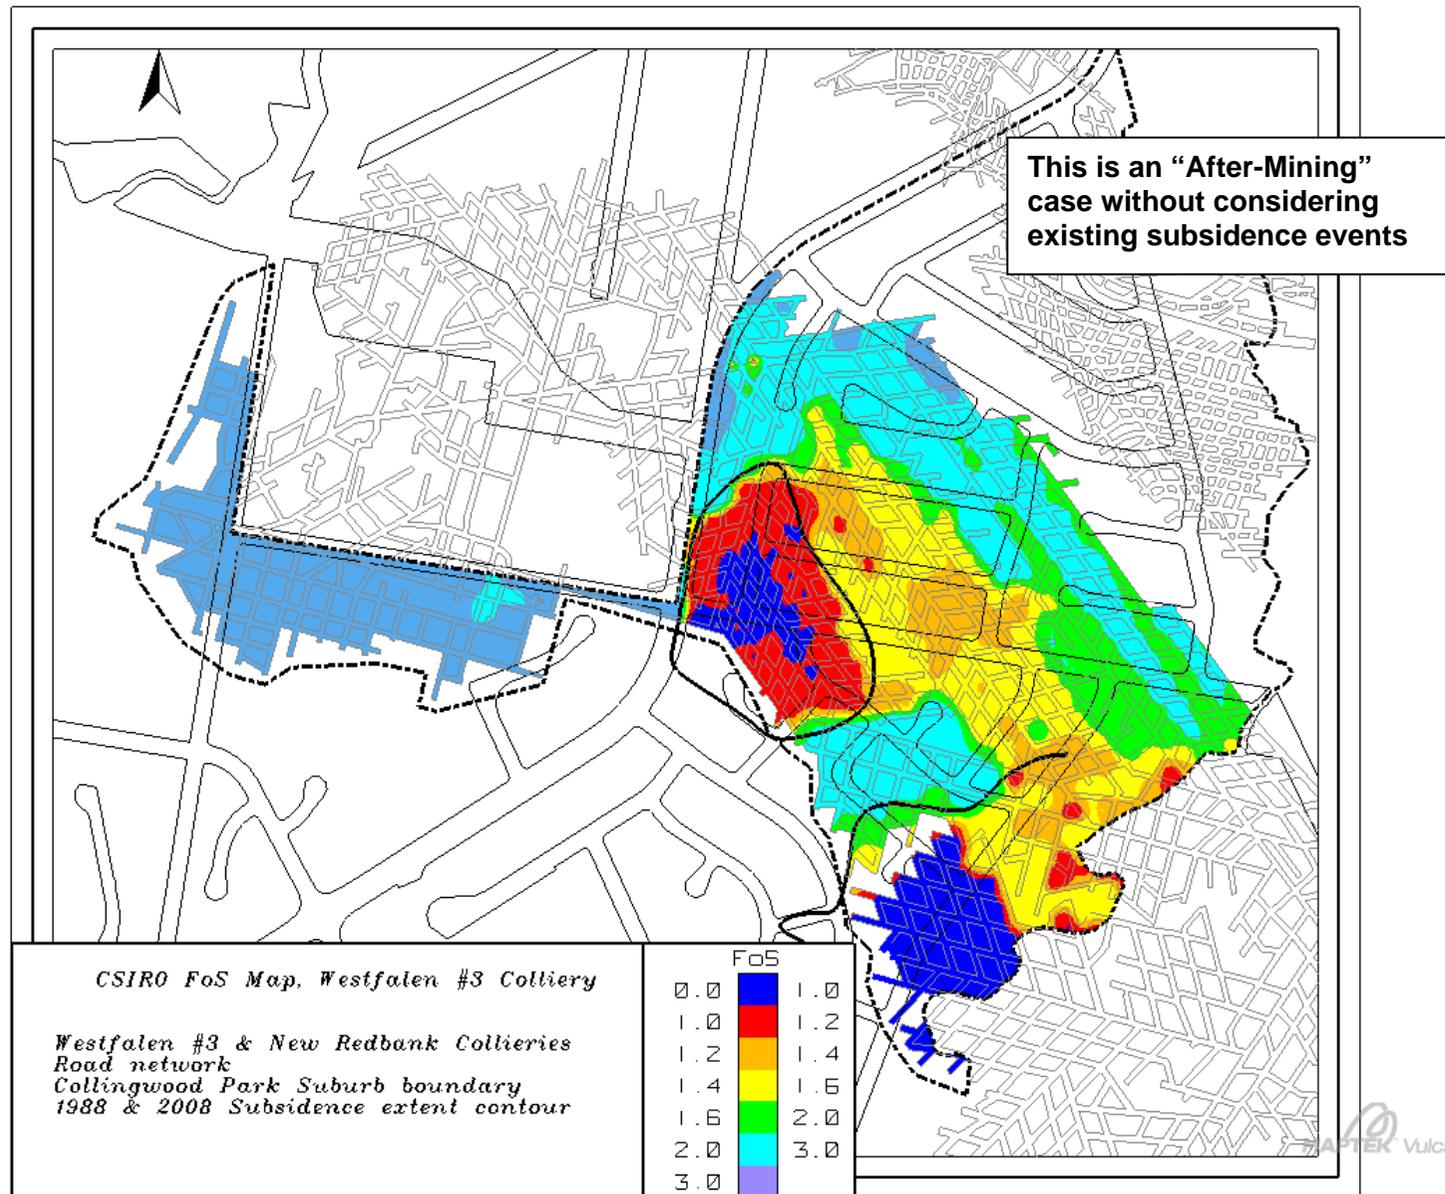
Figure 6-6. Factors of Safety (FoS) calculated without backfill. Mean FoS values (i.e 50% confidence level).

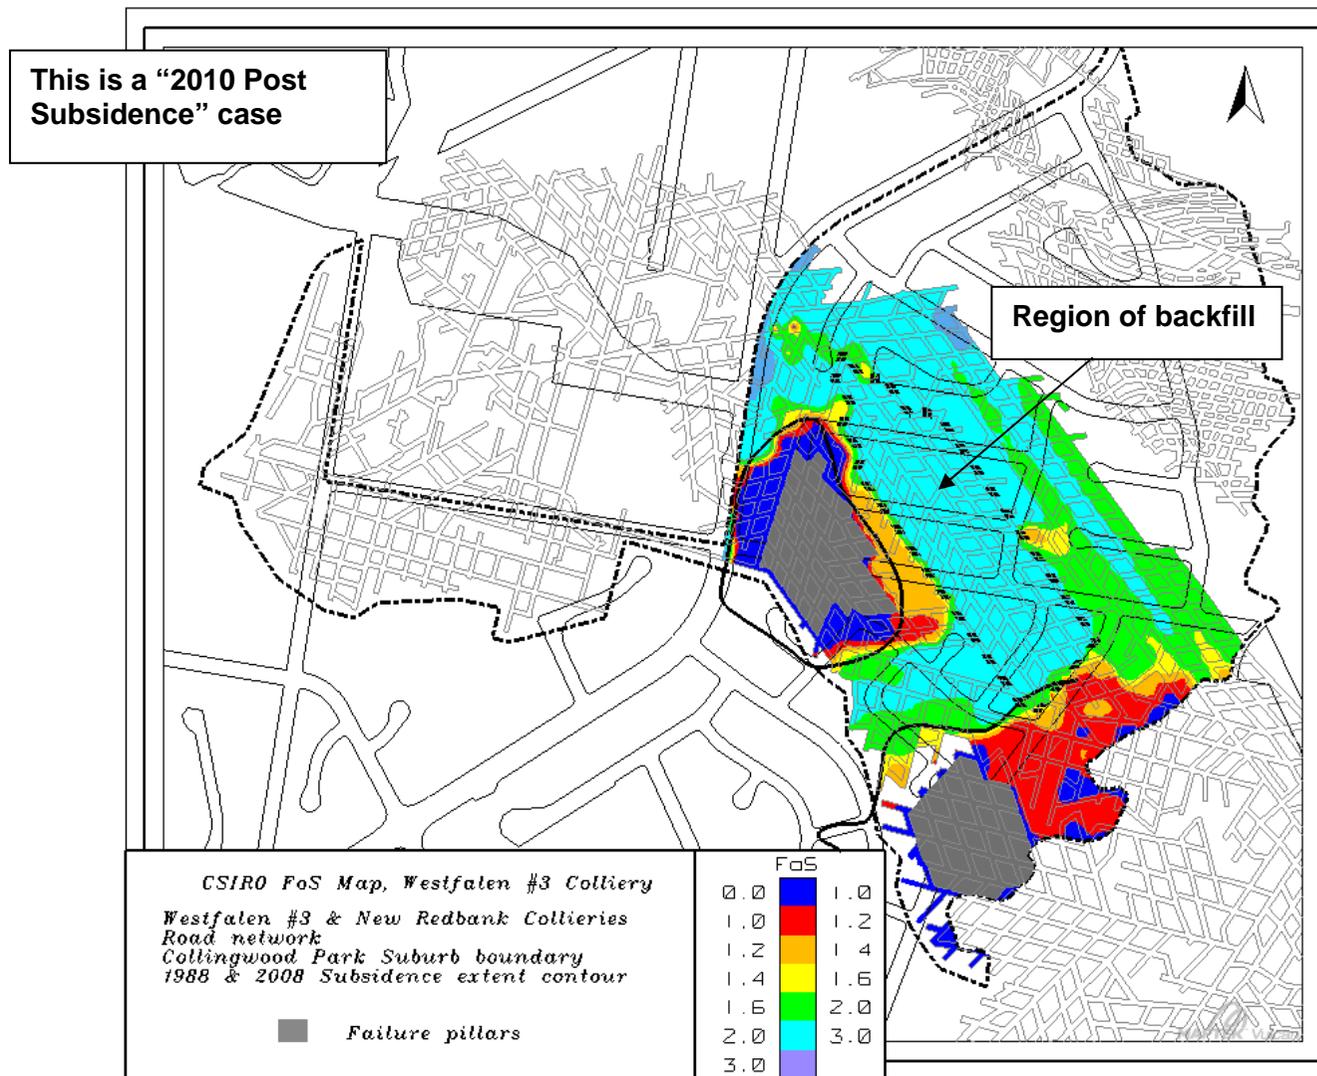
Figure 6-7. FoS Hazard Map with targeted 90% roadway fill using 0.5MPa cohesive backfill, minimum 10% FoS (i.e 90% confidence level). Backfill only in central region.

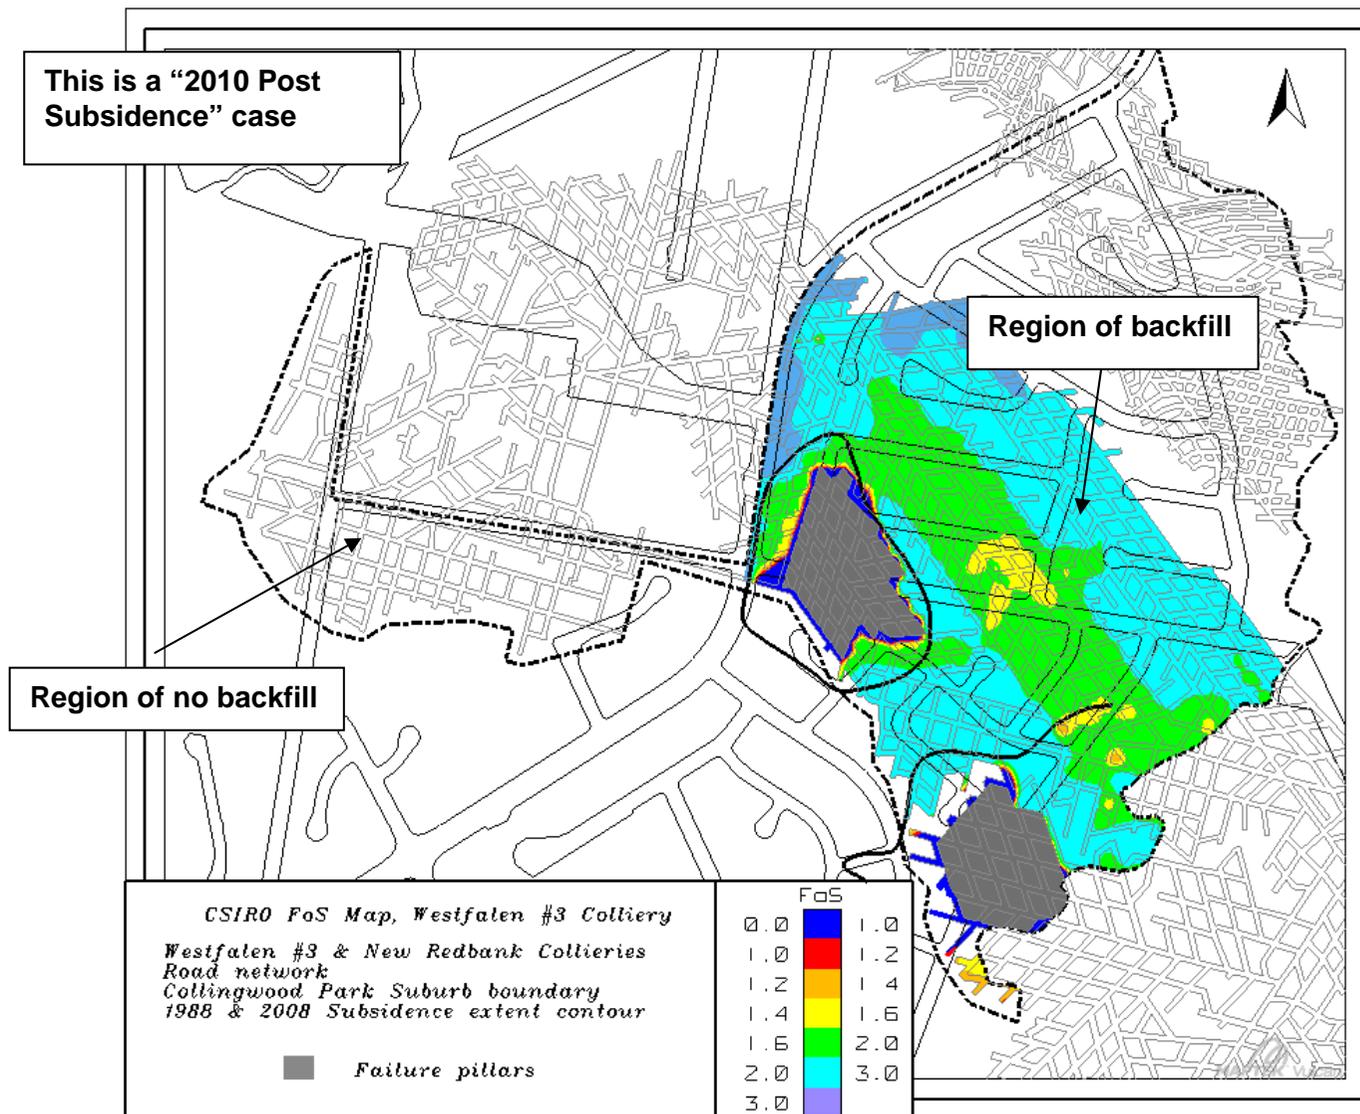
Figure 6-8. FoS Hazard Map with 90% roadway fill using non-cohesive backfill, minimum 10% FoS (i.e 90% confidence level). All roadways except those on the western side of Collingwood Drive are backfilled.

*CSIRO recommended that the Queensland State Government use remediation **Option 2** with non-cohesive backfill, i.e. backfilling all open mine voids of the Westfalen No. 3 Colliery north of Lawrie Drive and east of Collingwood Drive using a backfill grout consisting of fly ash and water with 50-60% solids-to-water concentration to a minimum of 90% void volume.*

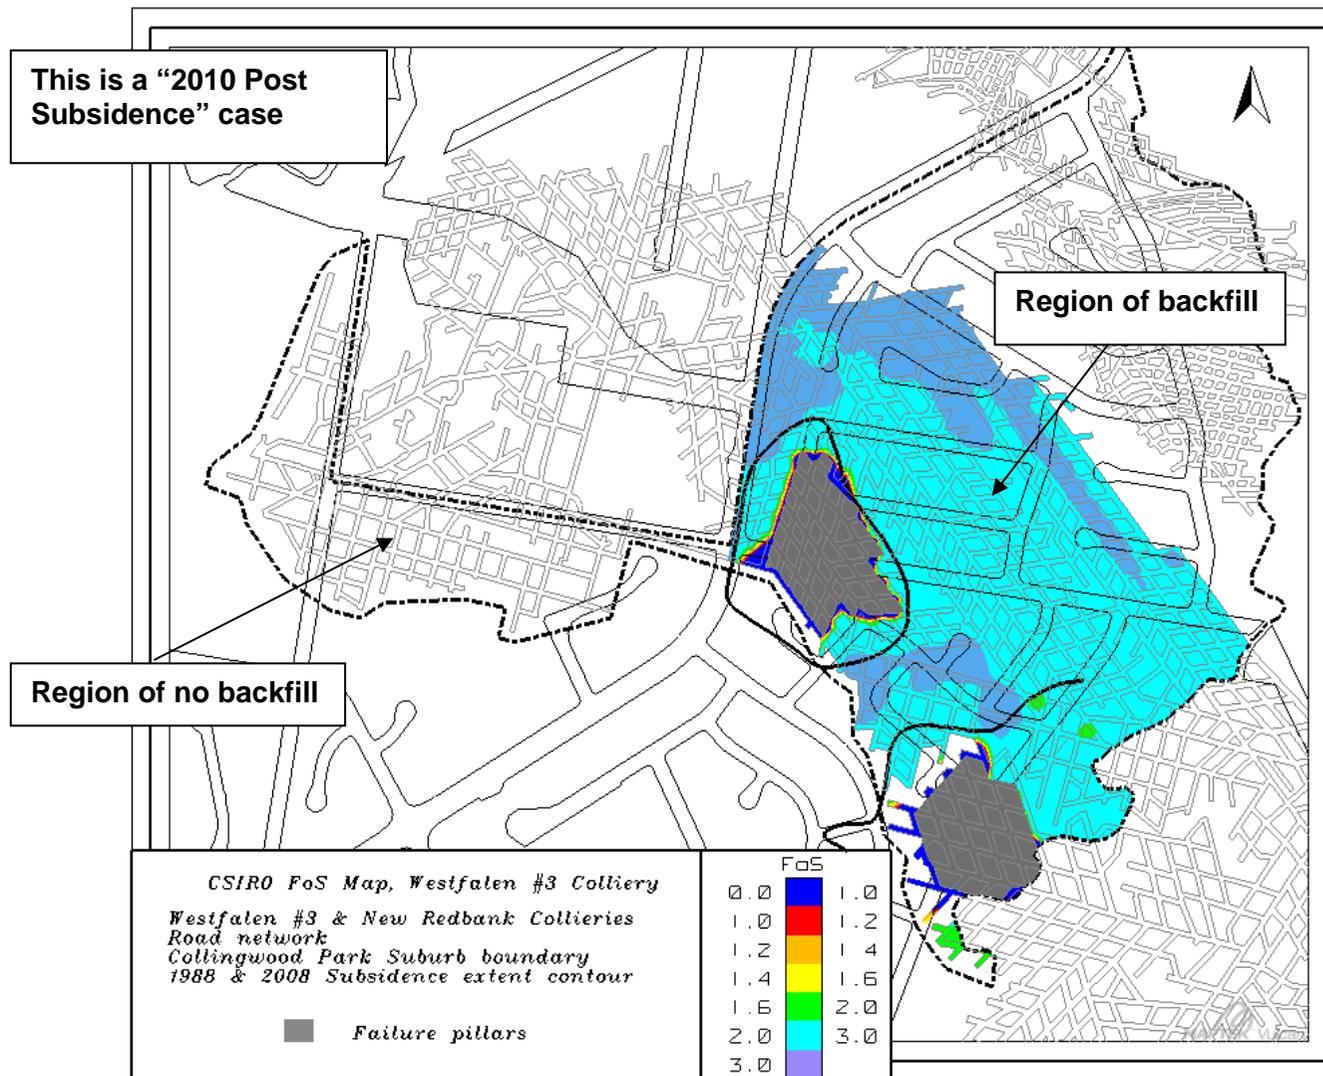
Figure 6-9. FoS Hazard Map with 90% roadway fill using 0.5MPa cohesive backfill, minimum 10% FoS (i.e 90% confidence level). All roadways except those on the western side of Collingwood Drive are backfilled.

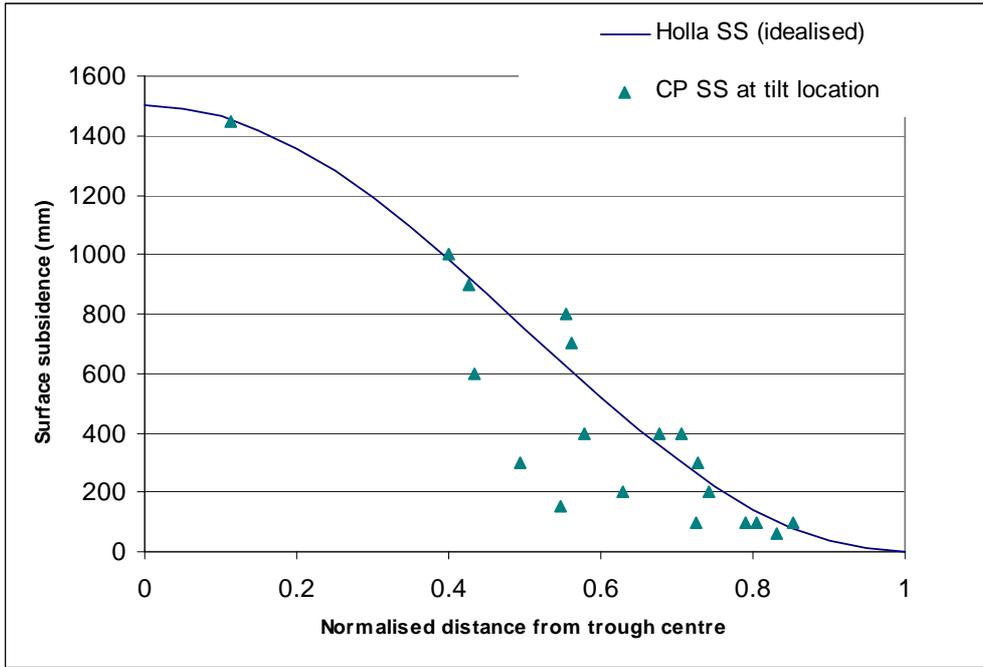
Figure 6-11. Collingwood Park measured subsidence with Holla ground subsidence formula.

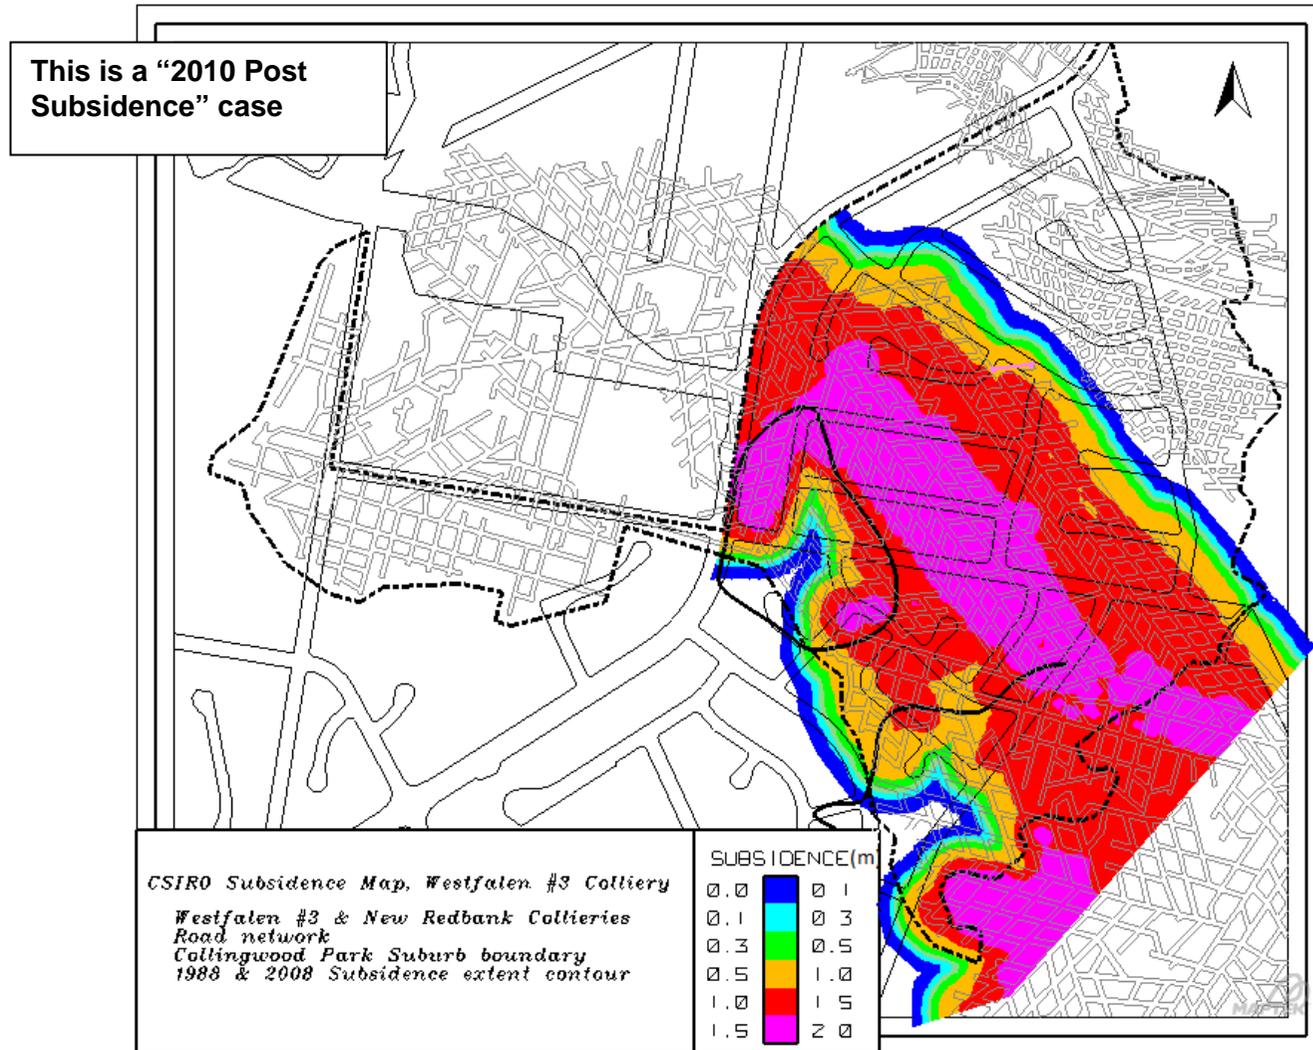
Figure 6-12. Estimated surface subsidence assuming ALL pillars fail with NO backfilling. Assumes height equal to 90% of the maximum reported height for each mining zone.

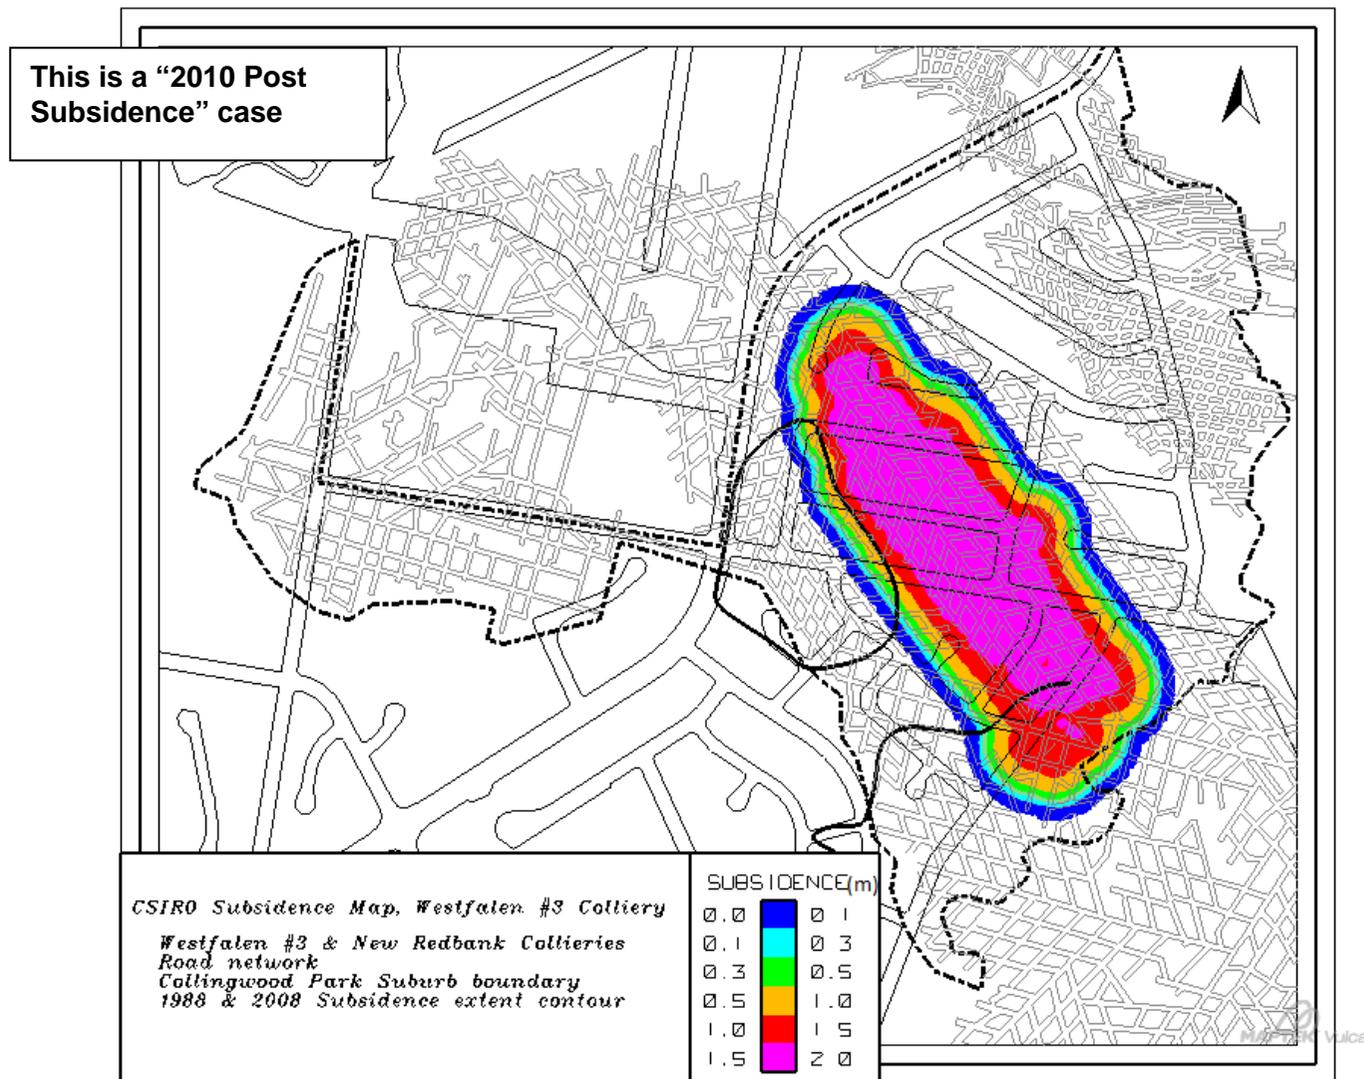
Figure 6-13. Estimated surface subsidence assuming central pillars fail with NO backfilling. Assumes height equal to 90% of the maximum reported height for each mining zone.

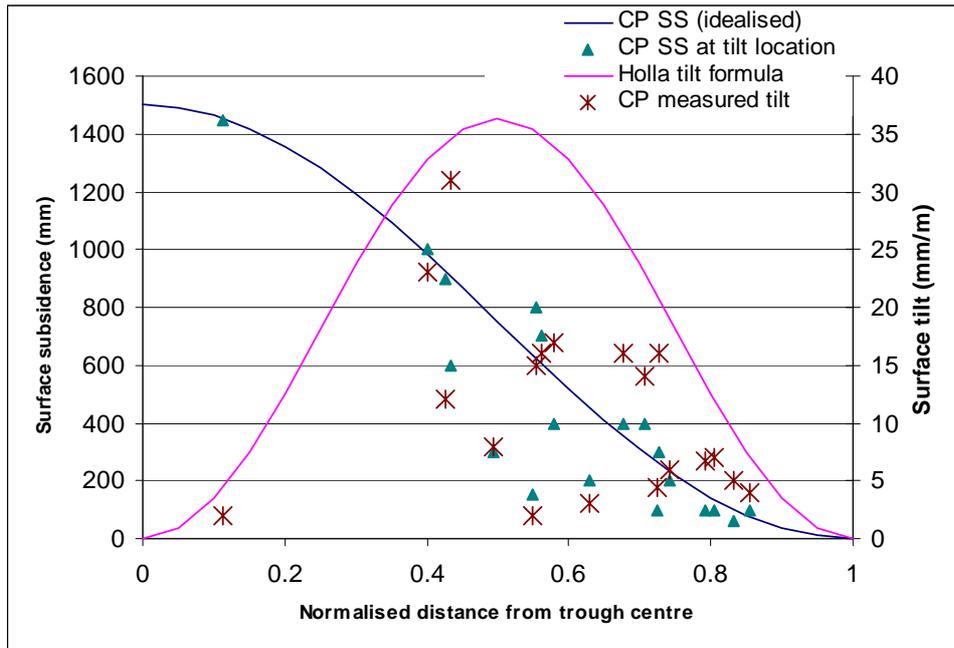
Figure 6-16. Measured tilts and subsidence at Collingwood Park are compared with Holla ground tilt formula. Note measured tilts are on foundations and will generally underestimated ground tilts.
