# Review of Causes of Northern Bribie Island Erosion

Customer Department of Environment  
and Science  
Project A11928  
Version 04  
6 February 2023

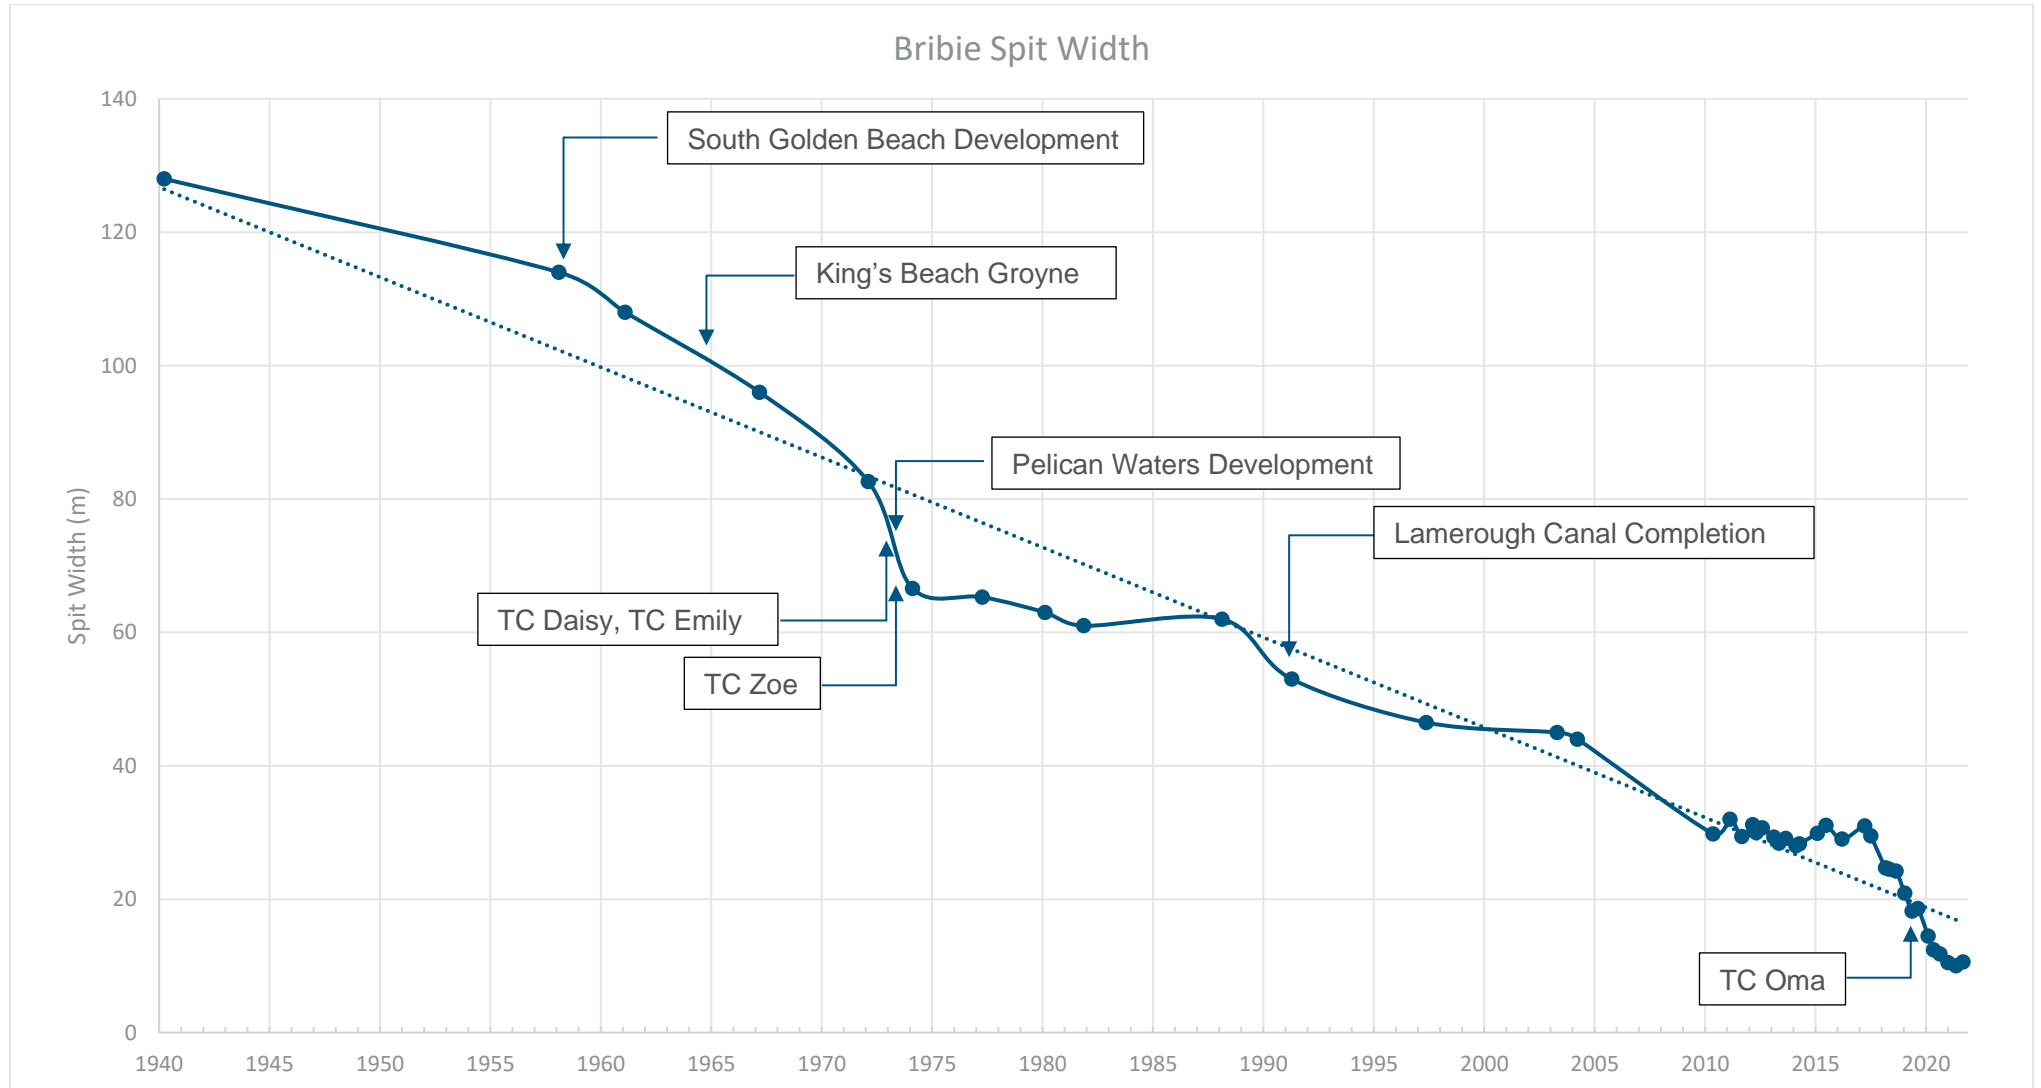
Figure 3.4 Vegetated width of Bribie Island at the location of the tidal breakthrough

Northern Bribie Island is shown to be consistently eroding since before the mid-20<sup>th</sup> century development of Golden Beach (Figure 3.4). Closely spaced cyclones in the early 1970s of TC Daisy, TC Emily and TC Zoe are clearly seen in the trend line, as the beach was not able to recover between events, while other events, such as TC Oswald (2013) are not prominent in the time series due to the healthy beach condition prior to the event. The erosion trend also accelerated in 2019, when TC Oma caused overwash of the island, resulting in vegetation loss at the breakthrough location and leading to subsequent dune erosion. The trend indicates reasonably consistent narrowing of northern Bribie Island of approximately 1.3m/year, and does not show acceleration by obvious human interventions such as the construction of the Kings Beach groyne in the late 1960s or Lamerough Canal in the late 1980s. Instead, the trendline indicates that consistent change has been occurring since before intensive development of the area occurred.

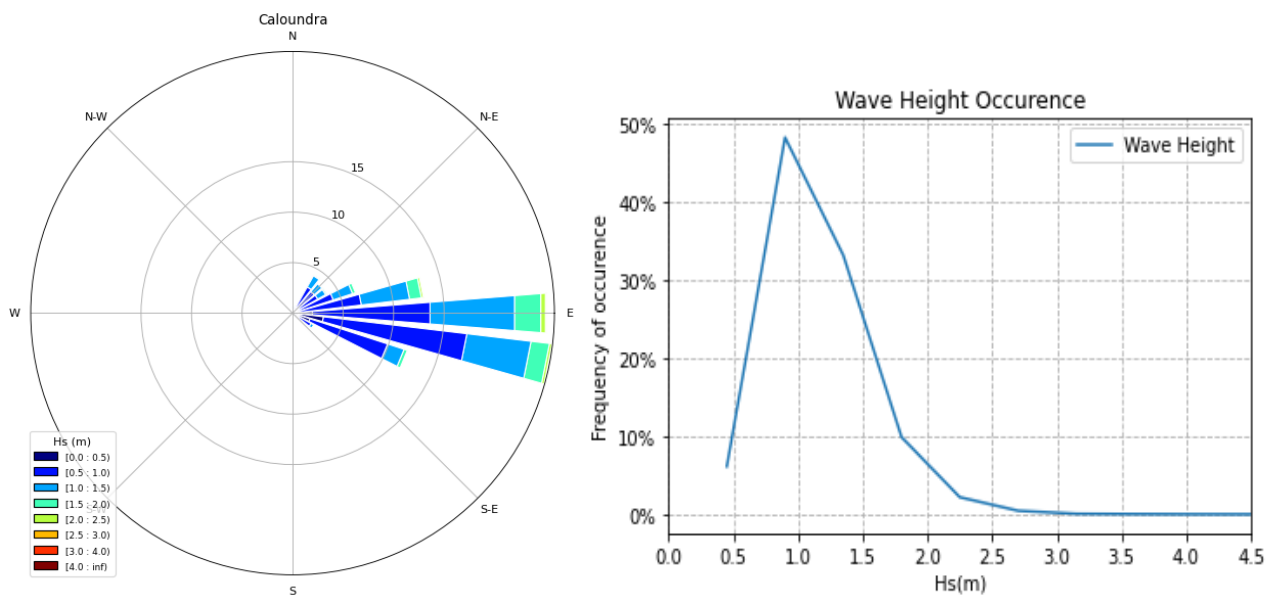
Figure 3.7 Wave conditions at the Caloundra wave buoy for the period 26/04/2013 to 31/03/2022.

Wave conditions on the open (eastern) coast of Bribie Island are recorded by the Caloundra waverider buoy (Queensland Government 2022), approximately 3.3km southeast of the recent breakthrough location (refer Figure 1.1). Operational since 2013, the Caloundra wave buoy is jointly operated by the Department of Environment and Science and the Port of Brisbane Corporation to monitor conditions in the North West Channel. The wave conditions at the Caloundra buoy (Figure 3.7) show a narrow range of wave directions from the east and east-southeast, with a median significant wave height of slightly more than 1m. The location of the wave buoy is partially protected from northeast wave conditions by the Hamilton Patches, and it is possible that the northern section of Bribie Island, which is unprotected from this direction, receives more wave energy from the northeast than the wave buoy indicates.

Sandy beaches exposed to wave impacts will tend towards an alignment that is perpendicular to the mean wave direction (Goodwin, Stables and Olley, 2006). The northern portion of Bribie Island exhibits a clockwise rotation of beach alignment from south to north of up to 25 degrees, indicating a change in wave exposure along the coast. Northern Bribie Island is well aligned with modal wave conditions from the east-southeast, but poorly aligned with wave conditions from the northeast. As such, it is expected that shoreline-oblique waves experienced during northeast swell conditions will result in longshore transport of sand to the south. Without southeast wave exposure of the southern parts of Bribie Island, this sand is not returned to northern Bribie Island, but accumulates along southern and central Bribie Island where the shoreline is rotated more perpendicular to the northeast swells. Further wave modelling would be useful to establish a sediment budget for these conditions and better understand the protection of Bribie Island from the sand patches.

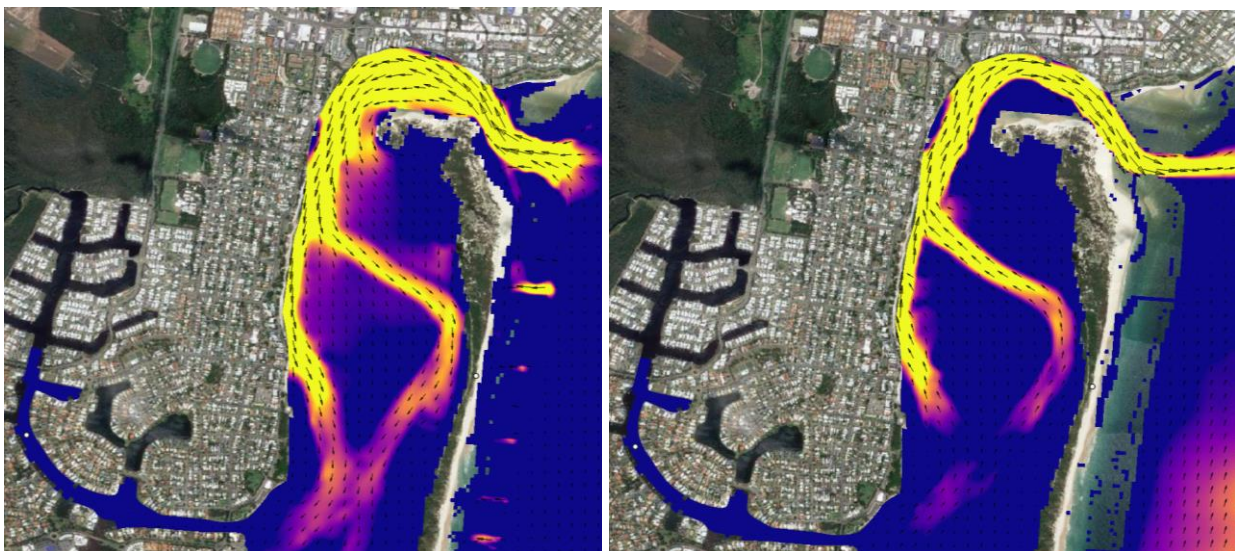
Figure 3.8 Peak flood tide (left) and ebb tide (right) for Pumicestone Passage for normal tide-only conditions.

- Peak flood tide velocities on the western side of Bribie Island at the recent breakthrough location are higher than ebb tide velocities by approximately 30%. Peak tidal velocities at the recent breakthrough location for flood tides are approximately 0.5m/s and ebb tides are 0.35m/s.
- The peak flood tide currents are more concentrated in the channels, while during the peak of the ebb tide currents more flow is distributed across the large sand shoal west of the recent breakthrough location.
- The concentrated flood tide direction turns through approximately 90 degrees at the location of the recent breakthrough, while on the ebb tide this occurs further north of the recent breakthrough location.

Overall, these results indicate that the flood tide currents are of more of a driver for erosion along the western shoreline of Bribie Island, both due to their magnitude and the direction at which they approach the Island at certain locations.

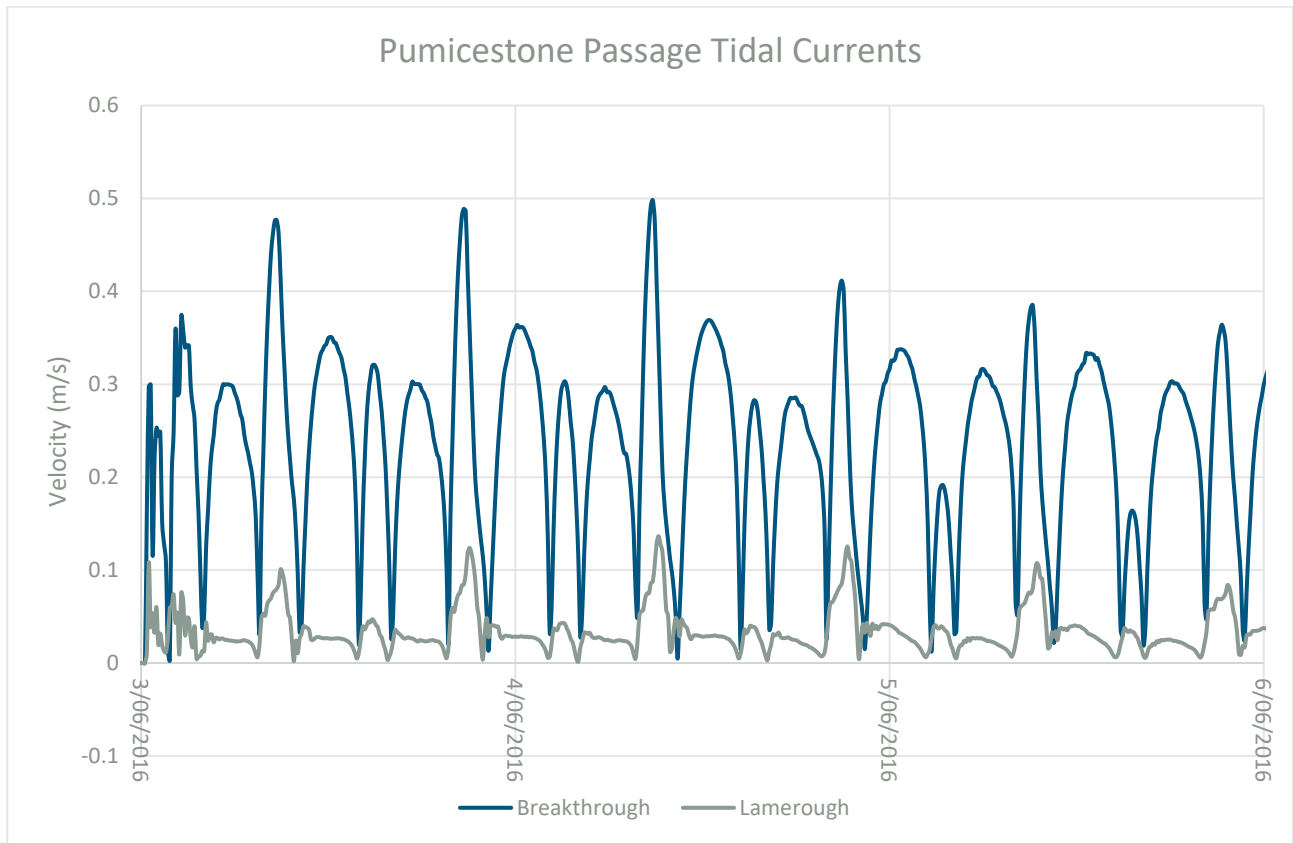
Figure 3.9 Distribution of tidal currents for a location adjacent to the recent breakthrough and at the mouth of Lamerough canal.

Tidal velocities at the entrance to Lamerough canal were assessed against those in the main channel to evaluate their contribution to the overall flow. To do this, a timeseries was extracted from a point within the entrance to Lamerough canal and a point within the eastern channel adjacent the western shoreline of Bribie Island and compared (Figure 3.9). The assessment shows that peak flood tide velocities in Lamerough Canal are approximately 0.13m/s, twice as high as ebb tide velocities, and considerably lower than the tidal velocity in the channel, which is up to 0.5m/s. With the main driver of erosion occurring due to flood currents, the entrance of Lamerough canal is therefore ‘downstream’ of where the channel passes close to the Island and thus is not a contributor to flood tide erosion.

Furthermore, with both the volume and velocity of the water exiting the canal being considerably lower than in the main channel, no influence from the canal on the main channel direction or velocity is detectable within the existing dataset. Further modelling could be undertaken to quantify the contribution, but given the canal is only ‘upstream’ during ebb tides, which are not the major contributor to the erosion of the western shoreline of the island, this is not expected to provide any further useful insight.

- The development of Lamerough canal does not significantly influence the flow of currents in Pumicestone Passage. Ebb tide currents exiting the canal are shown to be below 0.05m/s, approximately 10% of the peak flood currents in the main channel. Furthermore, the erosion to the western shoreline of Bribie Island has been shown to be caused by flood tide flows and not ebb tide flows, and as such, there is no causal link between the outflow from Lamerough canal and the erosion.

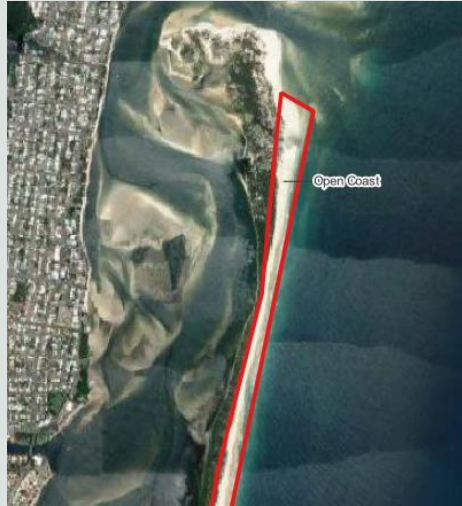
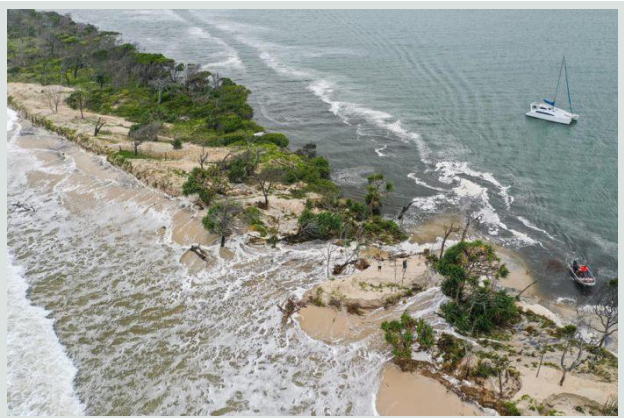
Postulated Cause 1b		Natural Coastal Processes (Wave erosion)	
<p><b>Postulated Erosion Mechanism</b></p> <p>Large waves generated primarily by tropical lows and cyclones in the Coral Sea erode the beach that is not completely balanced by accretion between events, resulting in a reduced beach width over time.</p>

<b>Commencement of Activity</b>	Pre-1940's	<b>Correlated with erosion?</b>	Yes
<p><b>Physical Process</b></p> <p>Large wave events periodically impact the eastern beaches of Bribie Island, causing erosion of the shoreline. Eroded sand from these events is typically transported south towards Woorim and north towards the entrance of Pumicestone Passage, where it accumulates within the sand bars in the channel.</p> <p>Longshore sand transport at northern Bribie Island is split with the northern 1km travelling net north into Pumicestone Passage and shoreline south of this travelling net south towards Woorim. There is limited evidence of cross shore sand transport, as evidenced by the presence of a series of indurated sand (coffee rock) reefs. Consequently, there is insufficient nearshore supply to replenish the beach, resulting in a disequilibrium of sand transport, where the volume eroded is not fully restored before the next storm occurs, resulting in long term shoreline recession.</p> <p>Periods of increased erosion correlate with periods of increased SEQ tropical cyclone activity, such as in the early 1970s.</p>

<b>Assessment of Magnitude</b>		<b>Magnitude of Contribution</b>	Major
<p>The short-term (storm) erosion along northern Bribie Island can be in the range of tens of metres, with sand transported primarily south away from the site. There is limited sand resupply to the site between events which results in long term sand deficit. This sand deficit forces year-on-year recession in the order of metres to tens of metres consistent with observed records.</p>

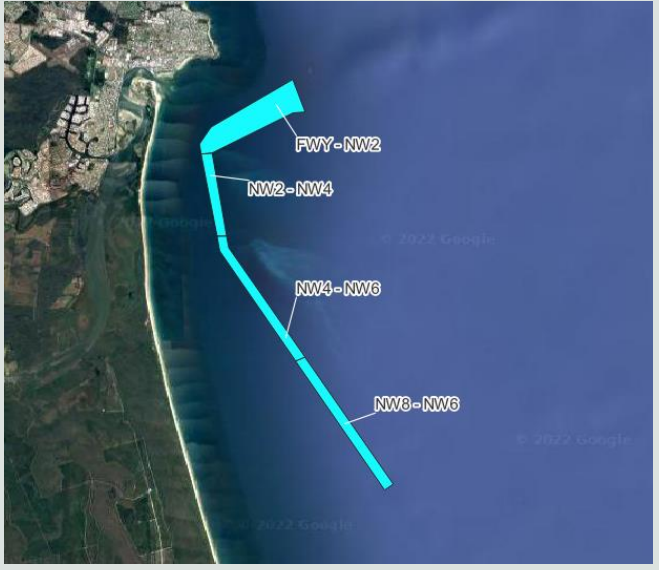
Postulated Cause 3		Dredging of North West Channel	
<p><b>Postulated Erosion Mechanism</b></p> <p>Dredging of the Northwest channel creates a sand sink, with sand from the eastern shoreline of Bribie Island eroding to fill in the dredged portions of the channel.</p>

<b>Commencement of Activity</b>	2000	<b>Correlated with erosion?</b>	No
<p><b>Physical Process</b></p> <p>A review of the bathymetric expression between the eastern shoreline of Bribie Island and the nearest dredged region of the Northwest channel indicates that there is limited cross shore sand transport. The nearshore region (within 500m of the coastline) has a stable profile of 1.5 vertical meters for every 100m horizontally. Between 500m and 1500m offshore, this profile flattens to 0.9 vertical meters for every 100m and flattens completely between 1500m and 1700m offshore, where the nearest dredging occurs. Furthermore, there is a continuous outcropping of indurated sand between the eastern shoreline of Bribie Island and the Northwest channel that indicates that there is limited cross shore transport.</p> <p>As a result, there is no evidence that dredging of the Northwest channel is creating erosion pressure on the eastern shoreline of Bribie Island.</p>		<p><b>Causal Link?</b></p> <p>No</p>

<b>Assessment of Magnitude</b>	None	<b>Magnitude of Contribution</b>	None

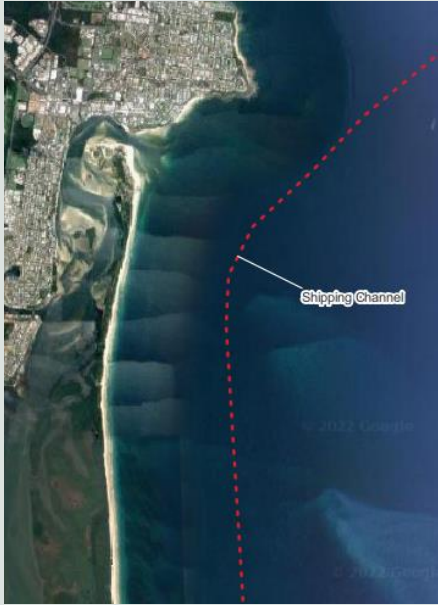
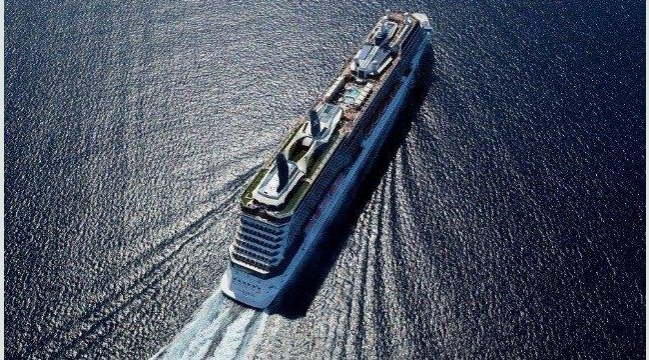
Postulated Cause 4a		Ship Wake and Propeller Wash	
<p><b>Postulated Erosion Mechanism</b></p> <p>Waves and propeller wash from large ships in the shipping channel (North West Channel) create erosion on the eastern shoreline of Bribie Island, resulting in long term recession.</p>

<b>Commencement of Activity</b>	Pre-1940	<b>Correlated with erosion?</b>	Yes
<p><b>Physical Process</b></p> <p>Large container ships create turbulent thrust from their propellers and a wake wave as they travel through the water. A recent study (Metters, Waldron and Ryan, 2021) reviewed the magnitude of these waves at the Caloundra Site, with ship waves of up to 0.3m detected offshore. These waves are only detectable during very calm days, where there is minimal background wave activity.</p> <p>The average ambient wave height at the Caloundra buoy is 0.92m, while storm events, such as TC Seth that triggered the recent ultimate breakthrough, have peak waves in excess of 5m. As such, wave activity from boat traffic is scarcely noticeable, and are an insignificant part of the total wave energy arriving at these shores.</p> <p>Turbulence from boat propellers is dissipated quickly, with scour from boat propellers detectable only in shallow water within a short range of the propeller (Cui et. al. 2019). As such, it is not plausible that propeller turbulence is contributing to erosion at Bribie Island.</p>

<b>Assessment of Magnitude</b>		<b>Magnitude of Contribution</b>	Insignificant
<p>While ship wakes do reach the shoreline of Bribie Island, the magnitude of energy when compared with the background wave conditions is minuscule. Ship propeller turbulence does not influence the Bribie Island shoreline.</p>

A recent study (Metters, D. et. al, 2021) reviewed the generation of waves from container ships offshore of Bribie Island. The study utilised the Caloundra wave buoy to identify ship wake from a passing container ship with a length of 228m, travelling at 12.7 knots. The waves generated from the ship wake are challenging to distinguish from background wave conditions, however, on exceptionally still days with very little wind and wave activity ship wake can be detected. The results indicate that ship wake can reach a wave height of approximately 0.2-0.3m with a wave period of approximately 5 seconds.

Wave records from the Caloundra wave buoy have been extracted for the period 01/01/2021 to 31/03/2022 and the wave energy calculated for each 30 min recording period. An approximation of the wave power has been calculated using the deep-water wave power approximation formula shown in Equation 5.1 and converted to wave energy in Equation 5.2. A synthetic record of ship wake waves for the same period has been created based on a total number of 20 passages per day of large ships, which is at the upper end of the number of vessels per day observed in the records. Figure 5.1 shows the significant wave height and wave energy for each 30-minute window within the extracted date range for both natural waves and ship wake. Figure 5.2 shows the contribution to total wave energy for natural waves and ship wake across this time period. The results show that the contribution of wave energy generated from ship wake detected at the Caloundra wave buoy is insignificant (less than 0.1% of total energy) when compared with background natural wave conditions.

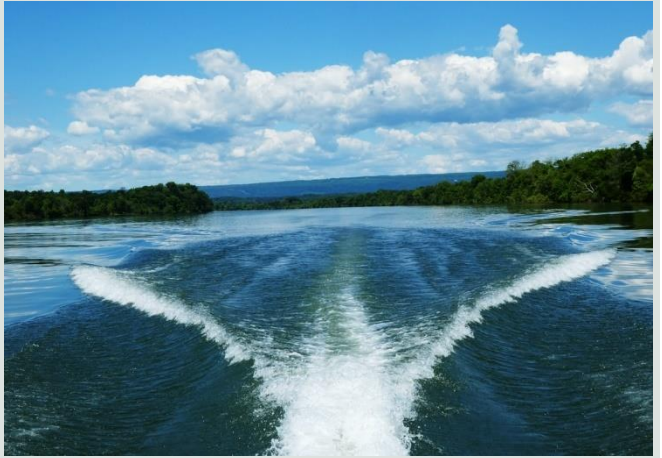
<p><b>Commencement of Activity</b></p> <p>1950s</p>	<p><b>Correlated with erosion?</b></p> <p>Partial</p>			
<p><b>Physical Process</b></p> <p>Several studies have looked at boat wash contribution to the erosion of estuary banks. There is some agreement that boat wash creates erosion of the bank, in combination with riverine or tidal flows transporting eroded sediments away from the target site.</p>

<p><b>Causal Link?</b></p> <p>Yes</p>		
<p><b>Assessment of Magnitude</b></p> <p>The literature has contrasting opinions of the contribution of boat wash to estuary bank erosion, that appears to be highly site dependent. Moreover, there does not appear to be an acceleration of erosion trends at Bribie Island as boat traffic increased post development of Golden Beach and Pelican waters.</p> <p>A detailed study of boating traffic in the waterway would be required to confirm the magnitude of this erosion mechanism at this location, however it is not expected to be significant compared to the contribution of other erosion mechanisms.</p>		<p><b>Magnitude of Contribution</b></p> <p>Insignificant</p>

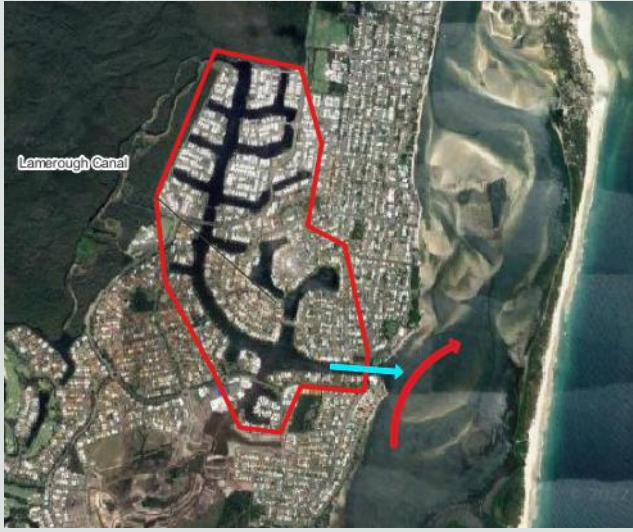
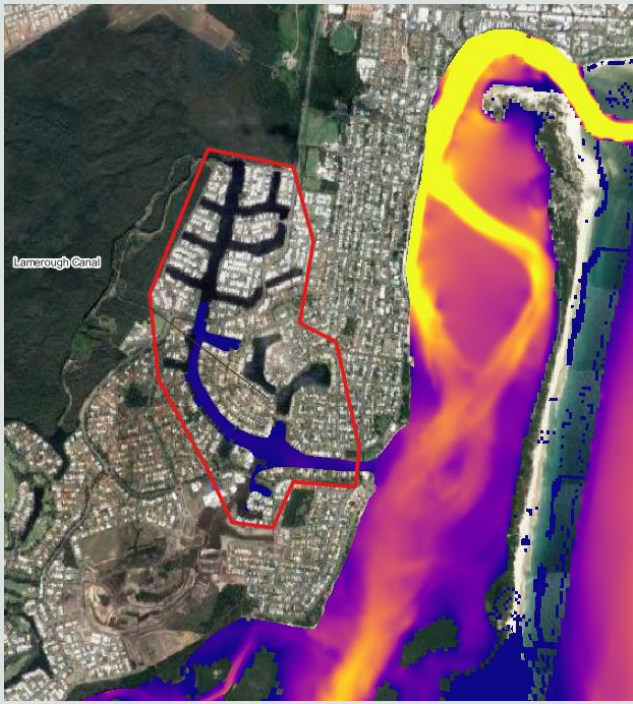
Postulated Cause 5		Development of Lamerough Canal	
<p><b>Postulated Erosion Mechanism</b></p> <p>Increased currents from Lamerough canal produce a 'jet' of water that pushes the main channel to preferentially flow through the eastern channel, adjacent to Bribie Island on the ebb tide.</p>

<p><b>Commencement of Activity</b>      1980's</p>	<p><b>Correlated with erosion?</b></p>		<p>Partial</p>
<p><b>Physical Process</b></p> <p>A review of a calibrated coastal process model for Pumicestone Passage indicates that ebb tide currents from Lamerough canal are below 0.05m/s, while main channel currents are at 0.4m/s. The model does not indicate that the canal currents provide any noticeable hydraulic control to the main channel.</p> <p>Furthermore, the presence of a flood tide shoal south of the recent breakthrough location indicates that erosion on the Pumicestone Passage shoreline of Bribie Island is driven by flood tides, which is supported by model results.</p> <p>The image (right) shows the velocity of water in Pumicestone Passage during a peak ebb tide. Of note, the channel deflects further north of Lamerough canal due to sand shoals, but both the east and west channel have similar flow velocities. The east channel is deflected away from the recent breakthrough area by the presence of the flood-tide shoal.</p>

<p><b>Assessment of Magnitude</b></p>		<p><b>Causal Link?</b></p>	<p>No</p>
<p>There is no evidence to support that flows in Lamerough Canal contribute to the erosion of Bribie Island.</p>		<p><b>Magnitude of Contribution</b></p>	<p>None</p>

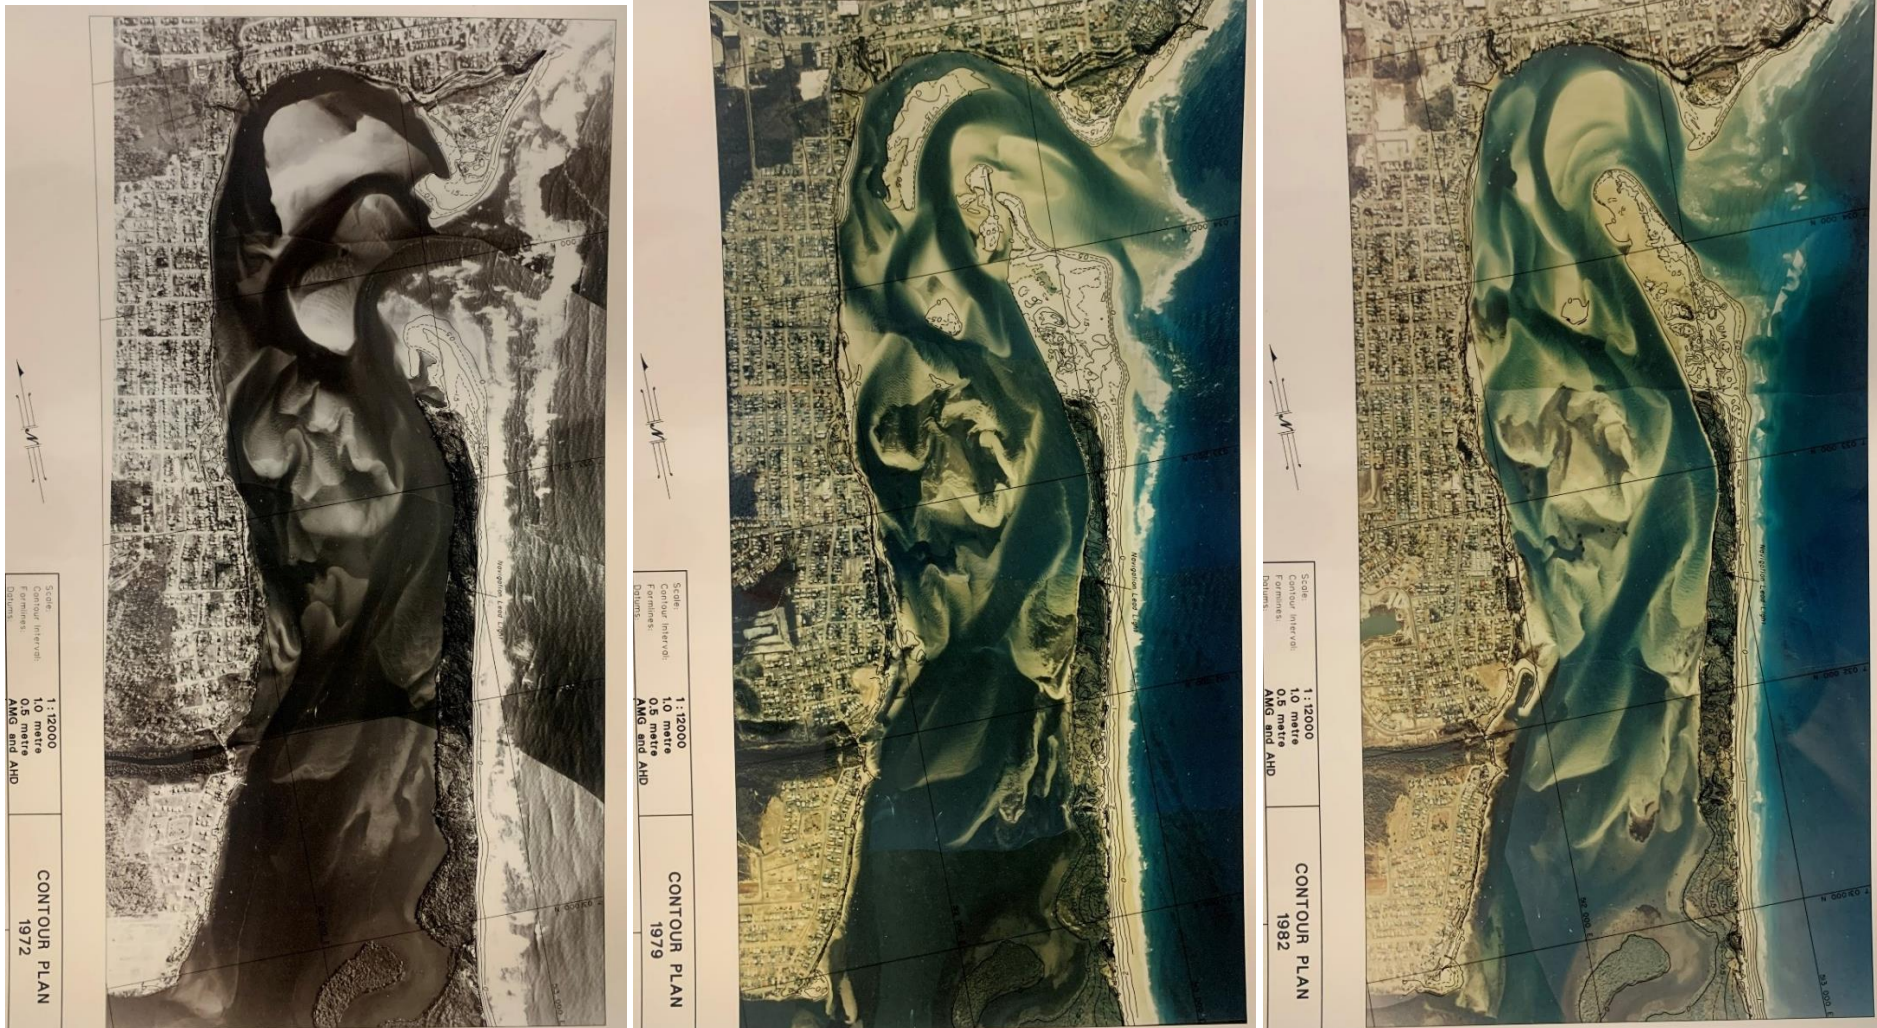
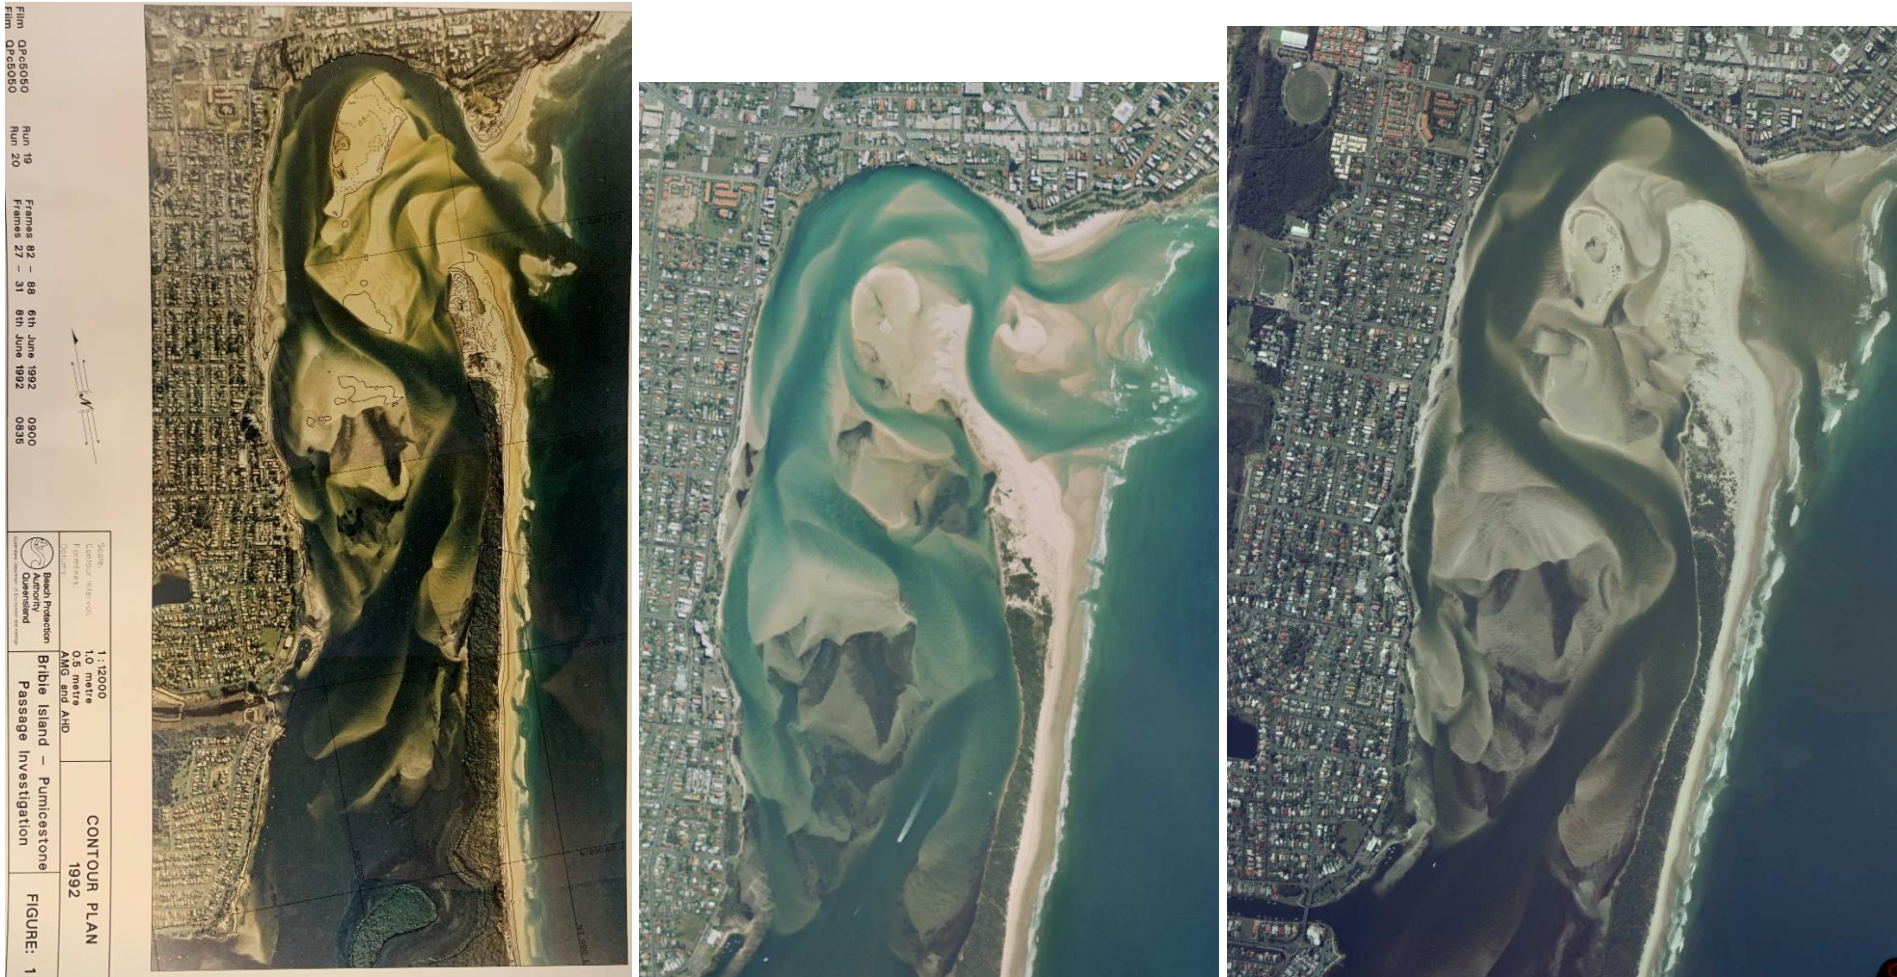
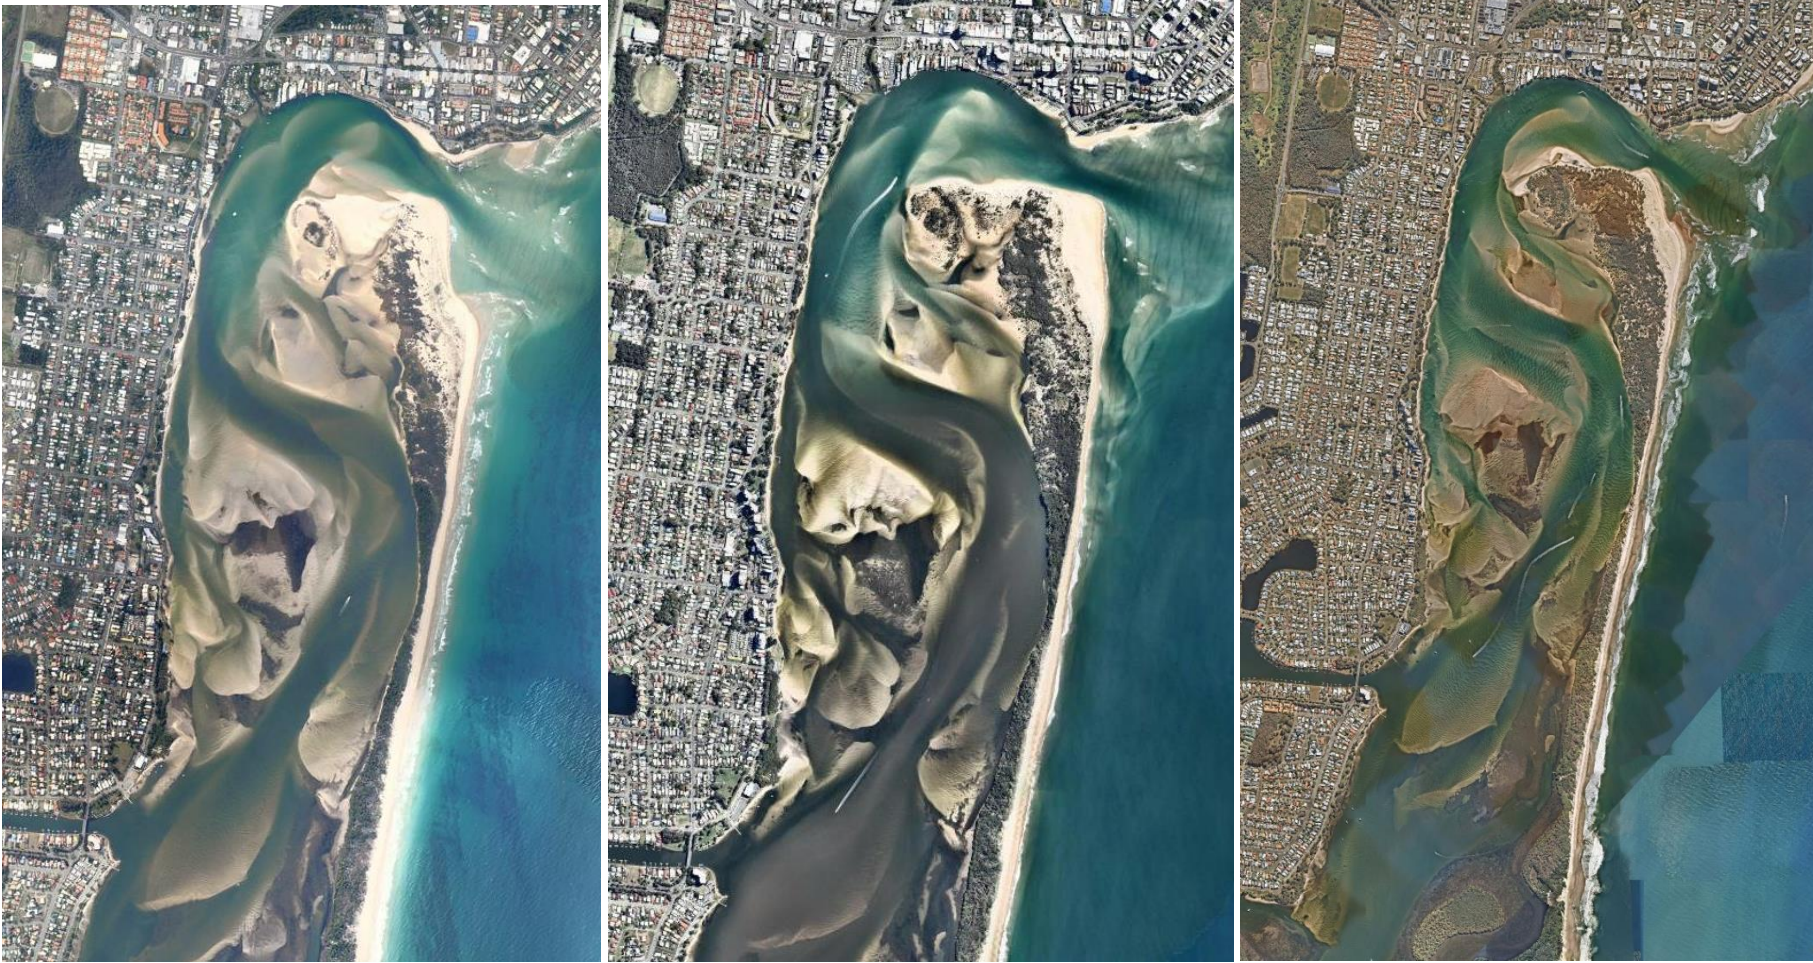
Figure A.1 Aerial images from 1940 (left, Source: BPA), 1961 (centre, Source: BPA) and 1971 (right, Source: BPA)

Figure A.2 Aerial images from 1972 (left, Source: BPA), 1979 (centre, Source: BPA) and 1982 (right, Source: BPA)

Figure A.3 Aerial images from 1992 (left, Source: BPA), 1997 (centre, Source: QImagery) and 2003 (right, Source: QImagery)

Figure A.4 Aerial images from 2010 (left, Source: Nearmap), 2015 (centre, Source: Nearmap) and 2021 (right, Source: Nearmap)
