Removal of a place from the Queensland Heritage Register

For a more detailed historical context of Ipswich Grammar School, please see Chapter 2 and Section 4.5 of the existing Conservation Management Plan (CMP) (AHS 2023) (Appendix A).

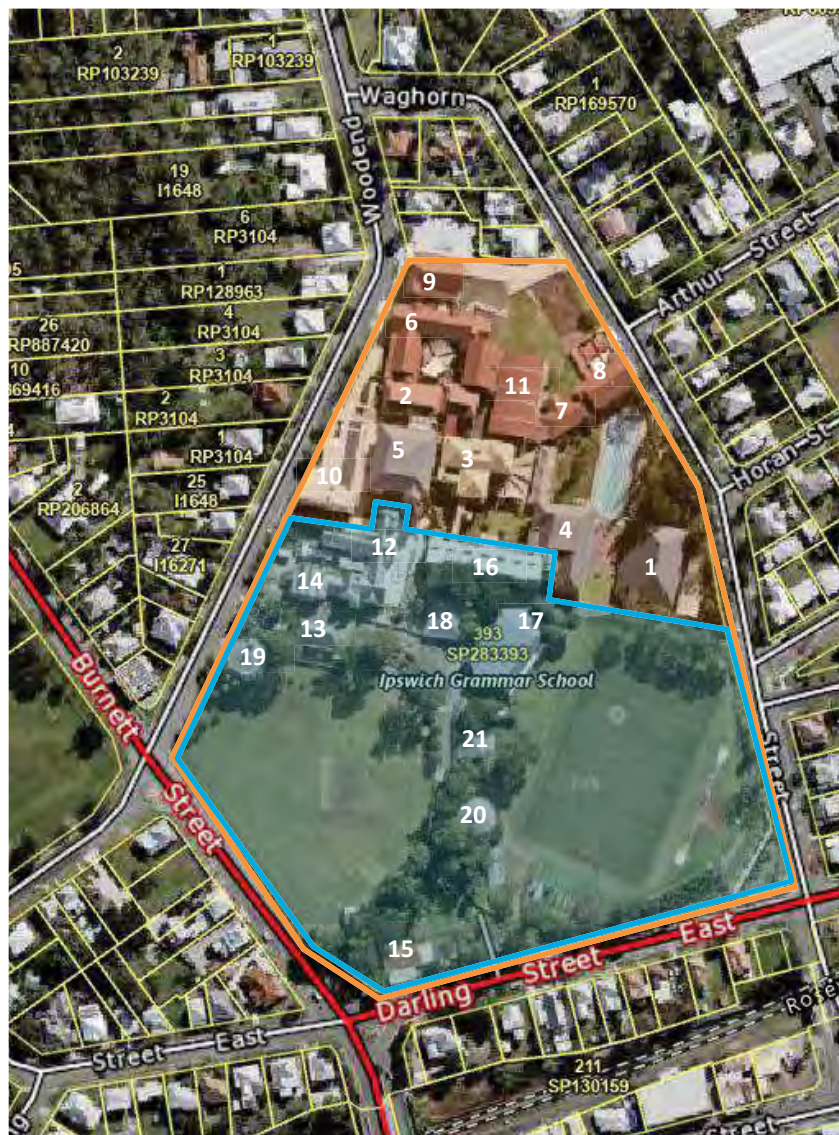
To be removed from existing QHR boundary [Orange]:

1. Ivor G Morris Physical Education Complex (1980)
2. C.A. Turner Manual Arts Building (1981)
3. H.G. Wilson Science Building (1983)
4. Clive Wyman Building (1987)
5. Ladley Centre (1989)
6. Igor Lapa Junior School (1999)
7. Preparatory Block (2005)
8. Early Childhood Education Centre (2009)
9. Junior School Library (2011)
10. STEM Building (2020)
11. Sports Dome (c.2000s)

Figure 1: Current Ipswich Grammar School QHR boundary [Orange]. Proposed updated QHR Boundary [Blue], along with features proposed to be removed and remain within the proposed QHR boundary. Please see Section 4.4 of the CMP for full rationale.

Buildings proposed for removal from the existing QHR boundary include the contemporary buildings located to the north of the Early Building Complex and were constructed from c.1980s onwards. The attached CMP (Appendix A) identifies these buildings as holding no heritage significance. The contemporary buildings proposed for removal from the QHR boundary are as follows (see Figure 1):

Attach a site plan to this form. Any plan/s and map/s in the register entry for the place can be used as base drawings. Tick to confirm: **See Figure 1 for current QHR Boundary, Proposed QHR Boundary and those features/buildings which will be removed from the QHR boundary.**

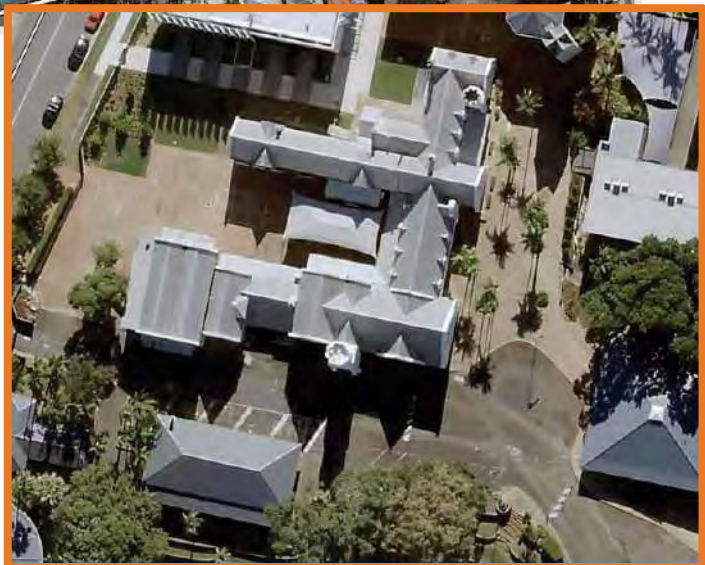
Figure 1: Study Area [blue] and the Early Building Complex including the Great Hall area, inset [orange] (Queensland Globe, 2021).

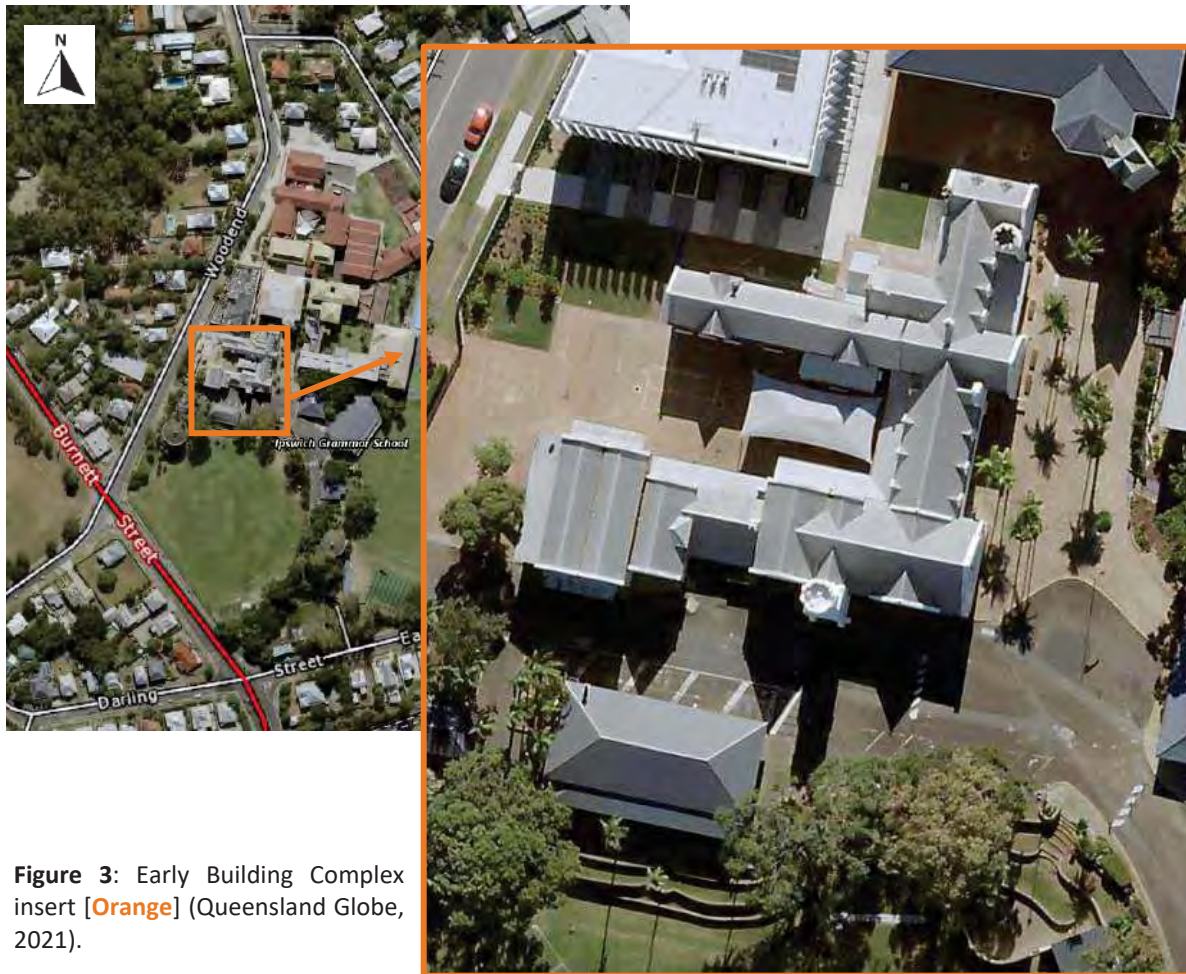
Figure 3: Early Building Complex insert [Orange] (Queensland Globe, 2021).

The objective of the updated CMP is to enable IGS to gain a better understanding of the significance of the place so that their heritage values can be managed, and that development, maintenance and forward capital works planning can be properly progressed. This CMP predominantly focuses on the original and early school buildings, with brief assessments conducted for later buildings (see Figure 3).

the early buildings in detail, with brief assessments and information provided for later and more contemporary buildings (see Figure 3 below).

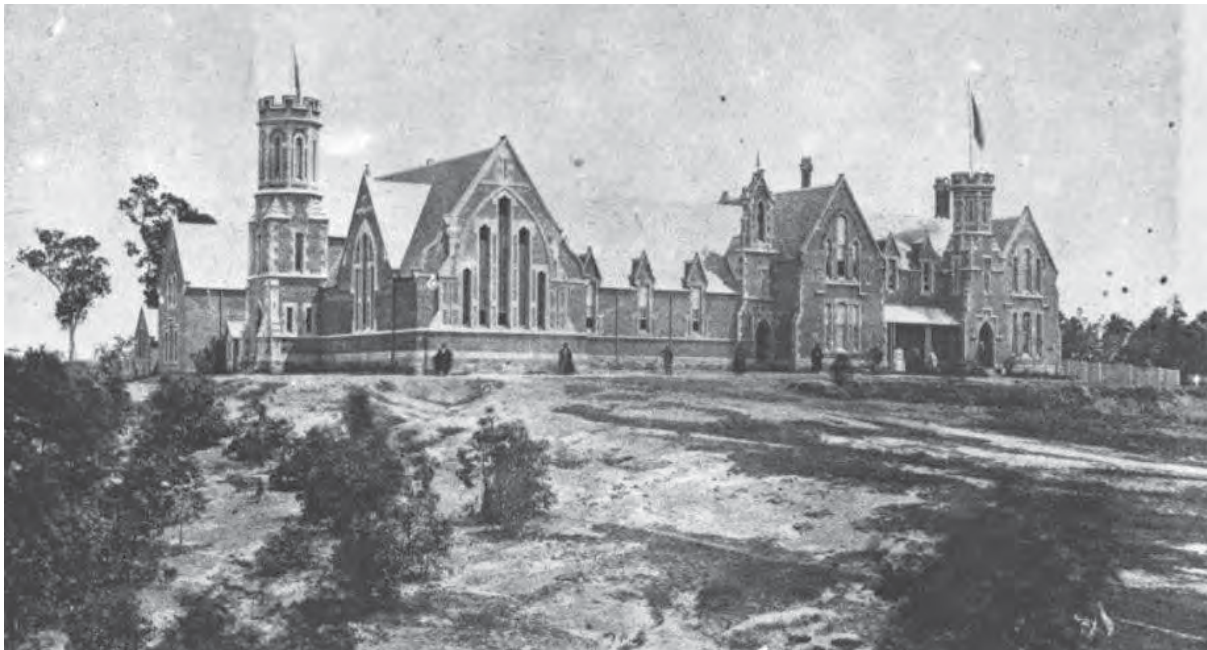
Figure 8: IGS, 1864 Note the sloping topography of the land and the clearance of vegetation, apart from some scrub in the foreground, and single specimens of gum trees in the background (John Oxley Library, Negative No.:69094). (John Oxley Library, Negative No.:69094).

When the school opened in 1863, the school consisted of the upper part of the Great Hall, containing the balcony and most of the wing of the school north of this (i.e., the section containing the bell tower and north tower).

The IGS was originally described as a two-storey red brick building with cement dressings, on a stone foundation and with a slate roof. It included classrooms, a dormitory, dining room, and usher’s room. At the rear were the kitchen, servants’ rooms and scullery. There was also a private residential area for the headmaster and his family; his residence remained in this location within the school buildings until 1962 (CMP, 2010: 12).

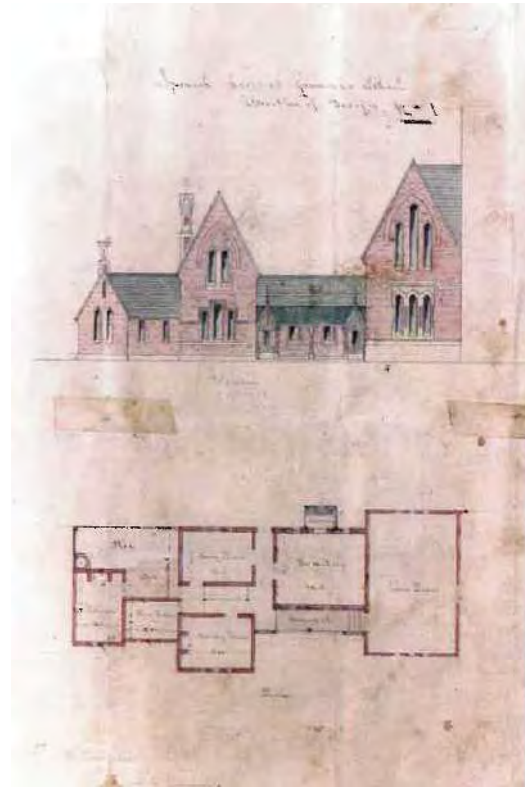
The new hall was an extension of the original hall, built at a slightly lower level and at right angles, making the whole hall a T-shape. The original 1863 hall was also re-floored at this time (CMP, 2010: 14).

Figure 10: Extension plan, c.1865 (Image taken from Sophie Church, 2013: 241). Note the Tower is missing from these plans.

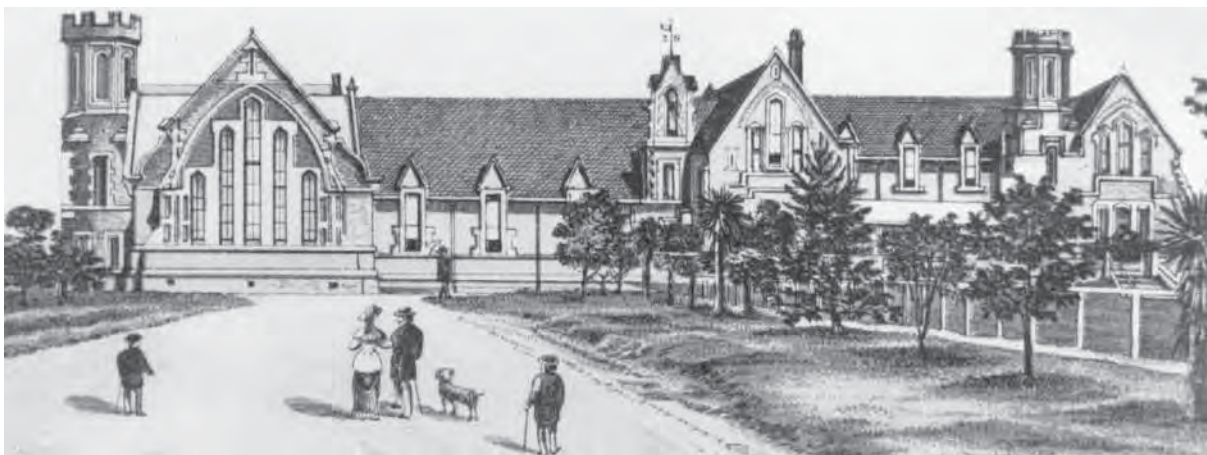
Figure 14: Sketch of IGS, date unknown though the clothing of the figures indicates late-19th or early-20th century (John Oxley Library, Negative No.: 58645). Note that the building is also drawn to be a rendered building.

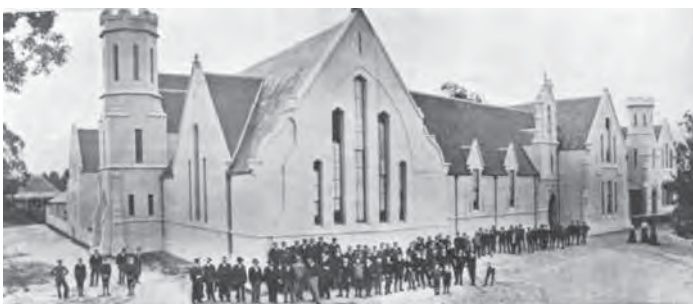
Figure 15: IGS, c.1912 (John Oxley Library, Negative No.: 202392). Note that by 1912 the building has been rendered.

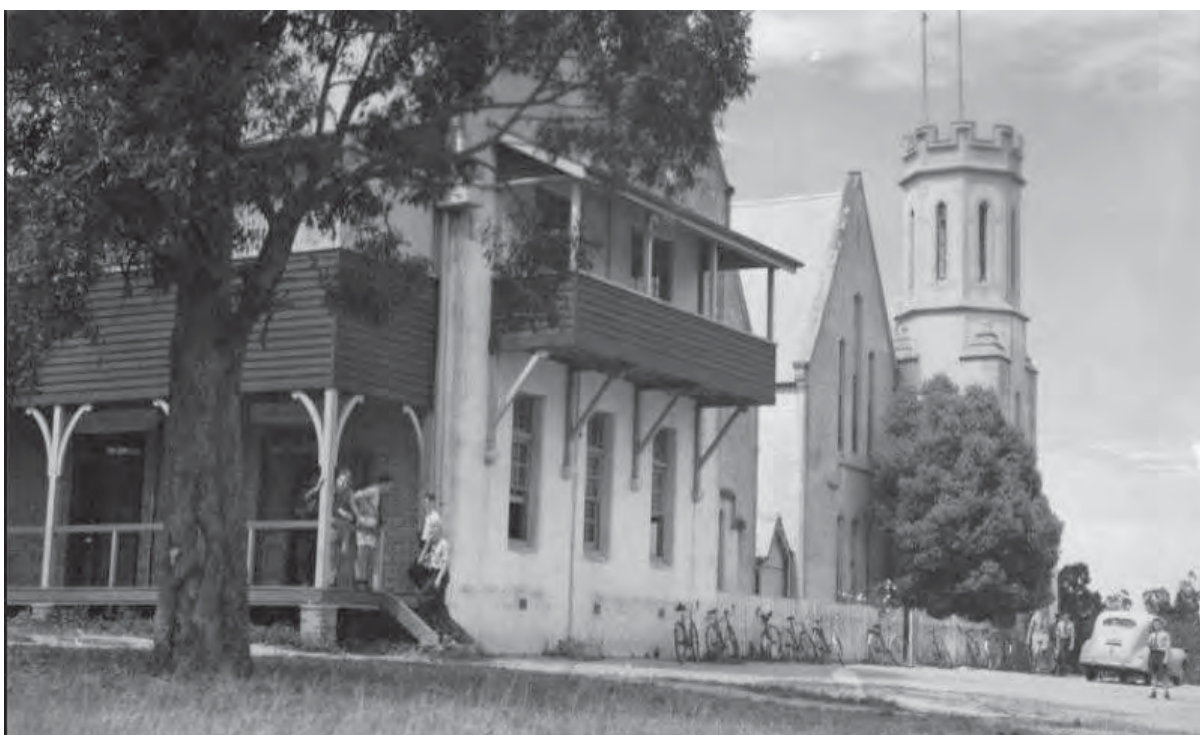
Figure 21: South West corner of the early building complex showing Bradfield House extension, n.d. (John Oxley Library, Negative No.: 202384). Note the cantilevered weatherboard balcony is not enclosed at this time and matches the detail of the northern façade addition (see Figure 19 above) (photo assumed to be c.1940s). The balcony was not enclosed until after 1965.

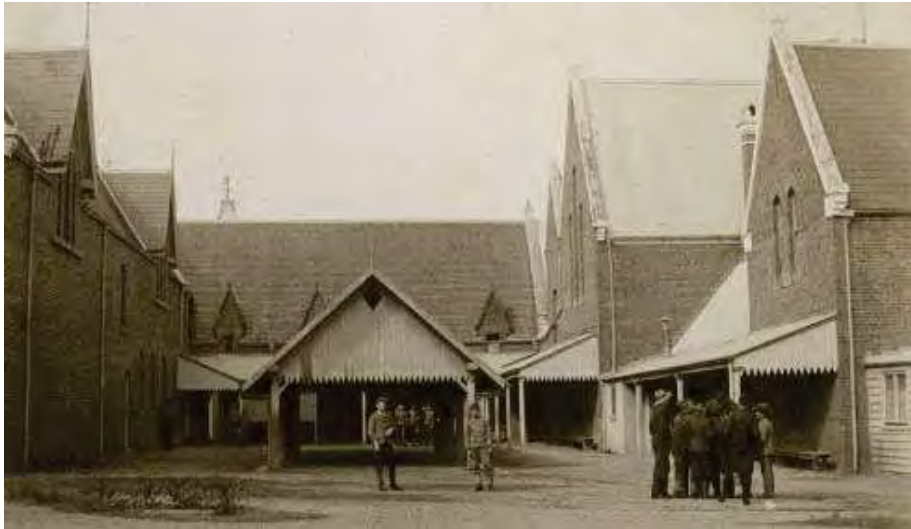
Figure 22: Quadrangle / courtyard, c.1910 (Ipswich Library, Reference No.: qips-2011-09-06-0035p). Note the small gabled structure in the centre that has long since been demolished. Also note that the buildings are un-rendered on these facades in 1910, suggesting there was different phases of rendering.

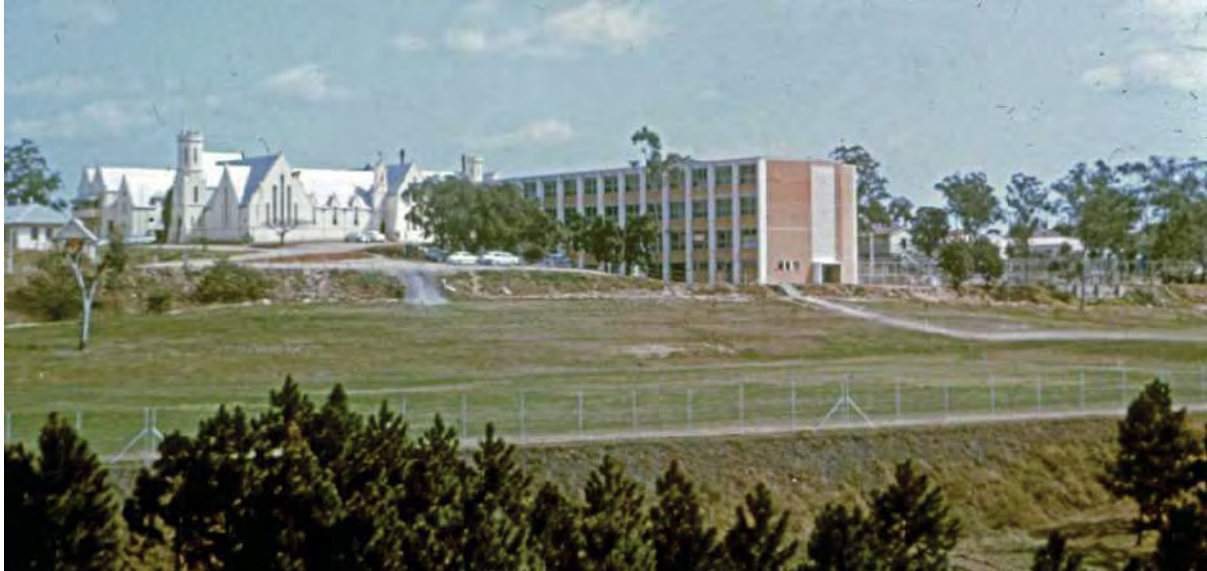
Figure 24: View of IGS from Waghorn Street, 1969 (Ipswich Library, Reference No.: qips-2010-02-20-0060p). Note the Secondary Block which, at the time of its construction, was regarded as being obtrusive to the original buildings, especially from the eastern views from the Ipswich CBD.

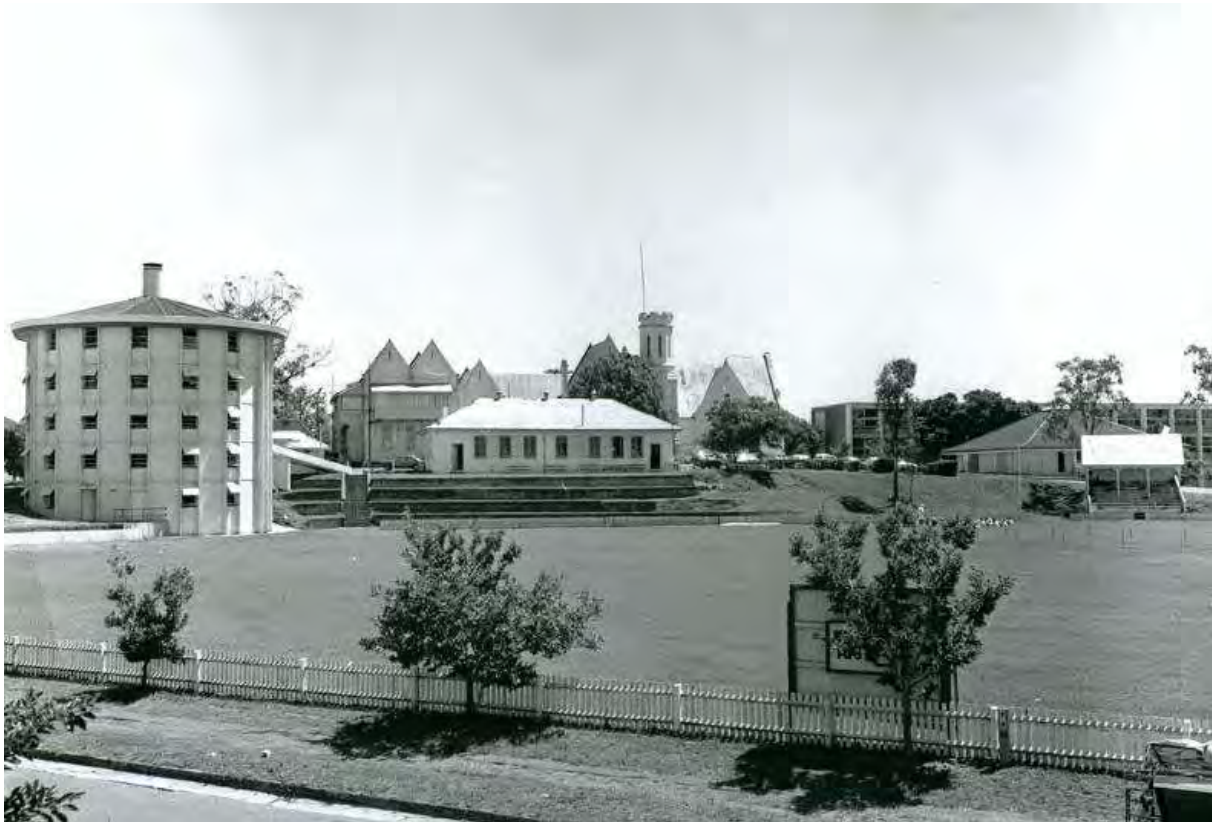
Figure 25: IGS, 1970 (Ipswich Library, Reference No.: qips-2011-06-07-0016p). Note the Fox Tower (left) and that some terracing has occurred below the former science building. The Fox Tower dominates in scale.

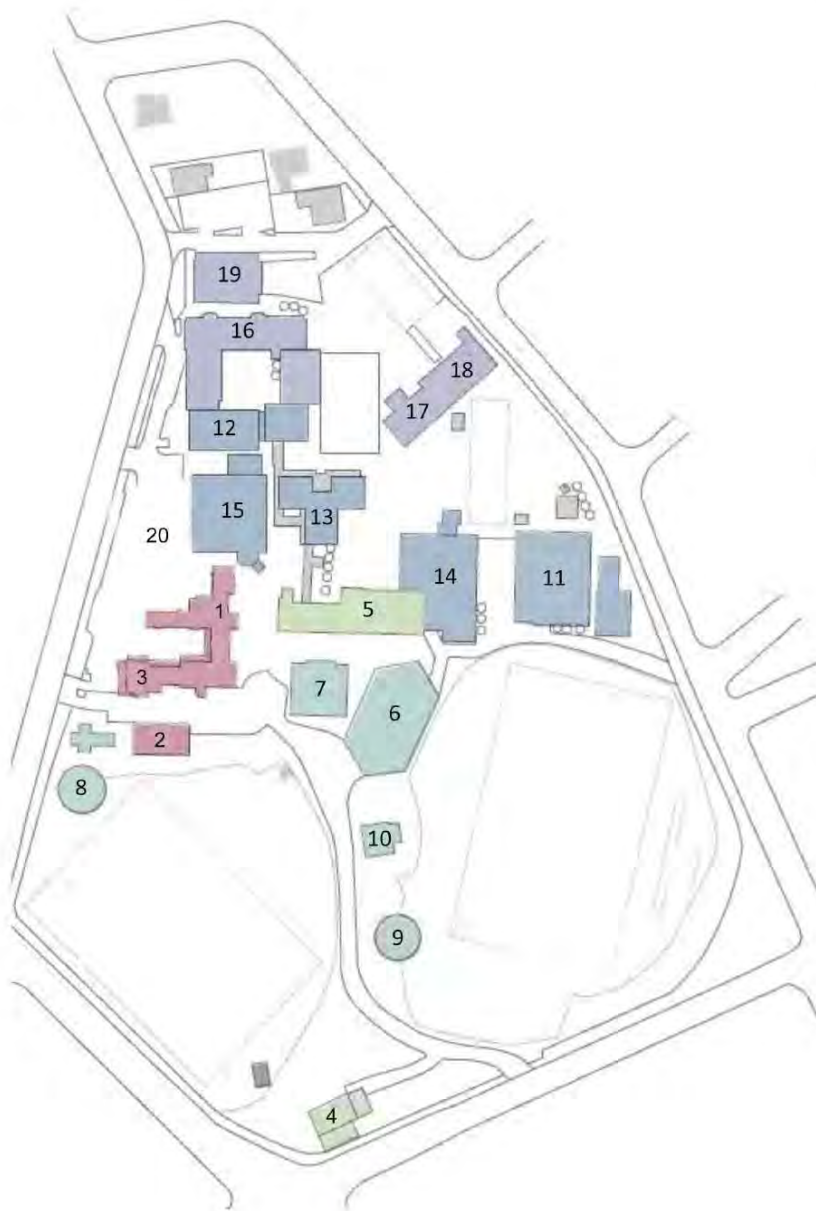
STAGES OF DEVELOPMENT

- 1863 - 1921
 1. Great Hall - 1863 to 1921
 2. Former c.1912 Science Building
Later the Gilmore Wilson Music Centre (1977).
 3. Bradfield House - 1921
- 1960-1962

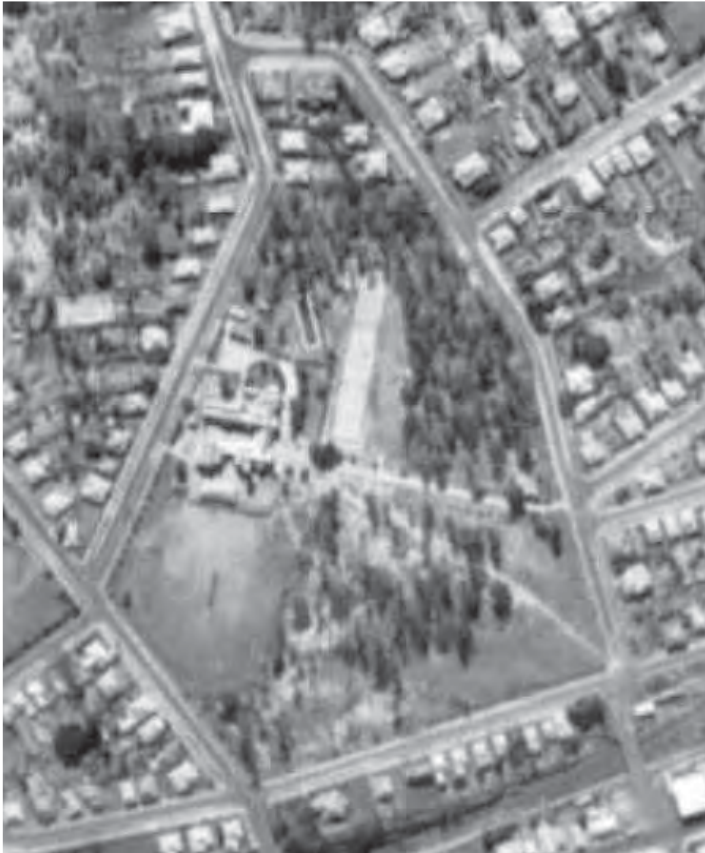
Figure 31: 1944 Aerial. Poor resolution but the original school buildings, science building and oval can be discerned. There also appears to be a strip of ground to the east of the original building which has been cleared. Note the Fig tree in the centre of the site, at what was then the top of the driveway from Waghorn Street (QImagery 2021).

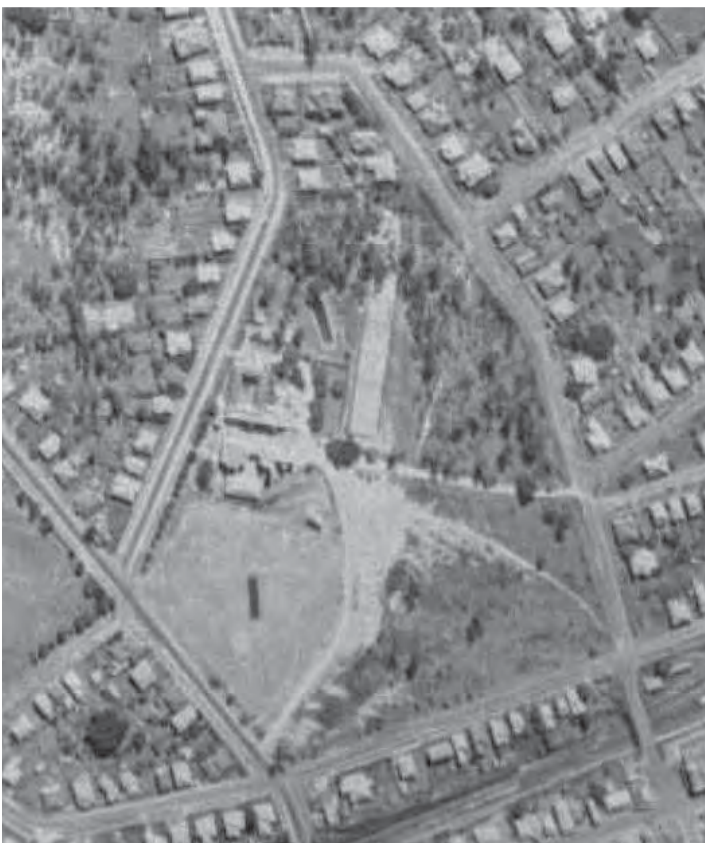
Figure 32: 1955 Aerial. Vegetation in this aerial looks sparser, indicating some trees have been removed. Note as well that the driveway originally exited Burnett Street, near the corner of Darling Street (QImagery 2021).

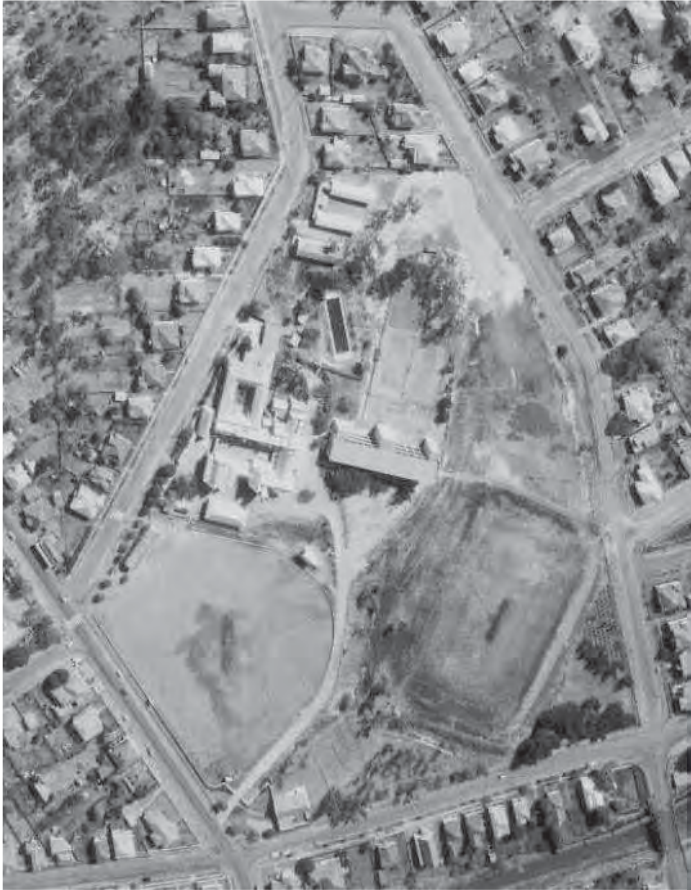
Figure 33: 1964 Aerial. The Secondary Block has been constructed as well as the Hancock Oval (No. 4 Oval). The driveway has also been more properly developed by this time and the headmasters house has been built. Note the Fig tree has been retained to the south of the Secondary Block (QImagery 2021).

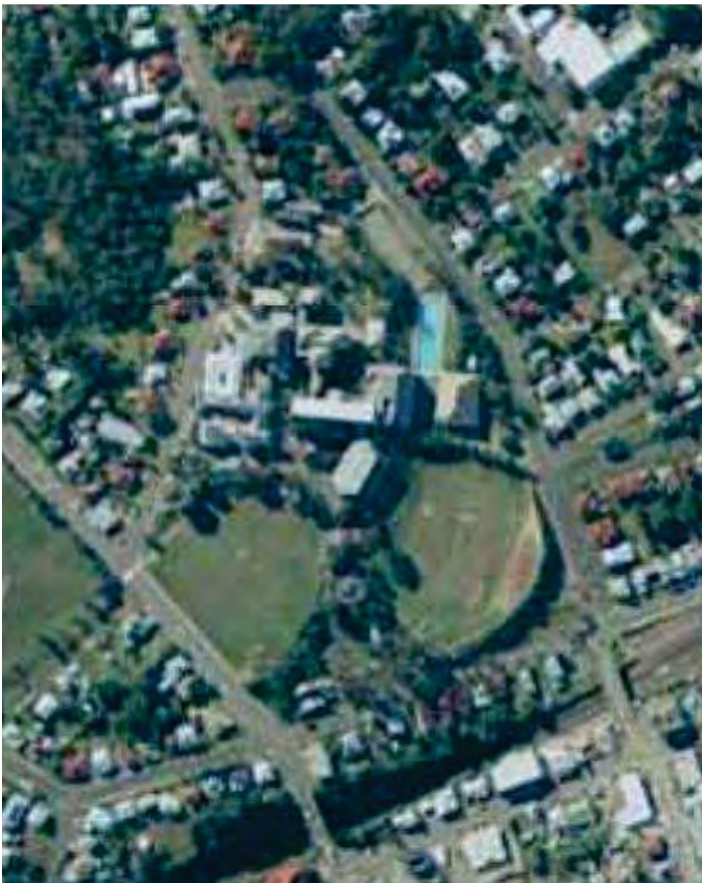
Figure 36: 1990 Aerial. The driveway has been realigned to Darling Street and the Clive Wyman Building has been constructed (QImagery 2021).

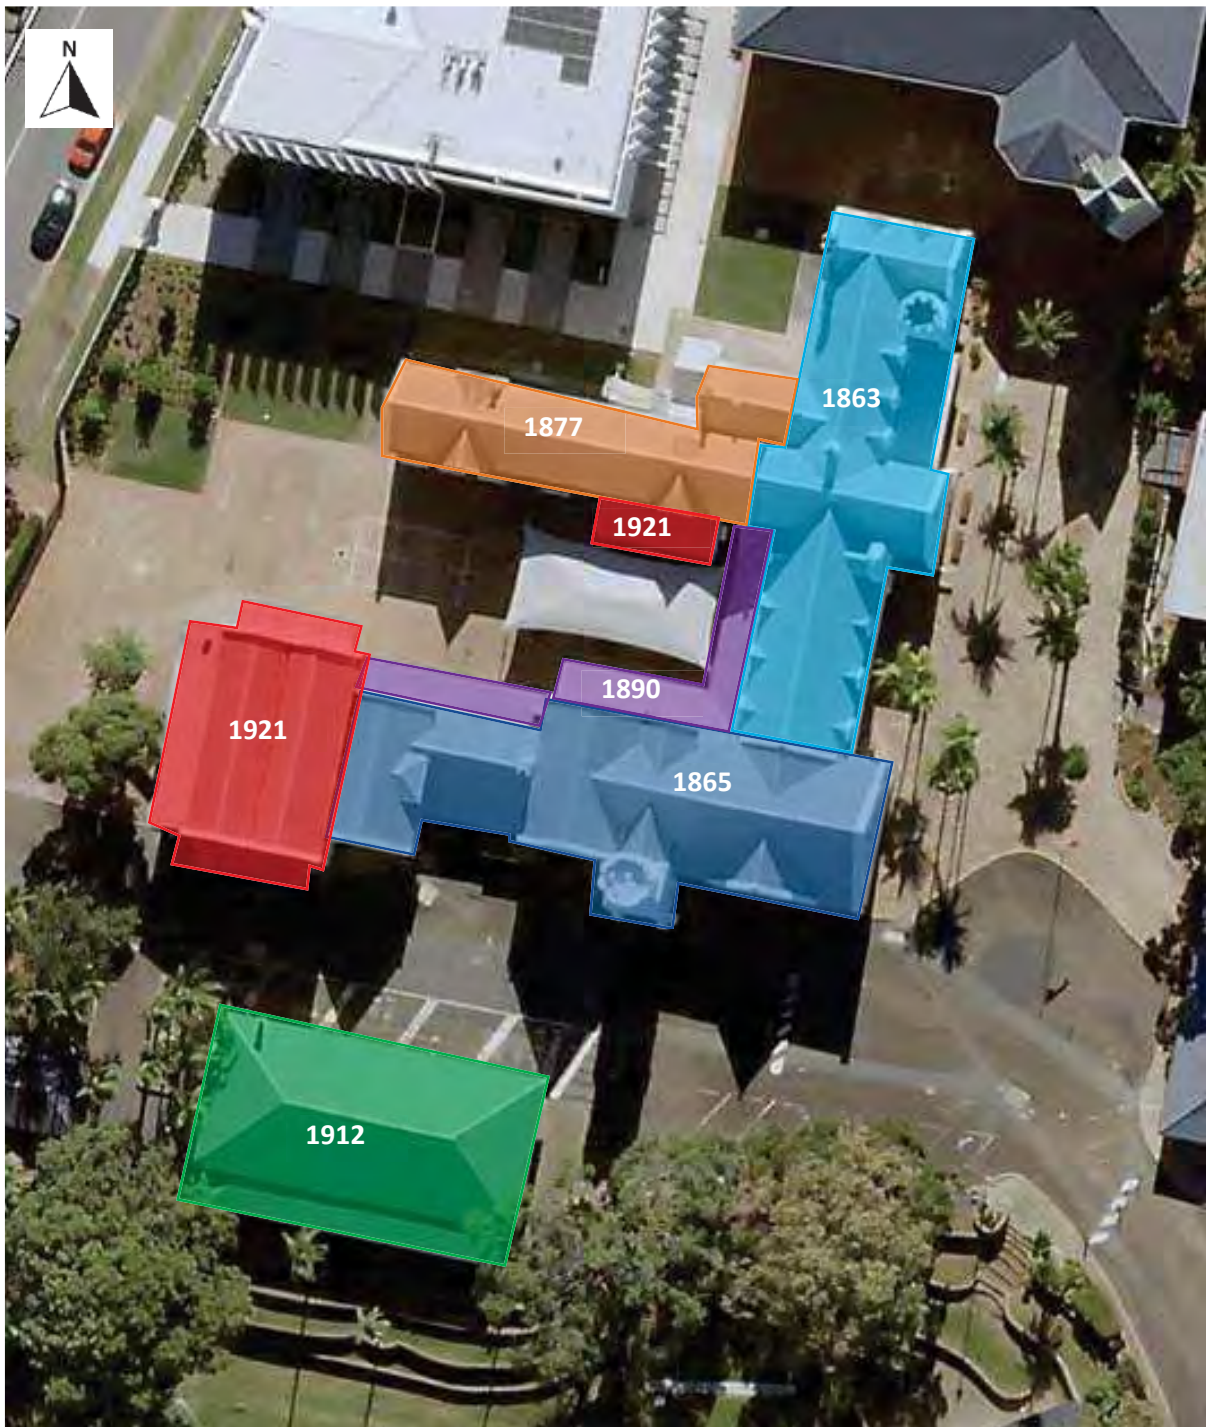
The early building complex is made up of the original 1863 and 1865 buildings, as well as the various early extensions and add-ons that occurred in the late nineteenth or early twentieth century, ending with the 1921 addition of Bradfield House (see Figure 41).

Figure 41: Early Building Complex (modified from Queensland Globe, 2020). The original 1863 portion of the building is indicated in [Blue], with the 1865 portion indicated in [Dark Blue]. The 1877 additions are indicated in [Orange]. The 1890 walkways and roofs are indicated in [Purple], the 1912 Science Block is indicated in [Green], and the 1921 additions are indicated in [Red] (Queensland Globe 2021).

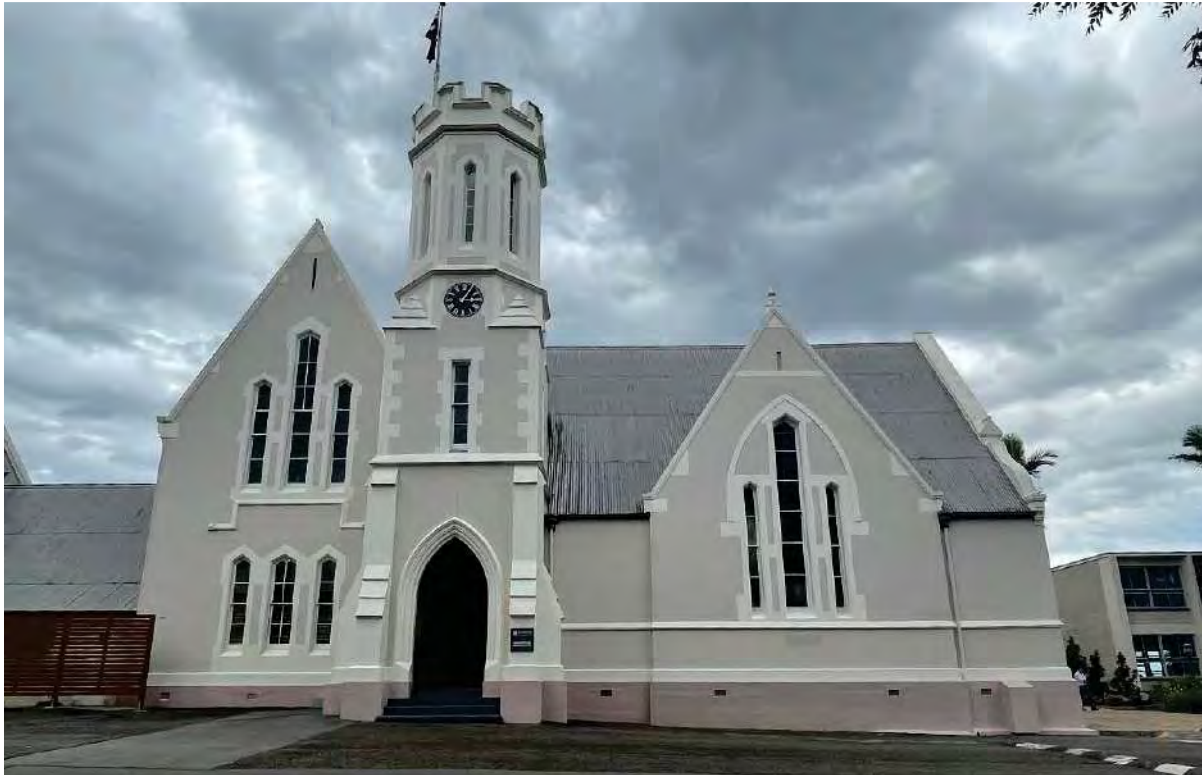
Figure 42: Southern façade and tower showing arched entrance to the foyer and Great Hall (AHS 2021).

The south-facing gable end protrudes from the exterior of the Great Hall, marking the former end of the 1863 structure (see Figure 42). A parapet coping is still visible to indicate where the 1863 end to the Great Hall was situated. The south-facing gable parapet incorporates three tall, narrow, triangular-pointed windows surrounded by decorative moulds and relief lines. There is a stone course at windowsill height that wraps around the hall's exterior, as do two lower baselines. The other south-facing gable is a taller gable with two-storeys. Both stores' also have narrow, triangular-pointed windows, with the second-storey windows being taller in design.

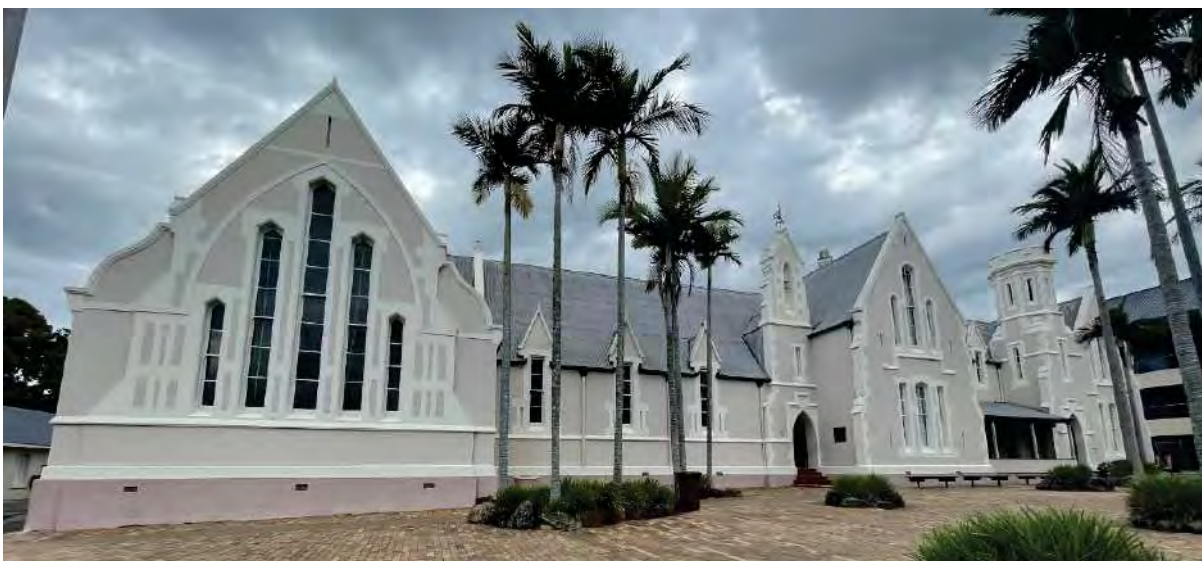
Figure 43: Eastern façade showing bell tower and northern tower (far right) (AHS 2021).

The east-facing side also has stone-capped parapeted gables and a tower which feature the same fenestration scheme as the southern facade. The gables also incorporate narrow, triangular-pointed windows, as well as square-headed windows in-between gables and in the tower. Some of the square headed windows have their own dormer roofs.

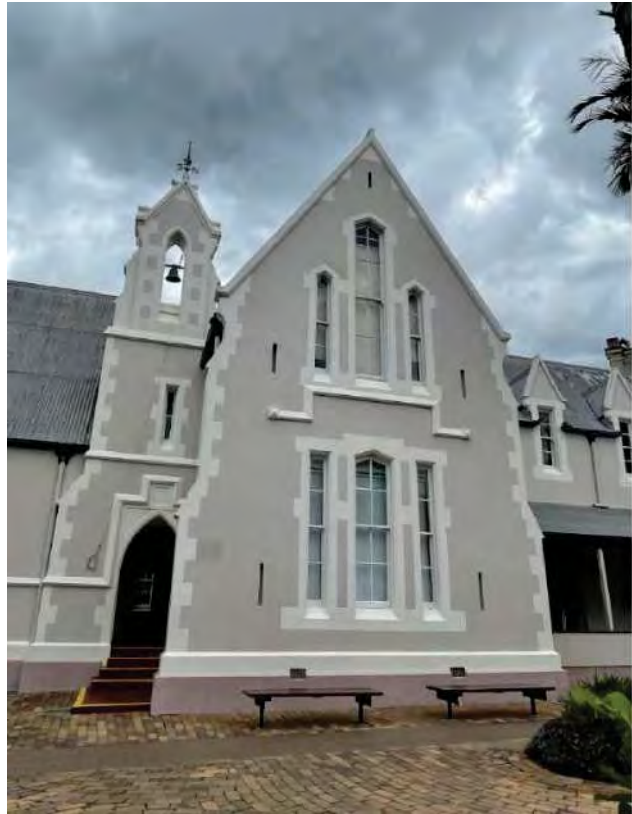
Figure 44: Bell tower entrance (AHS 2021).

There is also a bell tower over one of the main eastern entries to the 1863 building with gable fronted parapet (see Figure 44). The bell tower features buttressed side columns to support a gable over a pointed arch opening where the bell is suspended. Through this entry, access is provided to the Great Hall, a meeting room, and through to the west-facing courtyard.

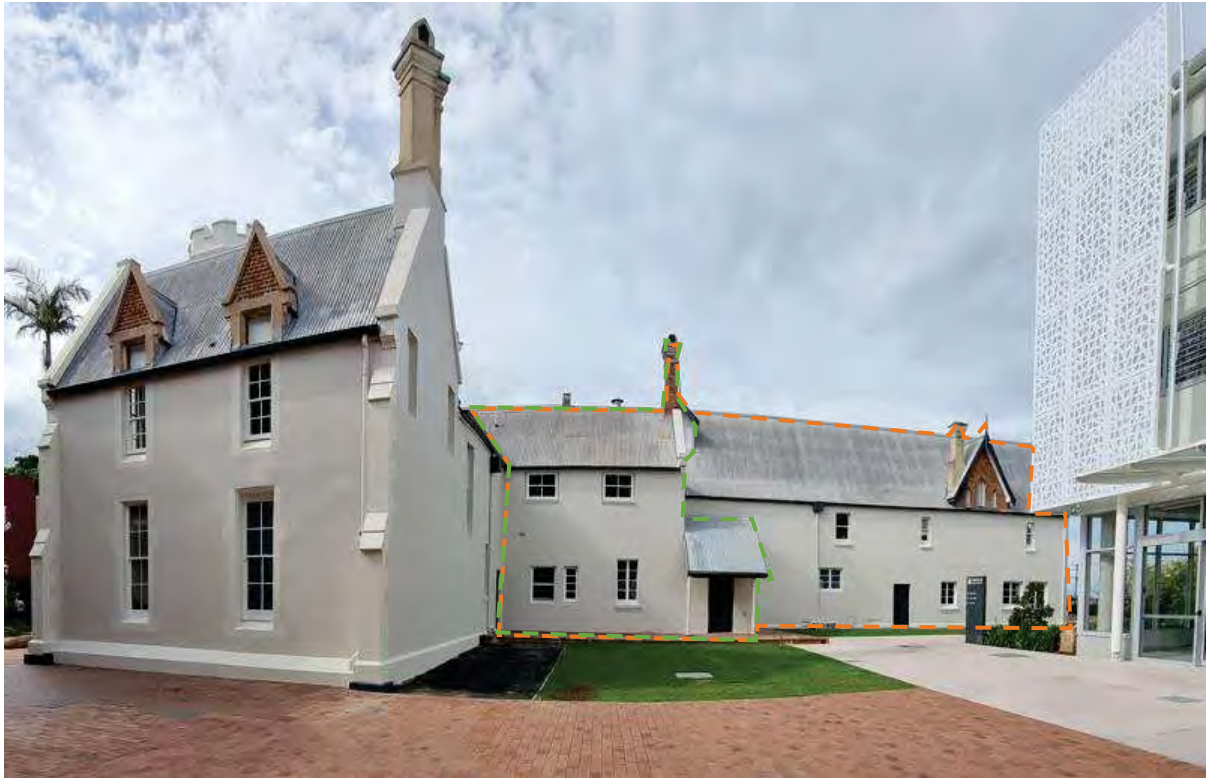
Figure 48: Northern elevation showing 1877 extensions [Orange and Green dashed line] (IGG, 2021).

The external walls of this section are consistent with the rest of the building and are rendered brick. Due to the recent restoration works, the northern and western elevations of the 1877 extensions have undergone repairs.

The northern and southern elevation of the 1877 building, along the far west side, has two protruding gables with three pointed arched windows and decorative finials. There is another protruding gable further east along the 1877 extension. The western elevation has had early windows removed when the Murray Hancock Complex (former accommodation and dining hall) was constructed in 1947. Since the demolition of these buildings to facilitate the new STEM building, the windows have been reinstated as part of the restoration works.

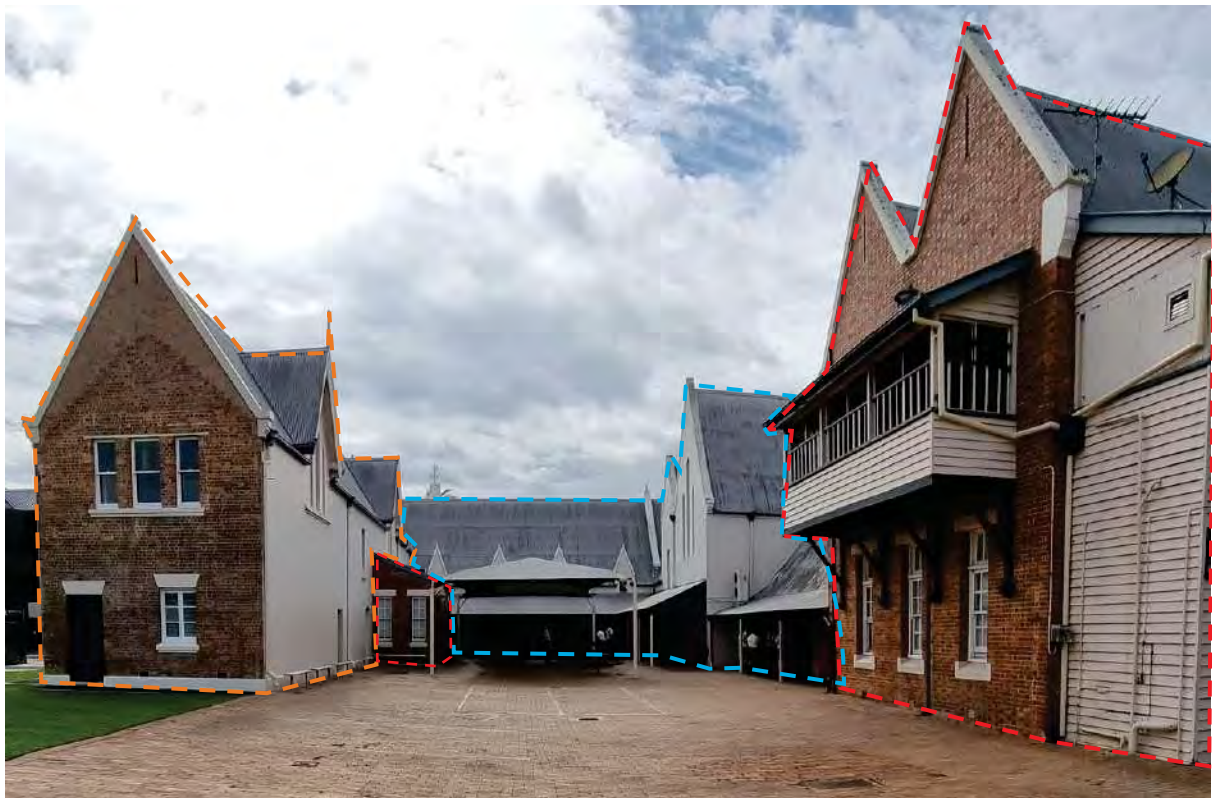
Figure 49: Image displaying courtyard area showing 1877 extensions [Orange dashed line], 1921 additions [Red dashed line], and original 1863-1865 building [Blue dashed line] (AHS 2021).

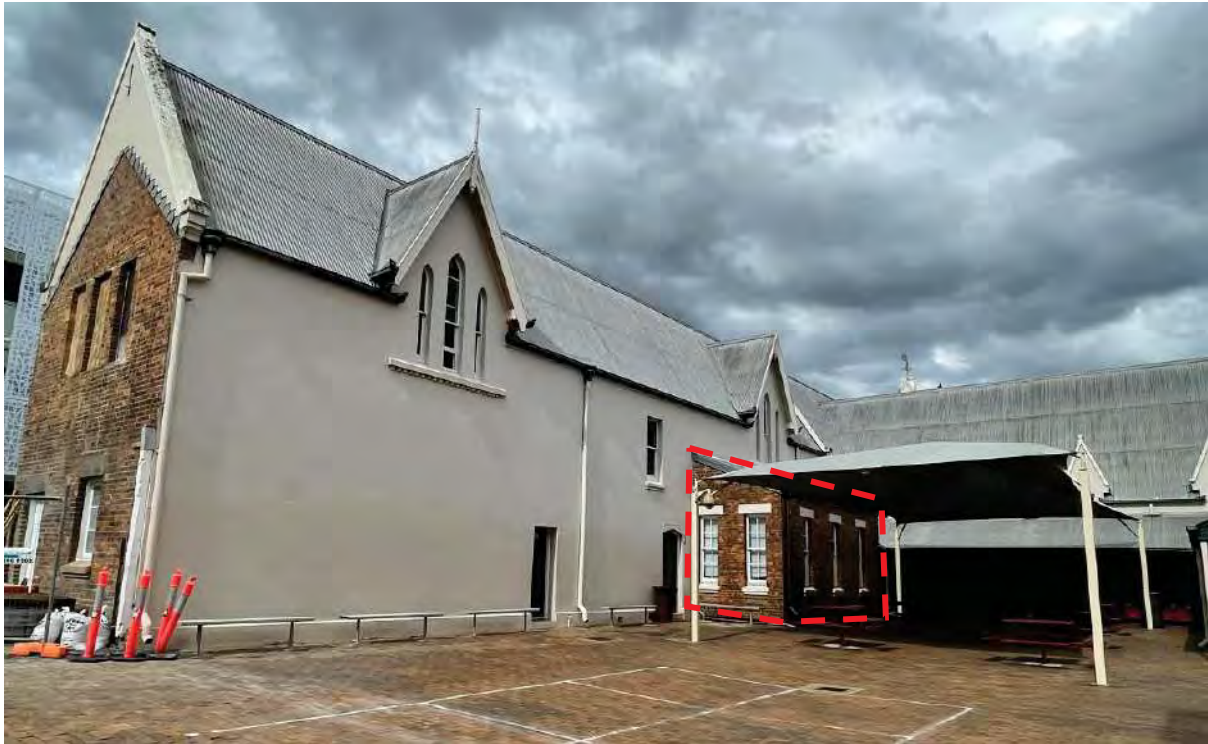
Figure 50: 1877 extension southern elevation and courtyard area. 1921 addition also indicated [Red] (AHS 2021).

Along the southern elevation is also a small 1921 building extension which forms part of the current sickbay (See Figure 50).

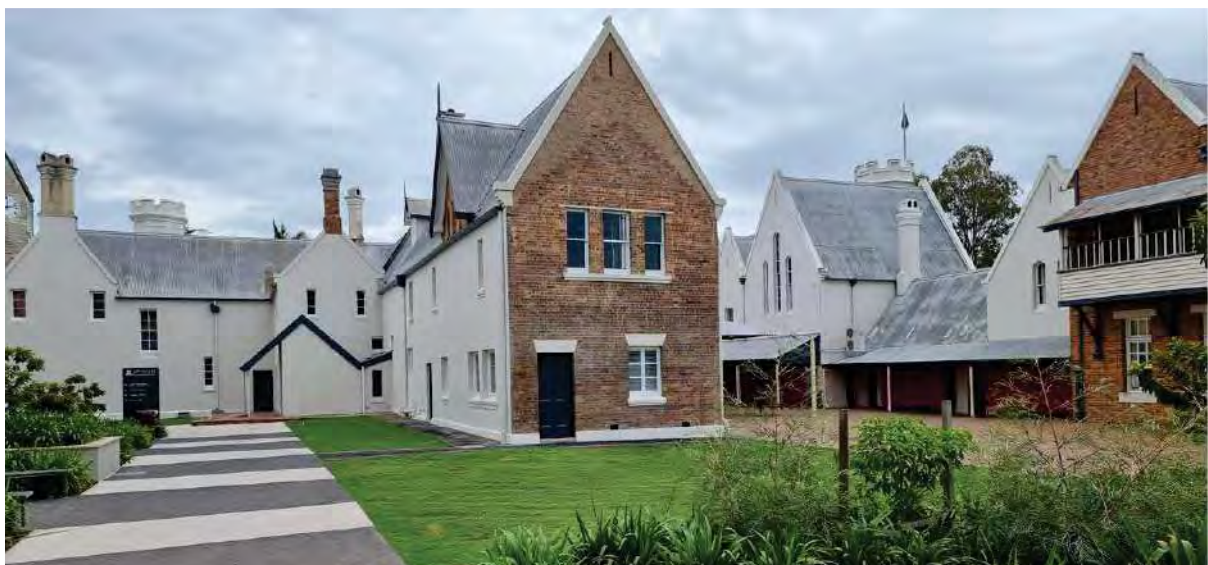
Figure 51: Western elevation showing 1877 extension and courtyard (right) showing the repair and re-render of the northern elevation of the 1877-extension (IGS, 2021).

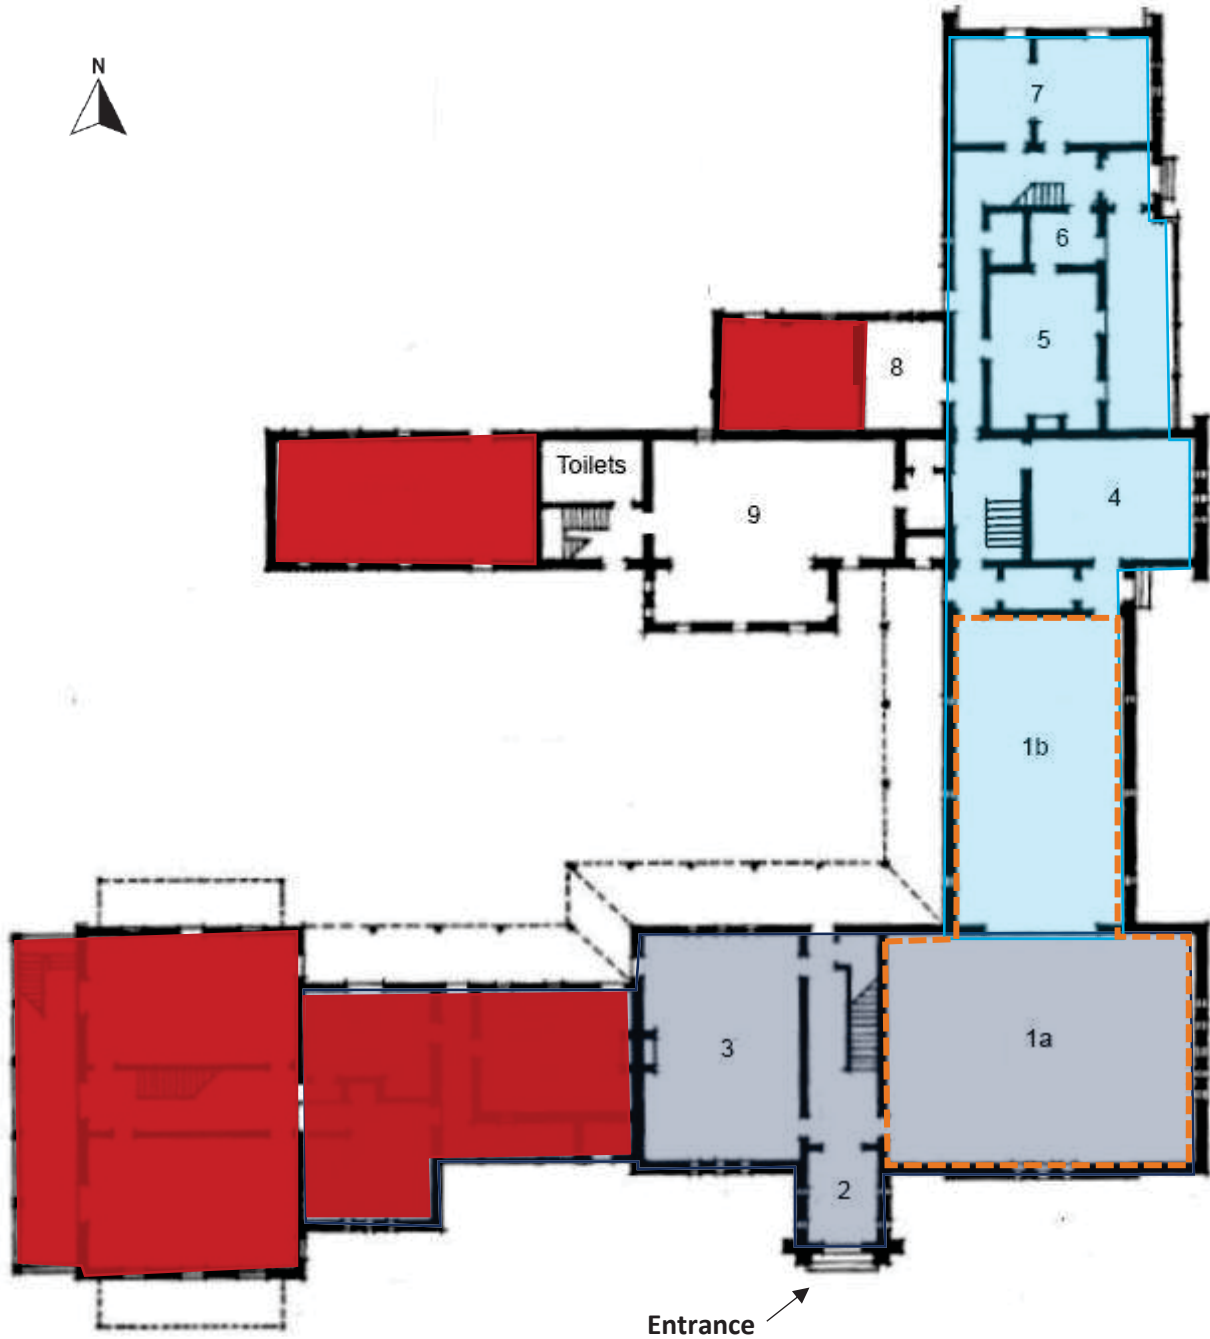
The following floorplan indicates the internal locations and numbers of each room inspected and should be utilised as a guide when reading the Physical Description. The original 1863-1865 buildings have been highlighted here in **blues**.

Figure 52: Ground Floor Plan of Early Building Complex with original 1863 building [Blue], and the 1865 building [Dark Blue]. The Great Hall is also indicated with an [Orange] dash.
