Removal of a place from the Queensland Heritage Register

For a more detailed historical context of Ipswich Grammar School, please see Chapter 2 and Section 4.5 of the existing Conservation Management Plan (CMP) (AHS 2023) (Appendix A).

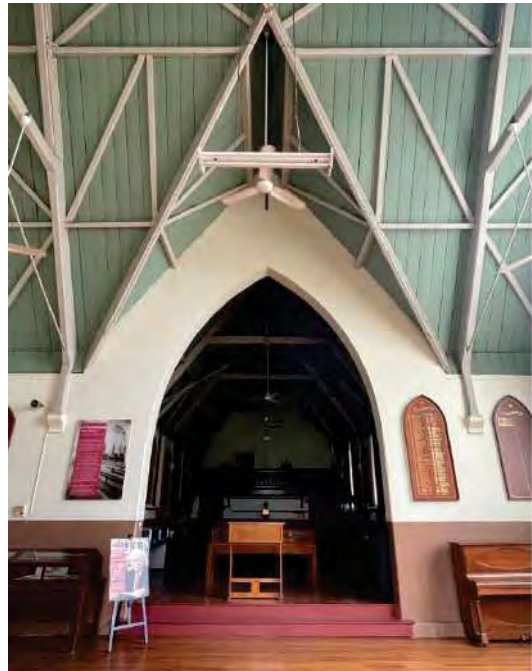
The walls are brick rendered (plastered) internally. Room 1b also has dado and picture rails decoration. There is a skirting that runs along each of the walls in both room 1a and room 1b though some of it has been removed along the southern wall of 1a (reason unknown). Running alongside the skirting on the original timber hardwood (HWD) floorboards is a brass-vent system. This system has been installed throughout many of the spaces within the original 1863-1865 buildings. In Room 1b, some of the original flooring has been patch repaired.

Figure 59: Great Hall facing north showing the intersection of the 1863 portion (1b) and 1865 portion (1a) to create a T-shape. Photograph was taken in section 1a (AHS 2021).

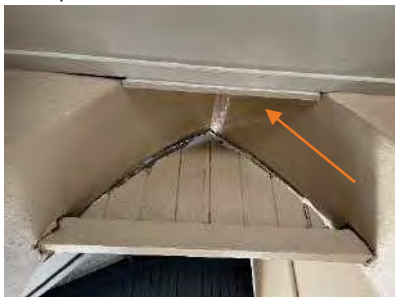
Figure 67: Decorative VJ panels in archway leading to courtyard. Note the new ceiling cuts into the arch [Orange arrow] (AHS 2021).

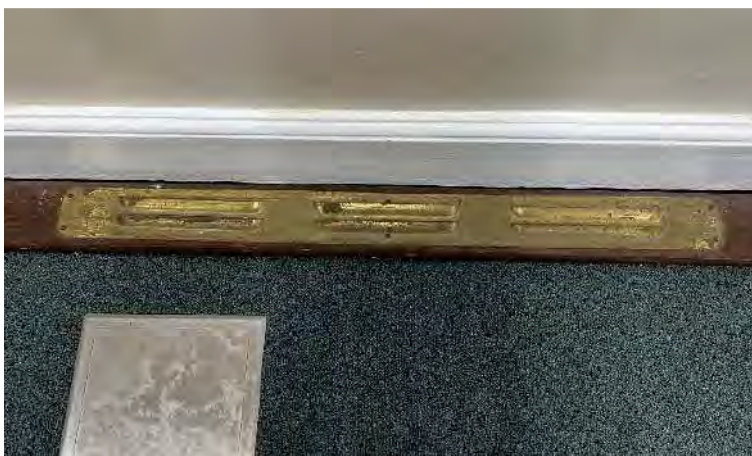
Figure 72: Brass vents alongside the skirting board (AHS 2021).

The walls are consistent with the rest of the original 1863-1865 building and are an ashlar render. There is a cream-painted picture rail that runs along the top of the wall, and a white skirting board that runs along the bottom. Running next to the skirting along the carpet are brass vents, supported by a timber board. In the middle of the wall is an interpretative sign that details the original paint finishes of the room (protected during a 1982 conservation project – Buchanan Architects) and illustrates where a dado rail was previously located.

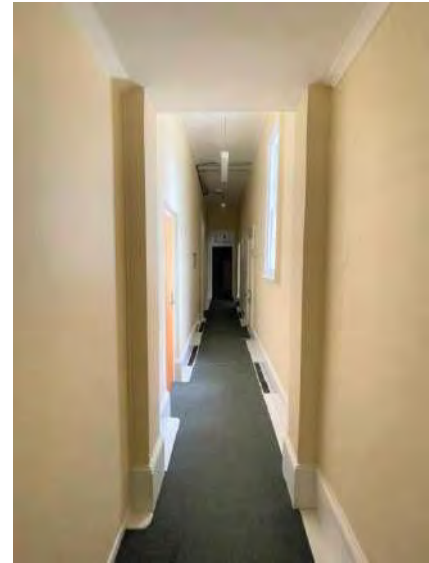
The hallway running from south to north is entered into via the Bell Tower hallway. This hallway has thick skirting consistent with the other rooms, contemporary carpets, and the same vent system that runs adjacent to the skirting. This vent system has been recently painted white and the brass vents replaced with black.

Figure 74: South-north hallway (photo taken facing south). Note the ceiling at the northern end drops much lower than the rest of the hallway (AHS 2021).

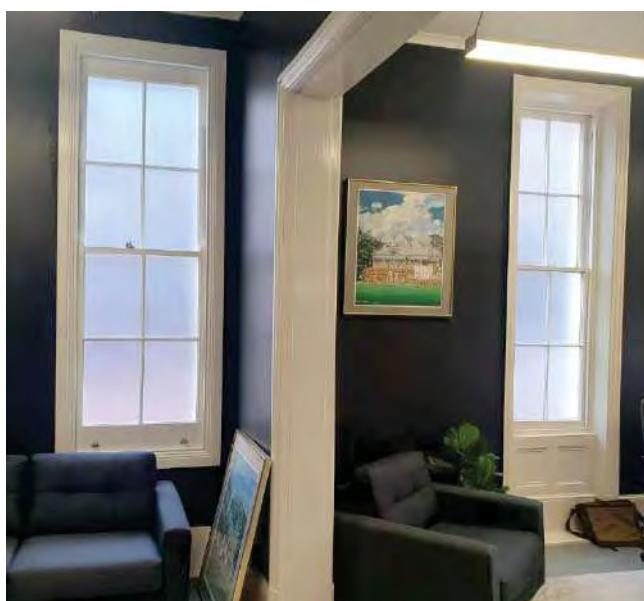
The ceiling in Room 7 has been replaced, with simple, contemporary cornicing installed and the more elaborate decorative cornice now

Figure 79: Room 7 showing contemporary fitout, and windows to the east (IGS, 2022).

removed. However, the central plaster ceiling rose has been retained. The floor is laid with a contemporary vinyl, and it is currently unknown if the original floorboards remain underneath, and if so, what condition they are in.

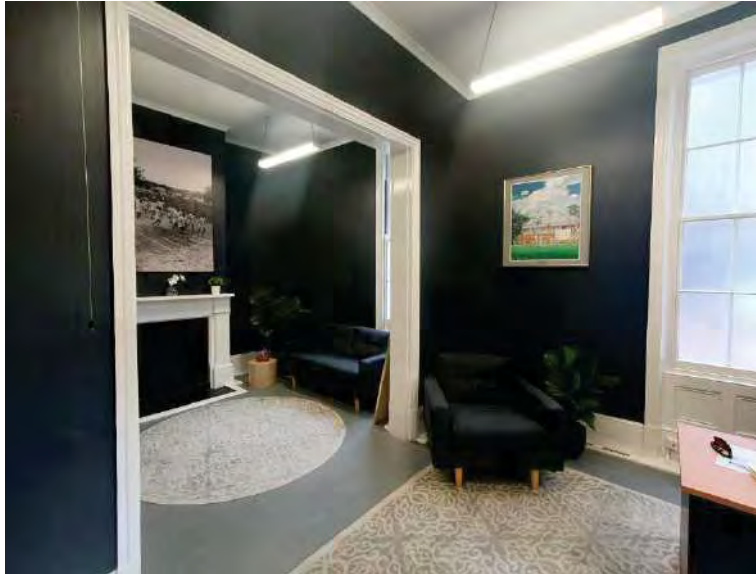
Room 7 has been altered over time with the middle wall now a large cut-through, providing a bigger open space. The room has also been recently repainted as it is being prepared to become a new staff office. Running next to the skirting board is the same vent system as the other rooms, although this system has been recently painted white and the brass vents replaced with contemporary black vents.

Figure 81: Room 7, showing cut through and doorway to the base of the north tower (IGS, 2022).

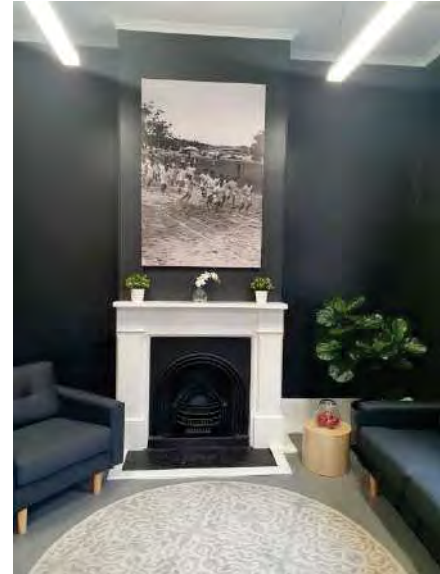
Figure 80: Fireplace. Note the change in corning compared to Room 5 (IGS, 2022).

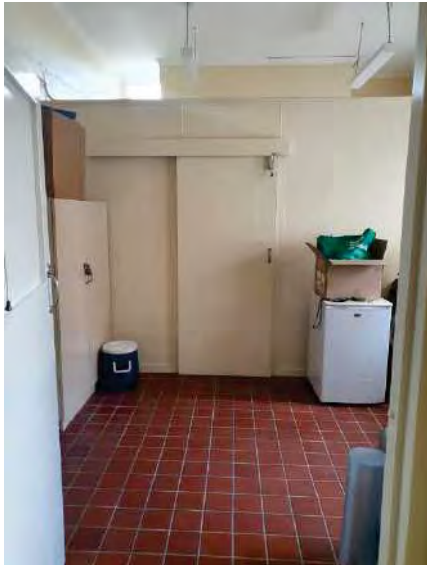
Figure 83: Room 8 showing tiles, VJ partition wall, and kitchen (AHS 2021).

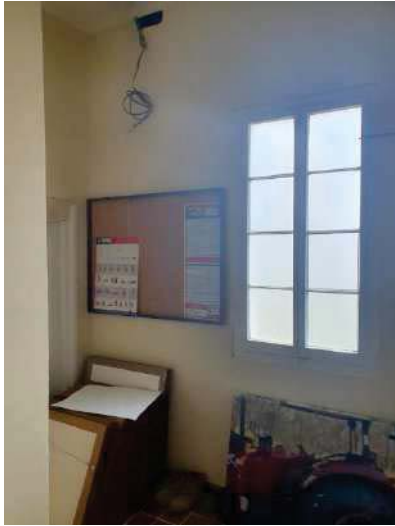
Room 9 currently operates as the school's 'sick bay' and has been recently painted and given a contemporary fitout. Not much early fabric remains in this space except for rendered pillar supports and some early picture rails (which have been painted white). The ceiling and flooring have been replaced over time, and the 1921 addition has had a room built in.

Figure 88: 1921 addition showing new room (IGS, 2022).

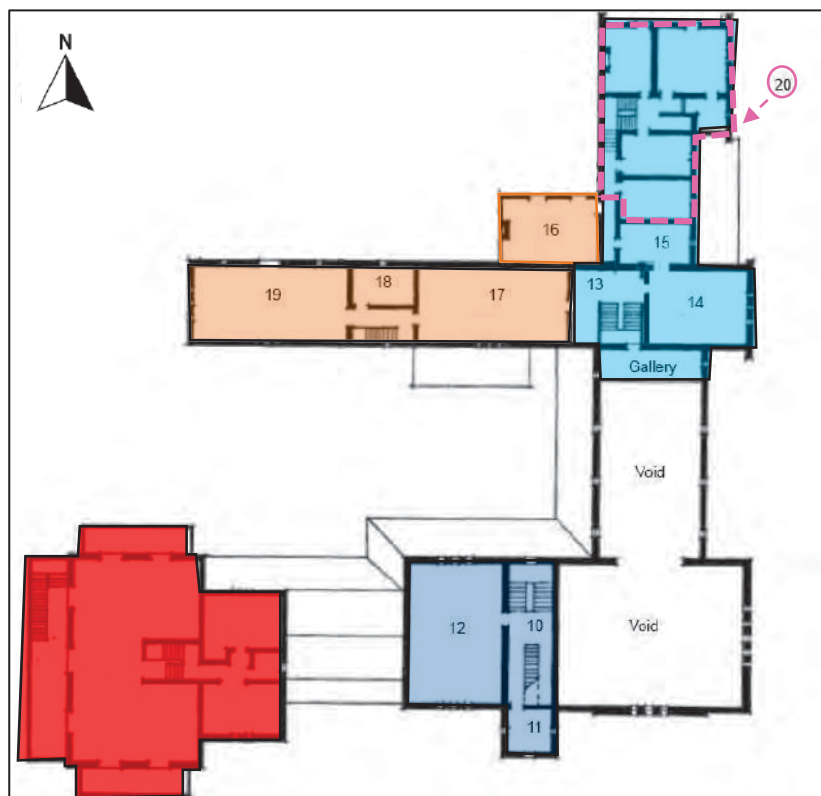
Figure 89: First floor plan identifying spaces that were inspected, including parts of the original 1863 building [Blue], 1865 building [Dark Blue], and 1877 extension [Orange]. Areas where access was not provided are indicated in Red (AHS 2021).

The first floor is currently not utilised for teaching or staffroom purposes, with rooms towards the northern end (Rooms 13-20) largely being utilised as storage spaces.

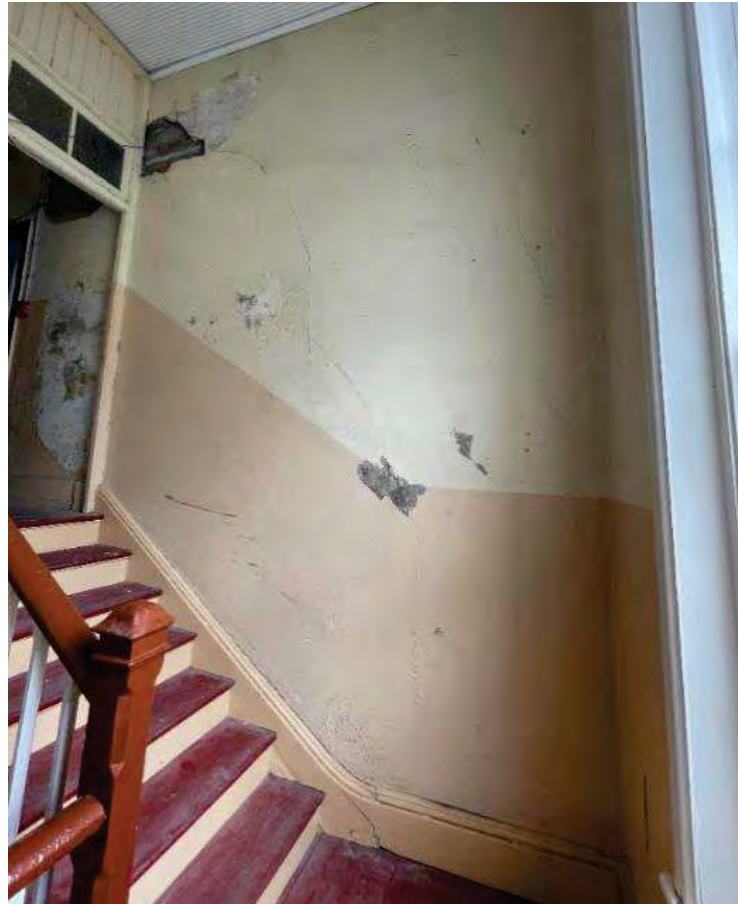
The staircase and First Floor rooms are in a dilapidated condition requiring repairs. At the top of the staircase is a VJ wall with horizontal, fixed-pane frosted glass windows and VJ door. This VJ wall has thinner timber boards compared to the thicker beaded VJ walls found in Room 10.

It is likely that the VJ wall enclosing the upper landing is a later (early twentieth century) addition and flooring repairs suggest this area has been reconfigured a number of times.

The ceiling in this space is corrugated mini-orb and original floorboards (with some areas having been patch-repaired). Much of the original skirting has been removed.

Figure 90: Staircase to the First Floor and Rooms 10, 11, and 12 (AHS 2021).

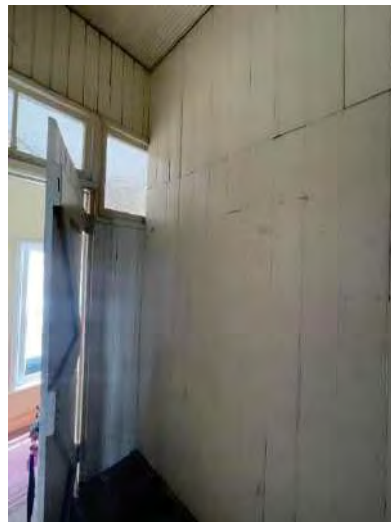
Figure 92: Wider beaded VJ wall compared to the thinner VJ (AHS 2021).

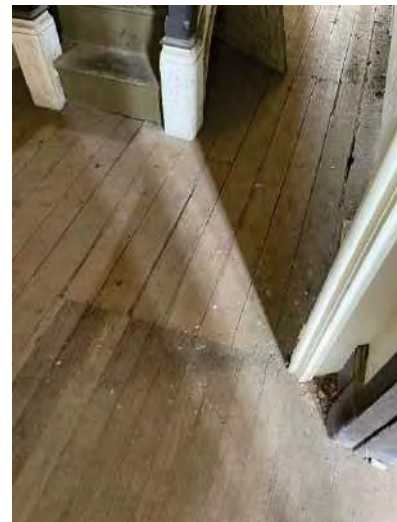
Figure 93: Photo showing patch-repair of original, thicker boards) (AHS 2021).

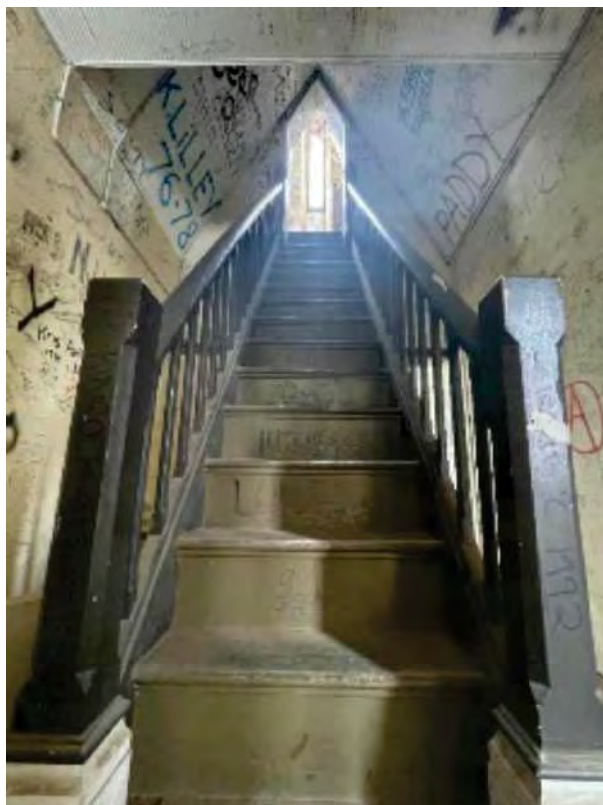
Room 10 also has a tall, narrow staircase that leads to the upper tower level. The upper tower as a tall winding staircase to an upper landing (this was not accessed due to safety concerns). The tower has an octagonal shape, with each wall (except one) hosting a tall, narrow, pointed arch window with decorative architrave.

Figure 94: Narrow staircase leading up to the upper tower level (AHS 2021).

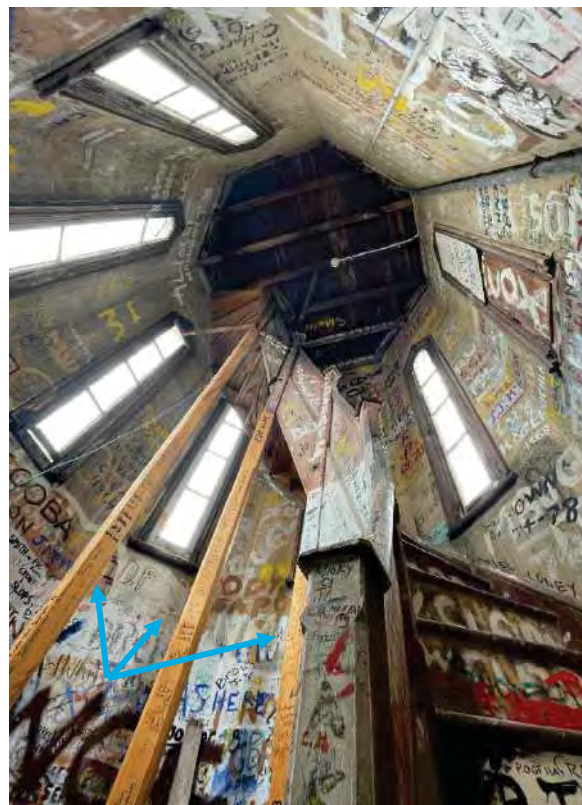
Figure 95: Upper tower winding staircase. Note the replaced support posts to the staircase [Blue arrows] (AHS 2021).

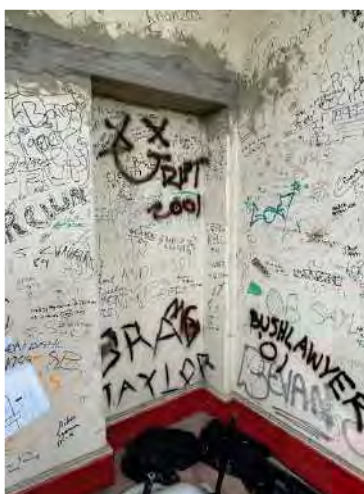
Behind Room 10's narrow staircase that leads up to the tower, is Room 11. Room 11 is a small room with original floorboards. Although this room has red-painted skirting, the skirting looks to be a replacement skirt as it wraps around an enclosed doorway.

Figure 96: Room 11 showing sash windows, red-painting skirting, and original floorboards (AHS 2021).

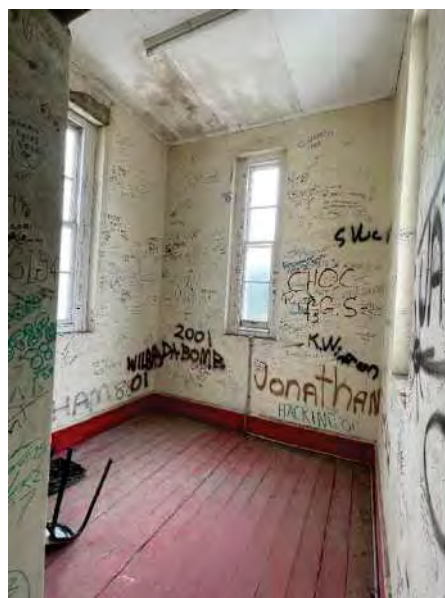
There were originally two entrances into this room, one on either side of the staircase, however the eastern-most doorway has since been enclosed. Room 11 also has tall, thin, sash windows.

Figure 97: Room 11 showing enclosed doorway (AHS 2021).

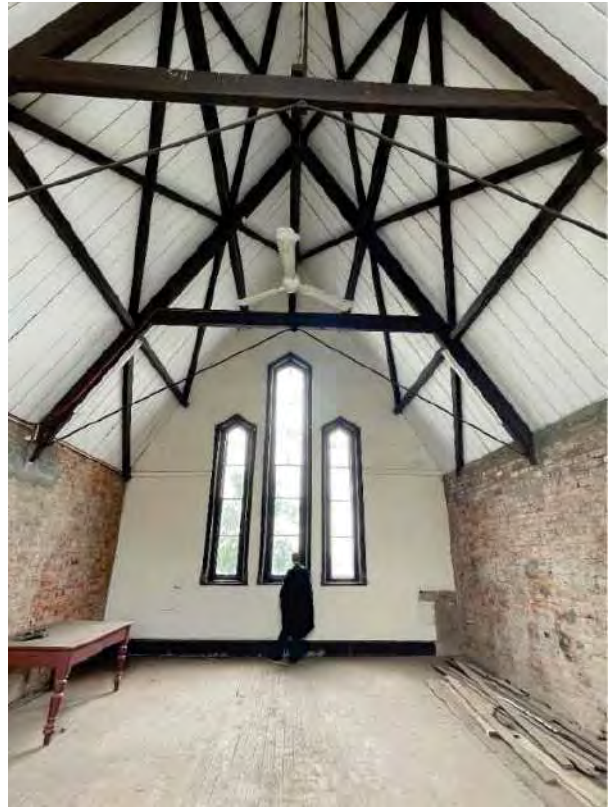
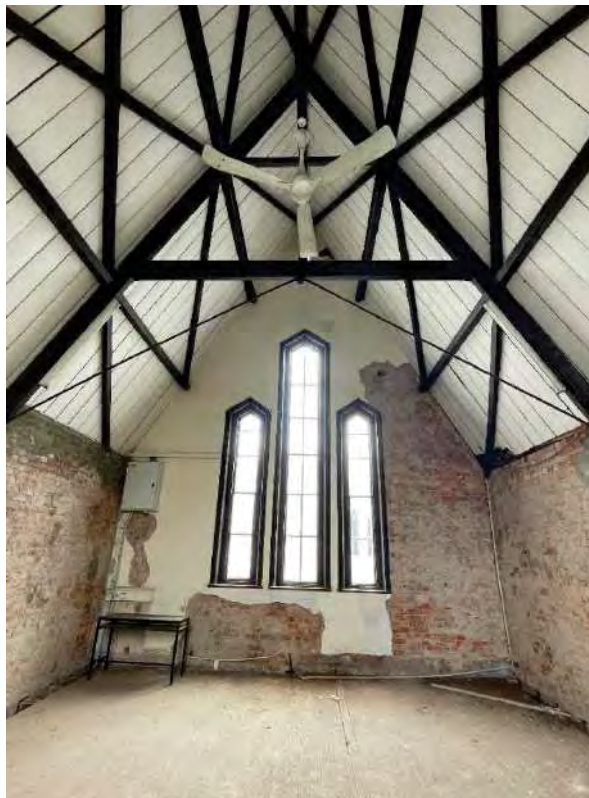
To the south of the room are three, tall, narrow, pointed arches with sash windows. However the upper portion of the central window glazing looks to have been replaced as it does not match the others. Much of the render has been taken off the walls of Room 12, exposing the red brick. Some of the original floorboards have also been taken up, exposing the bearers and joists underneath.

Figure 99: Room 12 facing north (AHS 2021).

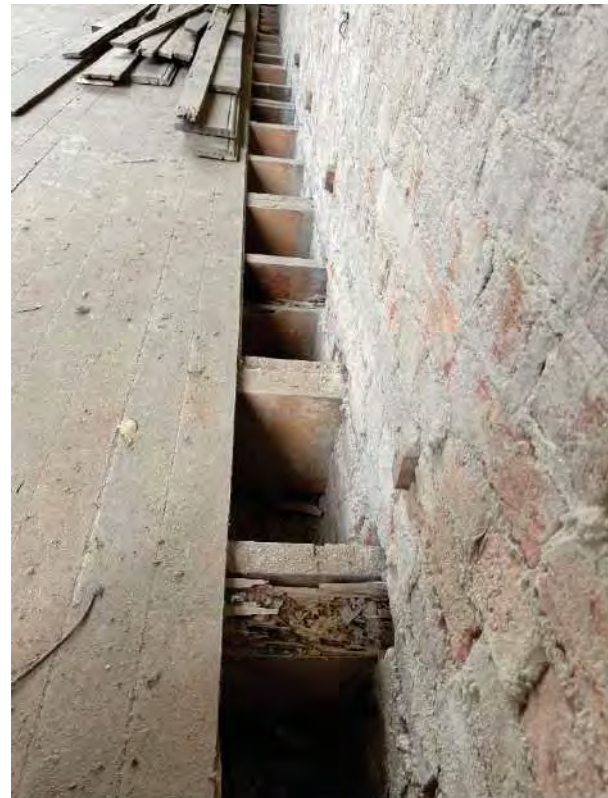
Figure 100: Floorboards removed to reveal termite affected timber bearers (AHS 2021).

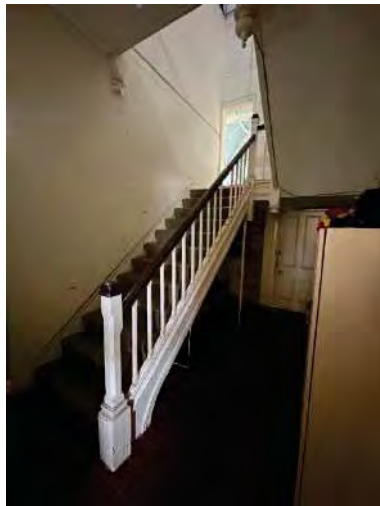
Access to the Great Hall Gallery is from the middle-landing of the staircase. The door to the gallery has replaced the original door, and half of the original, wide floorboards have been replaced and patch-repaired with narrower ones (however these floorboards still look to be early fabric).

Figure 104: Stairs on the ground floor leading up to the Great Hall Gallery. Note the western doorway into the great all in the far right of the image (AHS 2021).

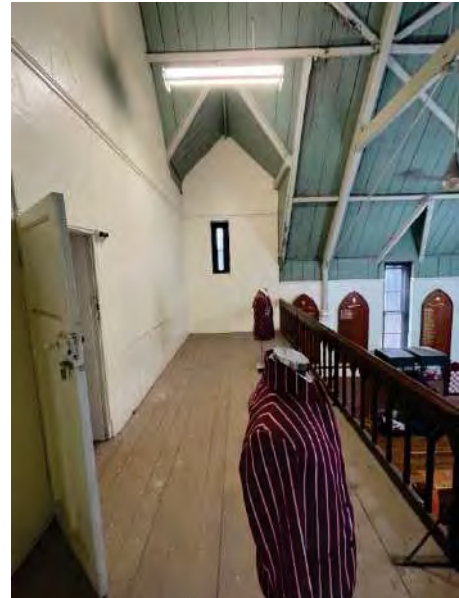
Figure 105: Great Hall Gallery showing two mannequins, original balustrading, replacement door, and a small, off-centred window to the eastern dormer (AHS 2021).

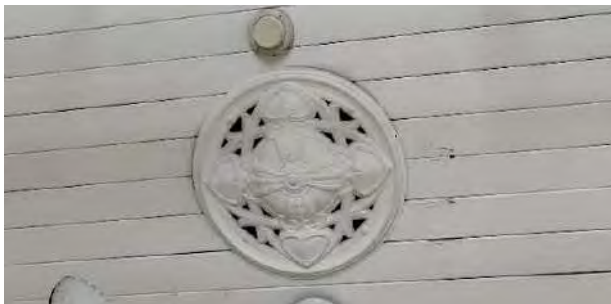
There are two types of ceiling in this space, one on either side of the former wall. To the east are narrow (c.100mm) timber VJ boards, and toward the west is a plaster batten ceiling. The timber VJ ceiling also has a small ceiling rose, whereas the plaster batten ceiling has a small roof access cavity.

Figure 108: Room 15 early ceiling rose (AHS 2021).

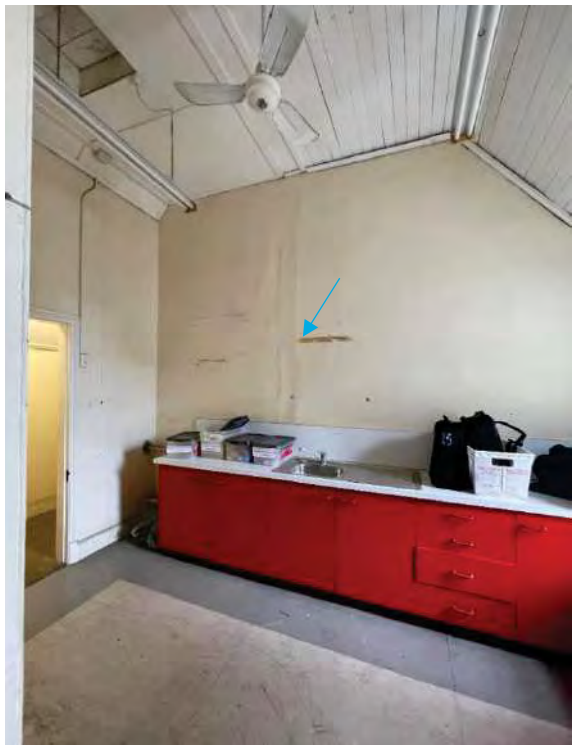
It is evident that the layout of this room has been altered and change over time, and a previous wall dividing the middle of the room has been removed. This is demonstrated by the outlined of the former wall along the existing northern wall, as well as in the ceiling.

Figure 109: Room 15 showing red kitchenette, vinyl flooring, and dual ceiling. The former wall is indicated with a **Blue** arrow (AHS 2021).

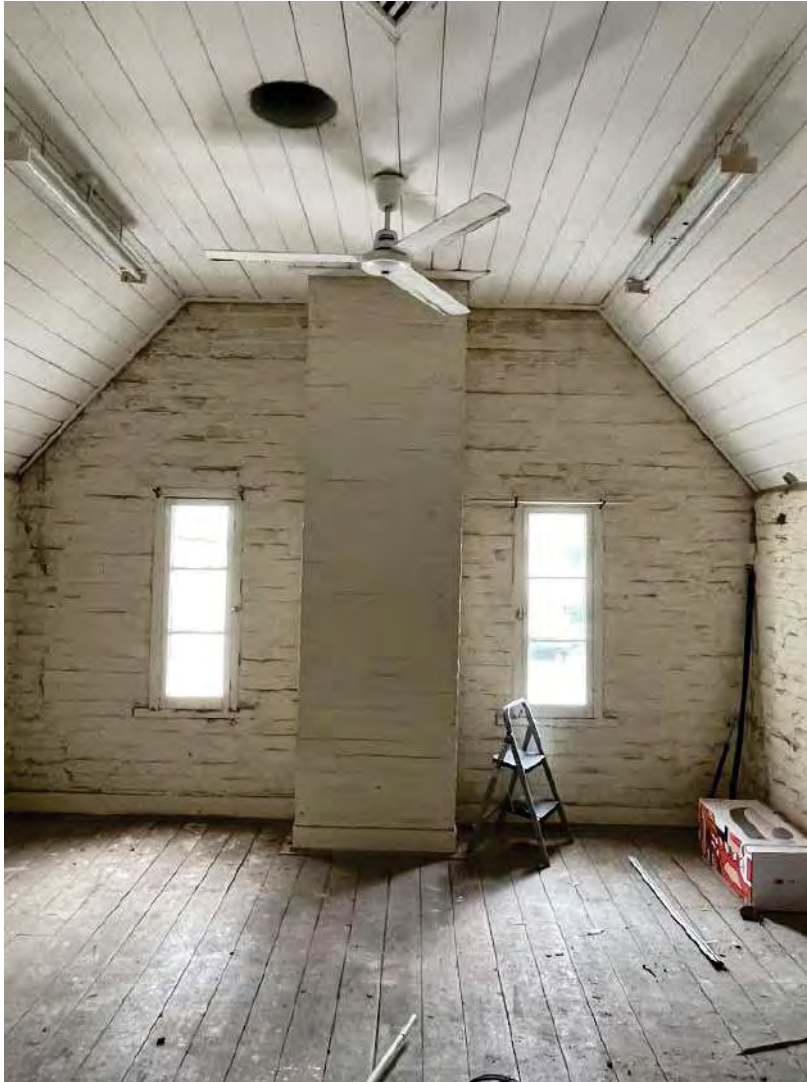
Like many other rooms Room 16 has had much alteration and change. This room is made up of white-painted brick, early timber floorboards, and a wide (c.150mm) jointed ceiling boards with a decorative, timber, diamond-shaped, lattice vent and an early flue. Along the western wall is a brick chimney for the fireplace below (in the former kitchen area next to Room 8).

Figure 113: Room 16 facing west showing brick chimney and walls, timber floorboards, VJ ceiling, and casement windows (AHS 2021).

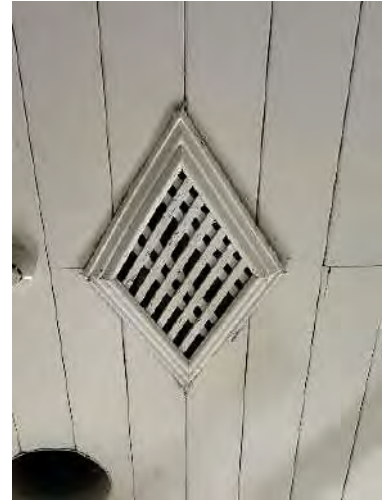
Figure 114: Diamond-shaped timber ceiling vent and flue (AHS 2021).

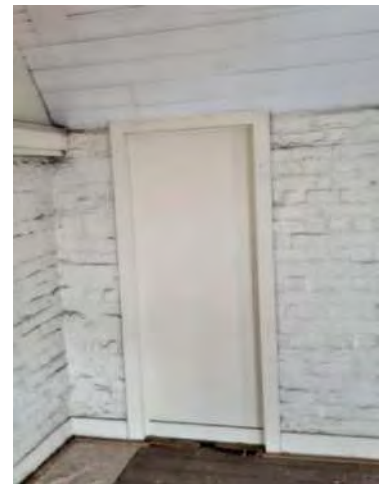
On the southern wall to Room 16 is a former doorway which has since been enclosed. This doorway would previously lead to Room 13.

Figure 115: Enclosed doorway on southern wall (IGS, 2021).

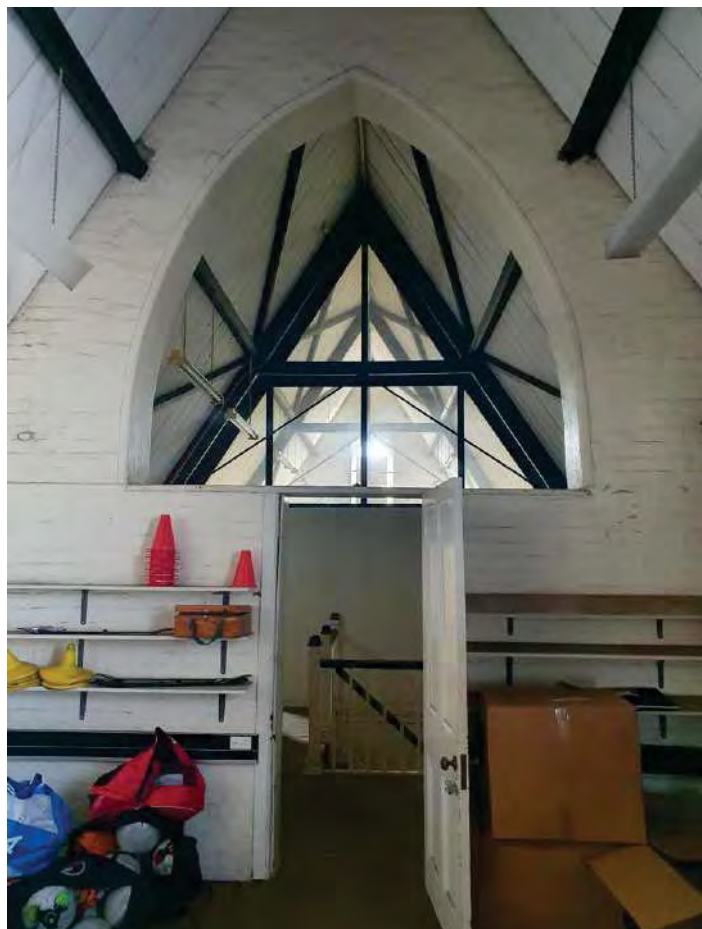
Separating Room 13 from Room 17 is a bricked gable with an arched opening in the middle (see Figure 117).

Figure 117: Brick gabled wall between Room 13 and 17 (facing east) (IGS, 2022).

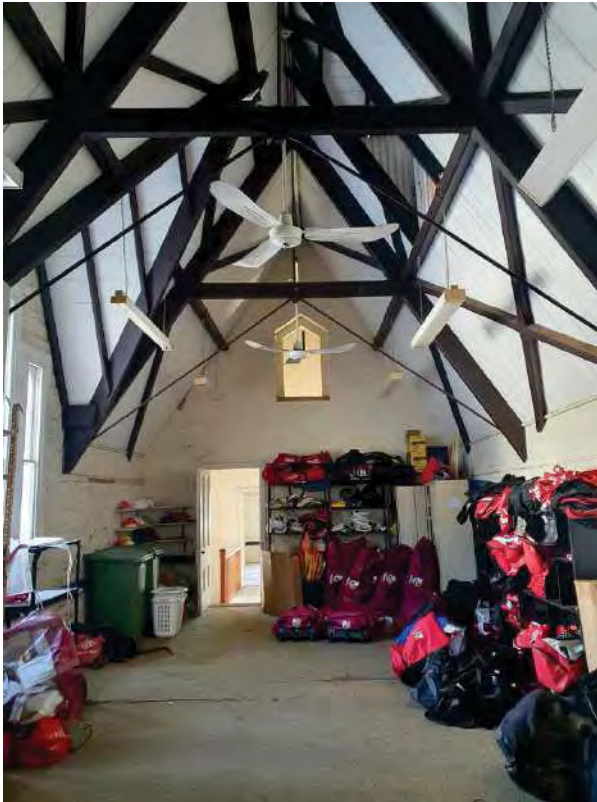
Figure 118: Room 17 facing west showing brick gable with pointed arch opening (IGS, 2022).

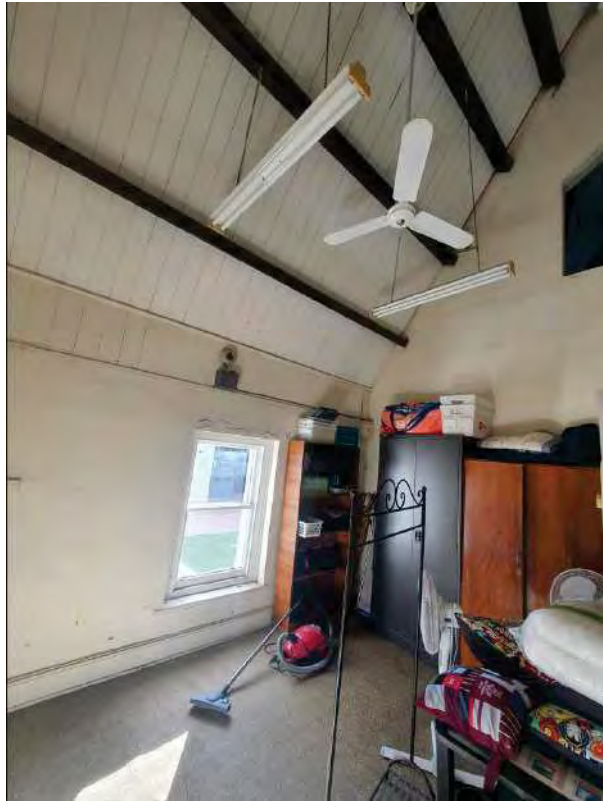
Room 18 is a small storeroom between 17 and 19 that has been added at a later date, evidenced by the partitioning walls that make up the room. The partition walls are likely a timber framed, plastered wall.

Figure 119: Room 18 storage space. Note the northern wall has been rendered on this side (IGS, 2022).

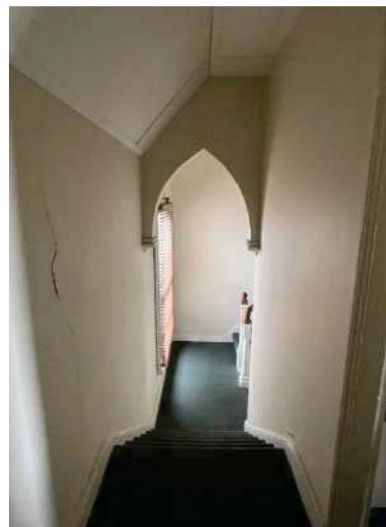
There is a small, carpeted staircase between the two levels of these spaces (see Figure 124). This staircase has a pointed arch over the top of it with decorative moulds, representing the Gothic design of the building.

Figure 126: Small staircase from Room 16 down into Area 20. Note the pointed archway (AHS 2021).

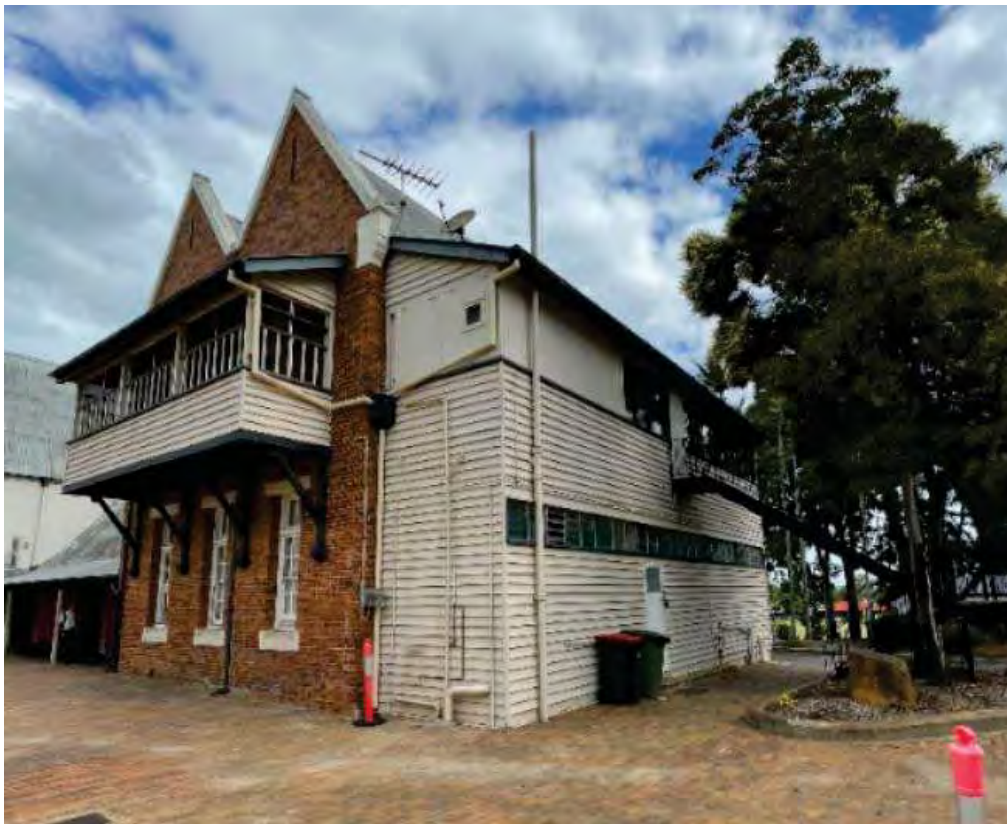
On its northern façade is a narrow, cantilevered room protruding out, previously a verandah. It is supported by timber brackets and clad with the same weatherboards as the western verandah. This cantilevered room is mirrored on the southern façade.

Figure 130: Bradfield House showing cantilevered room, weatherboard extension (c.1982) including external stairs, and exposed bricks (AHS 2021).

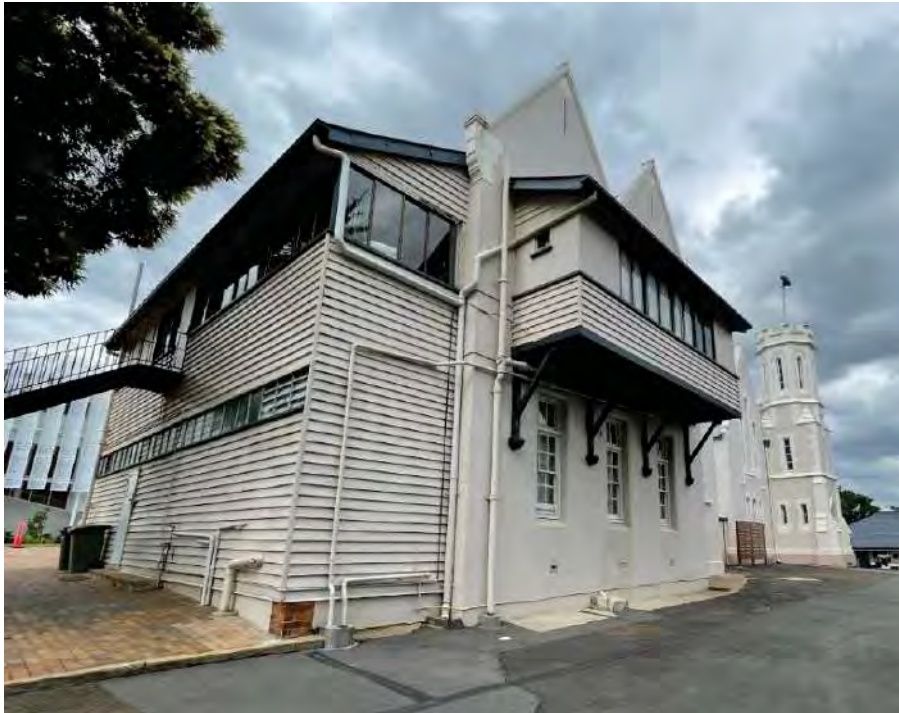
Bradfield House is left with exposed bricks on its northern façade but has been rendered on its southern façade.

Figure 131: Bradfield House showing the southern elevation with contemporary render detail and weatherboard skillion closed verandah extension to the west. The southern façade has a matching cantilevered verandah which has been enclosed with weatherboard and FC sheeting. Note the southern tower in the background (AHS 2021).

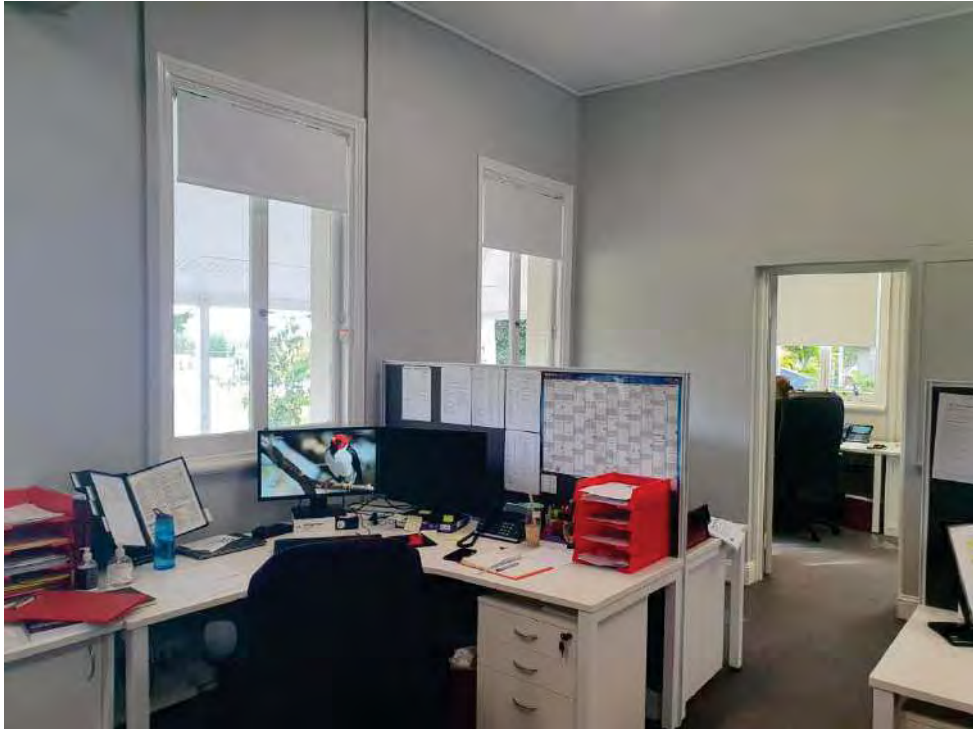
Internally, the former Science Building / Gilmore Wilson Music Building has received a contemporary fitout which retains limited early features.

Figure 133: Main office space inside the former 1912 Science Building, showing contemporary fitout (IGS, 2022).

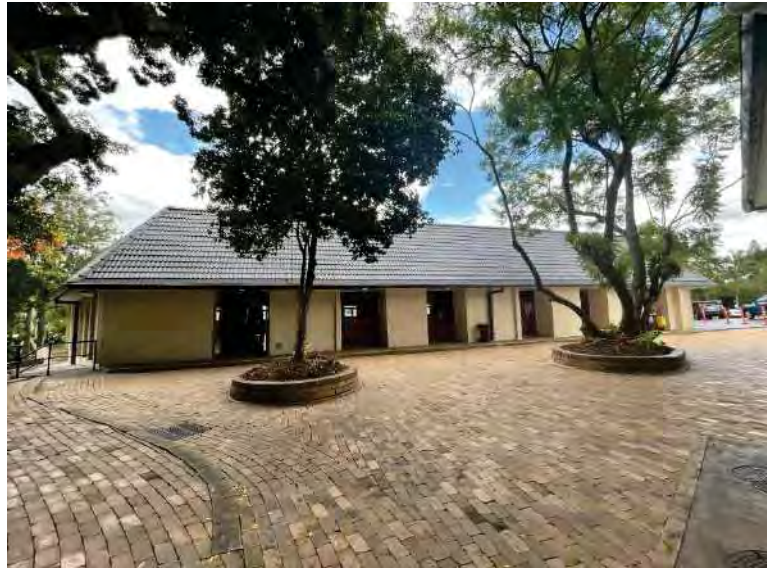
Figure 138: The Auditorium (AHS 2021).

The Auditorium was constructed in 1972 as the War Memorial Teaching Complex. Like the boarding towers, this building was designed by Stephen Trotter. It is a steel framed building with brick infill wall cladding and a tiled mansard roof.

Originally, the Auditorium had ceiling panels that could be lowered to create classroom spaces, and therefore functioned as a multi-purpose building. However, these panels have since been removed. In 1991, a recreation room was constructed underneath.

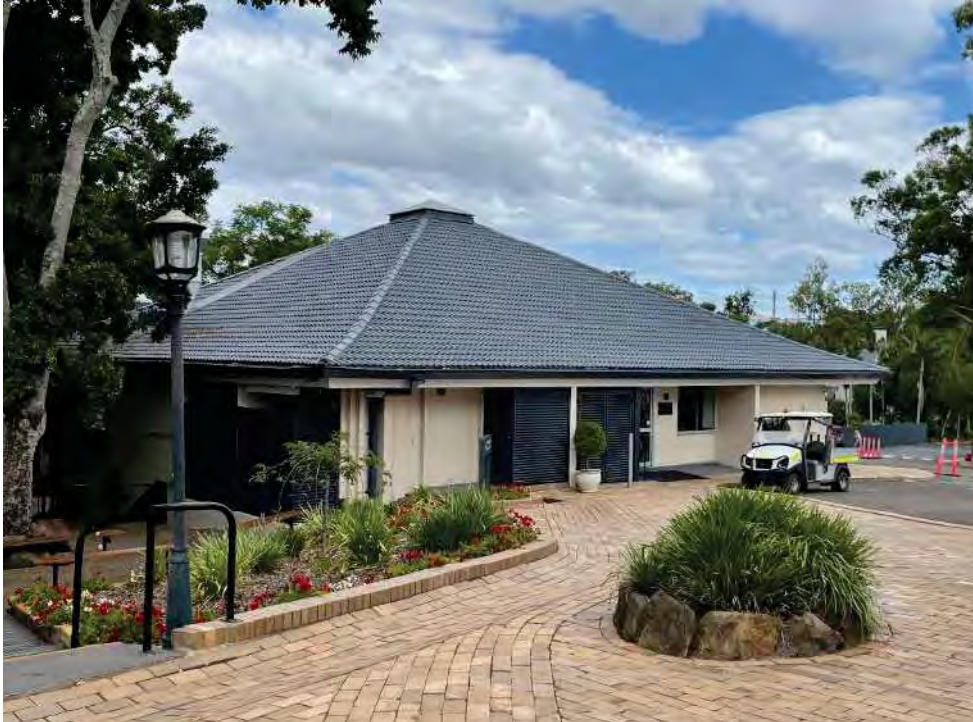
Figure 140: The Dining Hall (former M.E. Williams Building) (AHS 2021).

The building is a two-storey, square plan, brick building with a tiled pyramid roof and cupola.

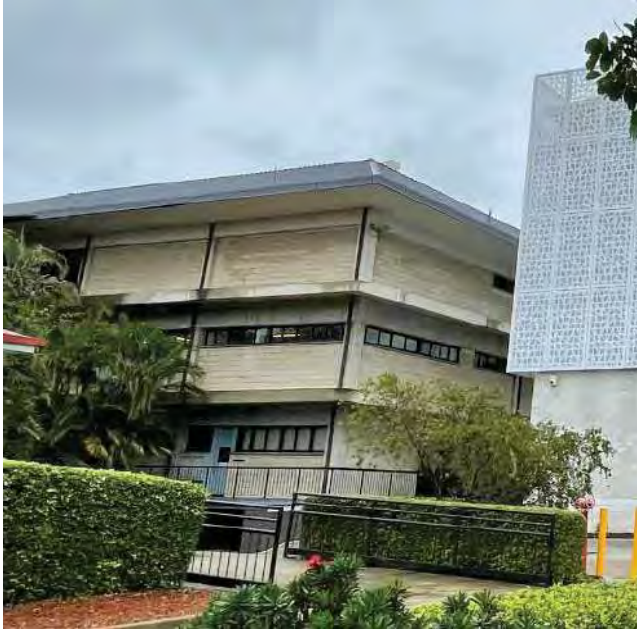
Figure 142: Rear of the Ladley Building (AHS 2021).

The Ladley Administration Building and H.C. Wilson Building are 1980 constructions that are contemporary in design and materiality. The Ladley Building is clad with concrete tiles, with the main entrance utilising gold anodised aluminium glazing panels. The building also has a Trimdek (or equivalent) galvanised roof sheeting. Outside of the Ladley Building is a tall clock tower also clad with vertical fluted concrete block.

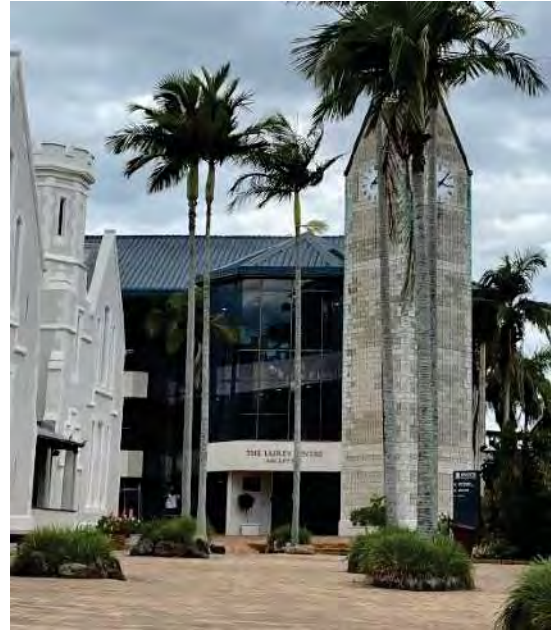
Figure 143: Entrance to the Ladley Building with Clock Tower (AHS 2021).

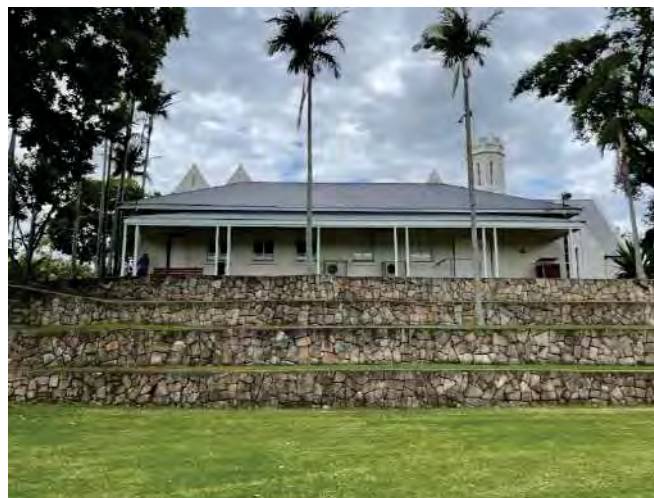
Figure 147: Terraced walls in front of the former 1912 Science Building (now the Accounts Office and Uniform Shop) (AHS 2021).

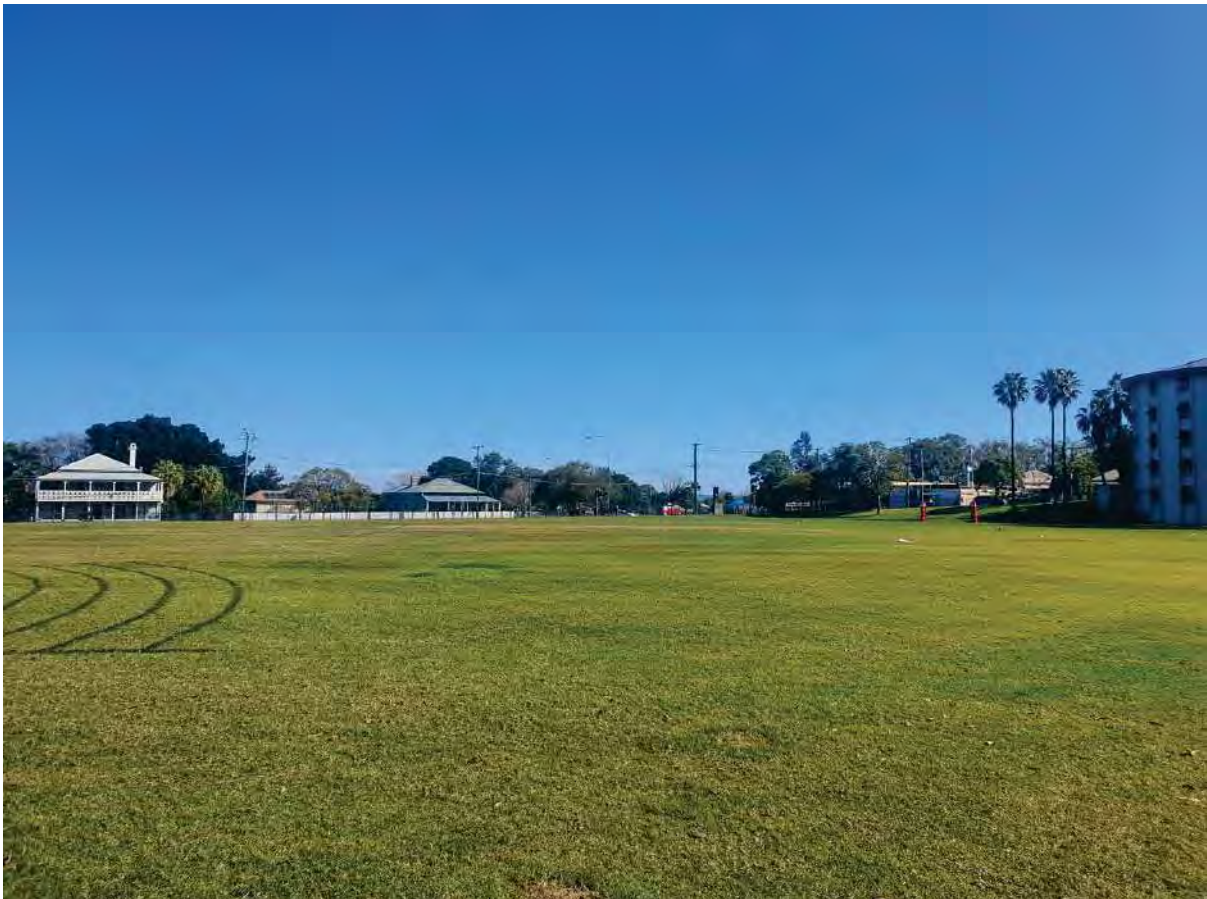
Figure 150: Maud Kerr Oval, facing west toward Burnett Street. Note Fox Tower in the background [right] (IGS 2022).

The Maud Kerr Oval (No. 1 Oval) was initially at a higher elevation and has been an established oval since 1925. In 1956 however, the oval was lowered, enlarged, and fenced and was also named the Maud Kerr Oval, known now as No. 1 Oval. The stone-pitched terraced retaining walls were established in 1978, arranged in a ‘crazy pave’ design.

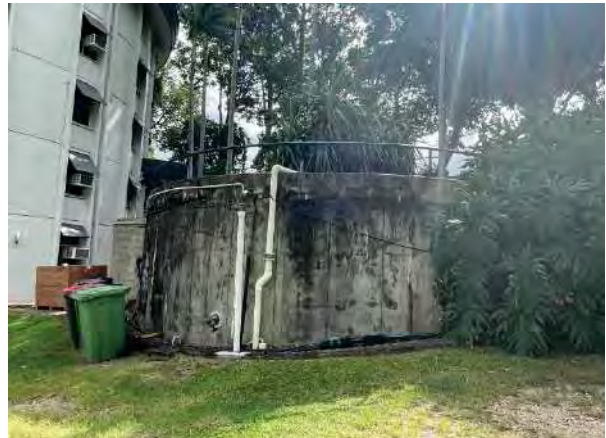
Figure 153: River water tank (AHS 2021).

The concrete water tank next to the Hancock Oval is said to store around 130,000 litres of river water that is used across the site for irrigation. It was constructed in 1985 by Monocast Manufacturing.

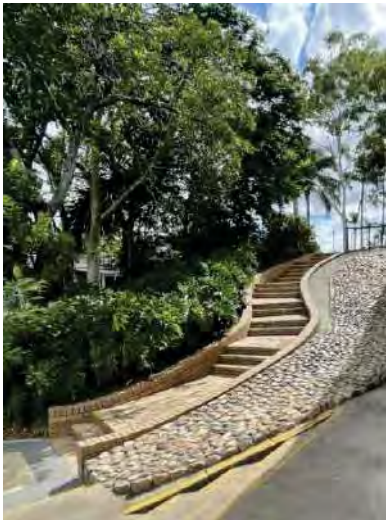
Figure 156: Brick paved walkway and stone-work set in concrete (AHS 2021).

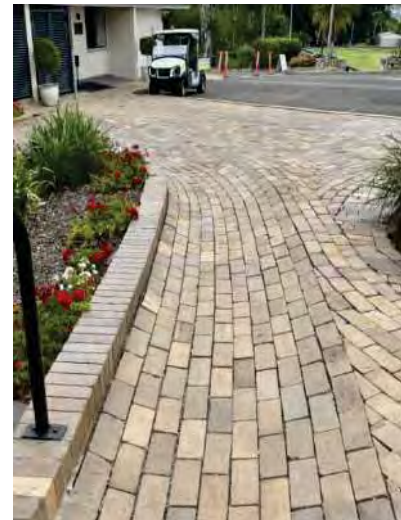
Figure 158: A low profile paved drain (AHS 2021).

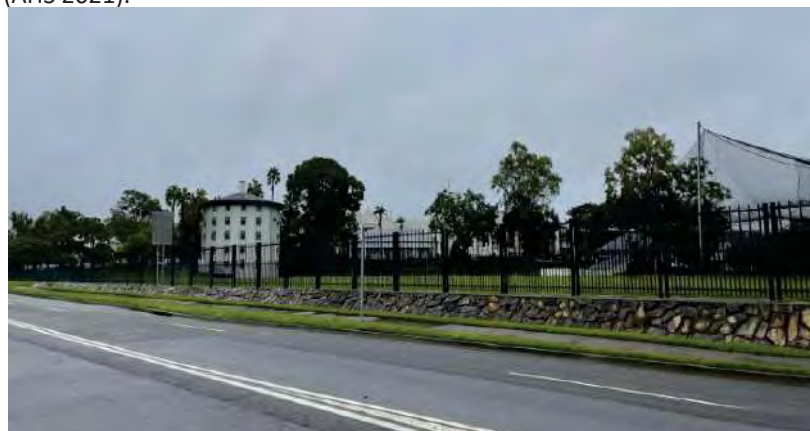
Figure 160: The powder-coated perimeter school fence and low stone retaining wall along Burnett Street (AHS 2021).

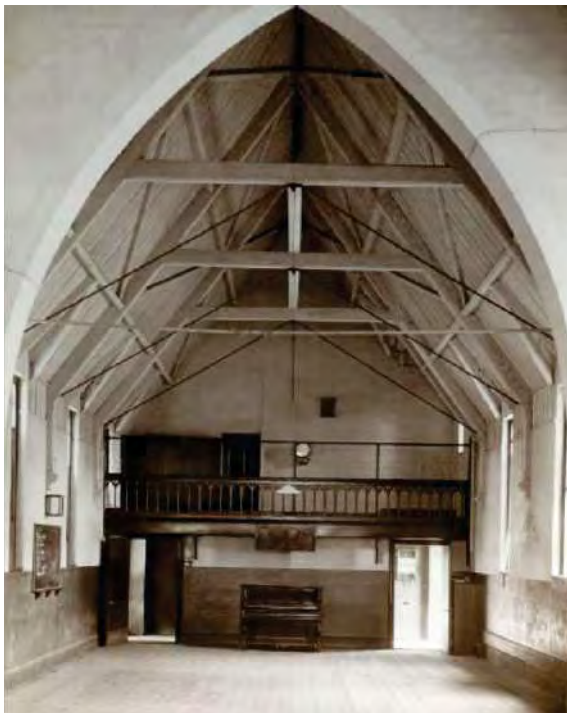
Figure 163: Great Hall, c.1929 (Ipswich Library, Reference No.: qips-2011-09-06-0009p). Note how the walls were painted, with darker colouring the lower third. Also note the door to the gallery was a four-panel door which has now been replaced (See Chapter 3 – Physical Description).

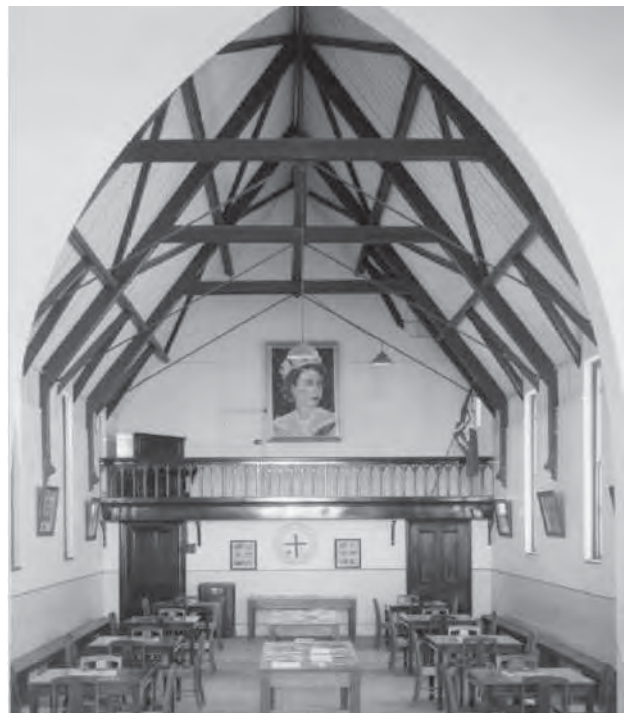
Figure 164: Great Hall, 1954 (Ipswich Library, Reference No.: WHD-014-NEG-0965p). Note that the hall has a lighter colour scheme, with the dado rail delineating the lower wall colour. The timber roof structure has also been painted a darker colour. The piano has been moved to the gallery space, and a large portrait of Queen Elizabeth II is mounted in the centre, likely due to the 1954 Royal Tour.
