Removal of a place from the Queensland Heritage Register

For a more detailed historical context of Ipswich Grammar School, please see Chapter 2 and Section 4.5 of the existing Conservation Management Plan (CMP) (AHS 2023) (Appendix A).

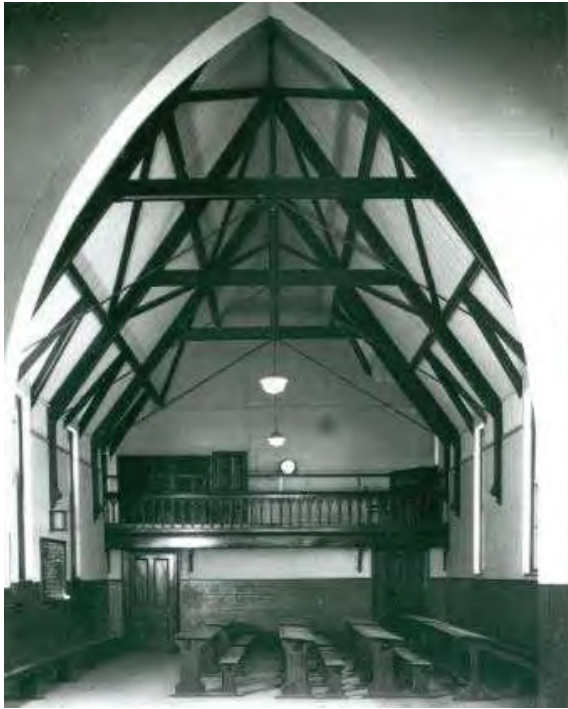
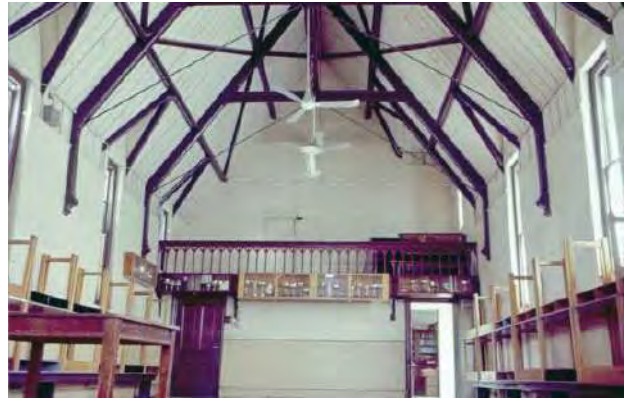
Figure 165: (Above) Great Hall, c.1971 (Ipswich Library, Reference No.: qips-2009-09-15-0075p). Notes the walls are back to a lighter colour scheme and the gallery door has changed.

Figure 166: (Left) Great Hall, c.1963 (Ipswich Library, Reference No.: qips-2011-09-06-0006p). Not much has changed since 1954 except for some painting which has resulted in a darker brown being used on the walls.

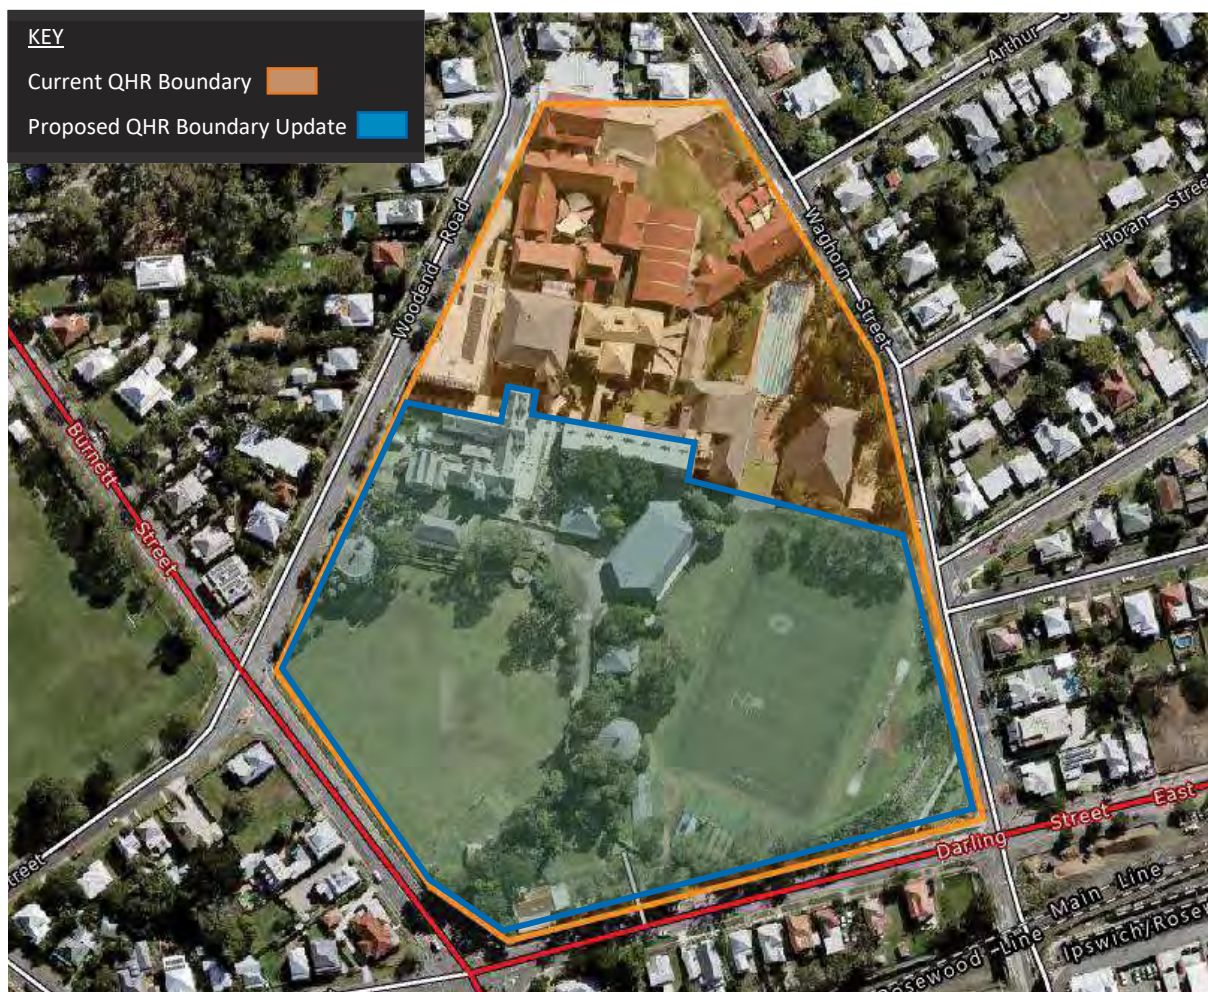
Figure 167: The current QHR Boundary [orange – L393 SP283393] encompasses the entirety of Lot 393 SP283393. The recommended updated QHR Boundary [blue] encompasses the Early Building Complex and the remainder of the school south / south-east of the complex.

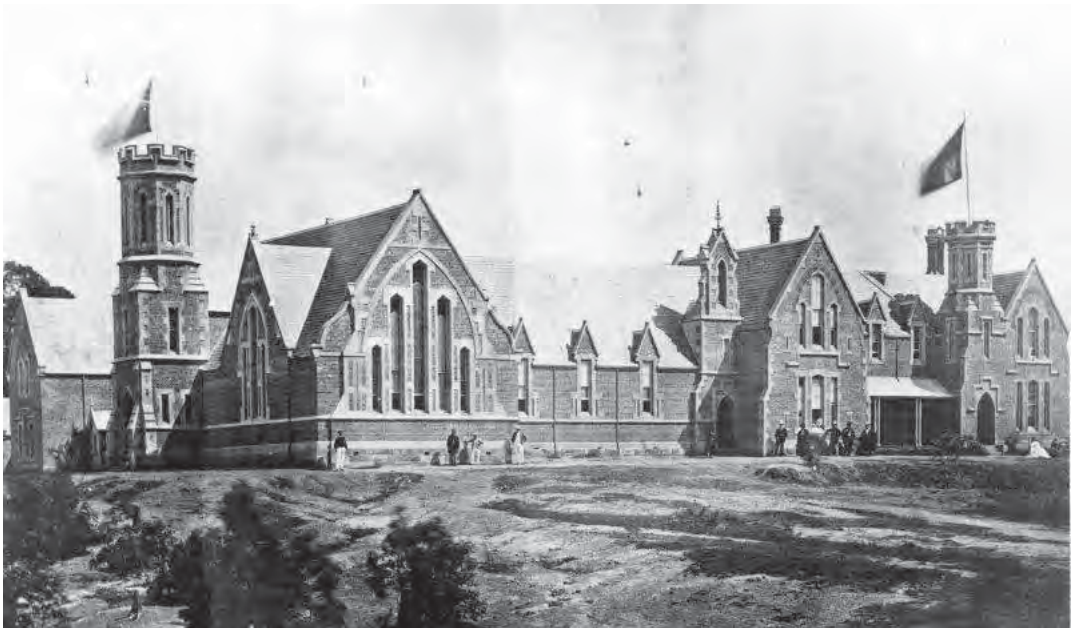
The original section of the 1865 building extends from the far right through to the around the gable of the Great Hall (facing). The prominent gable front of the Great Hall with the tall stepped windows extending to the rear left is the 1868 addition. (Image obtained from IGS Archives)

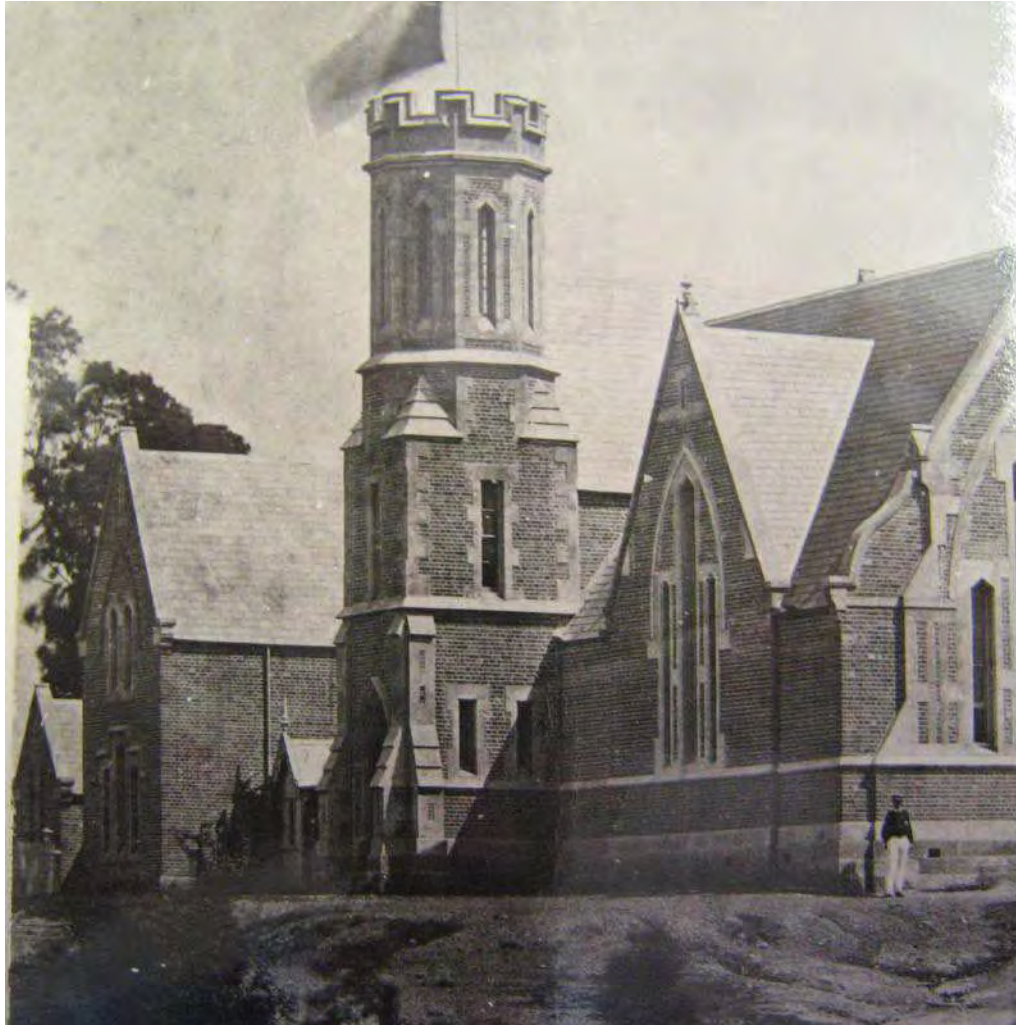
Detail view of the 1868 wing addition (Image obtained from IGS Archives)

It is commonly thought that the whole of the southern and eastern wings of the building comprise the "original" school. However, this is not correct. The initial enrolment in October 1863 was 18 students. The following year numbers had increased to 64 and by August, the Trustees were discussing plans and specifications prepared by Backhouse for a major extension.

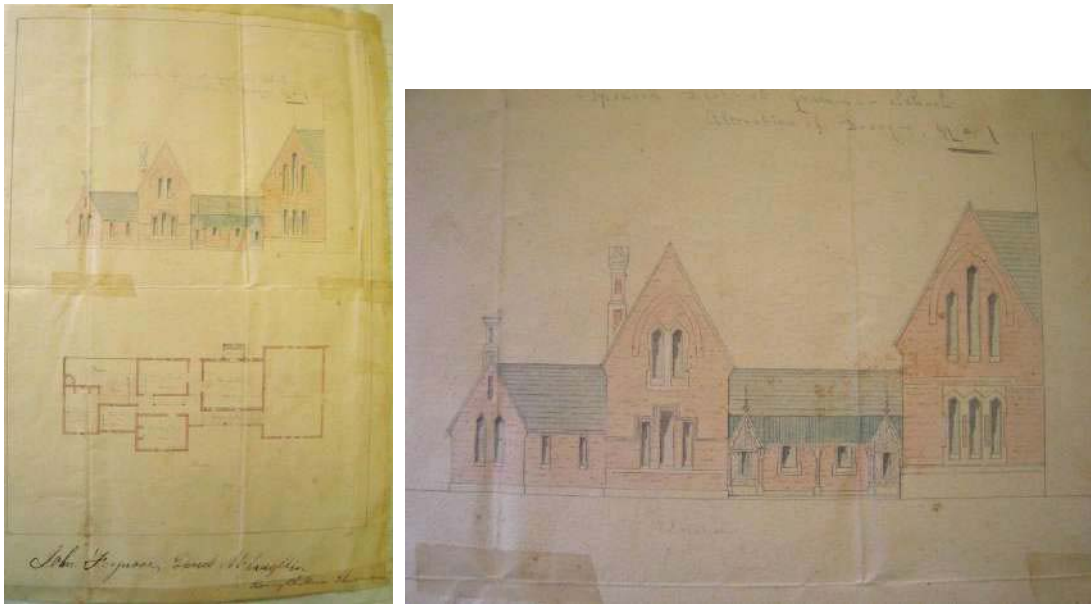
*Extension plan photographs of originals held in the School Archives (1865) (Detail above right)
Plan signed by John Ferguson and David McLaughlin, and the Chairman, this drawing is provided by Benjamin Backhouse.*

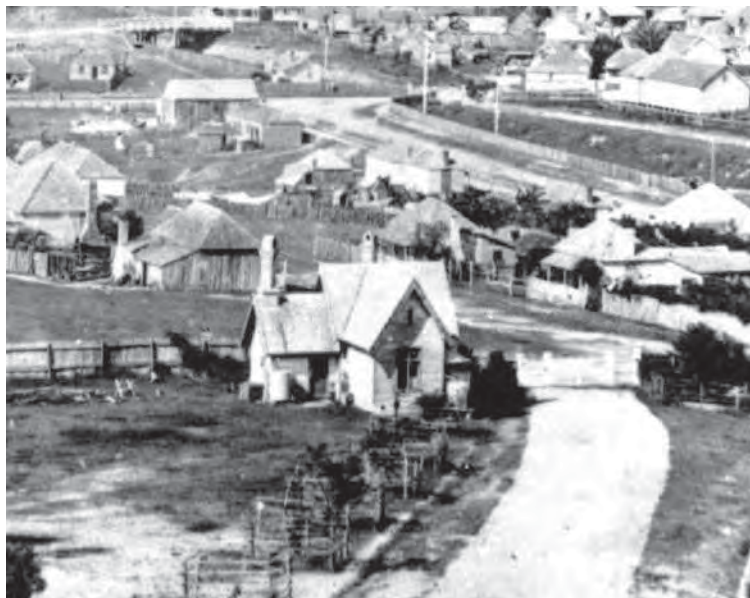
The gate keeper's cottage (Image source - Buchanan Heritage Services)

Put more generally, this included the lower part of the Main Hall, the main tower and the section of the building facing south (i.e. facing towards Burnett Street). A parapet coping still visible in the roof appears to indicate the original end wall of the Great Hall. The "Lodge" was probably the gatekeeper's lodge, a small cottage on the eastern side of the school grounds.

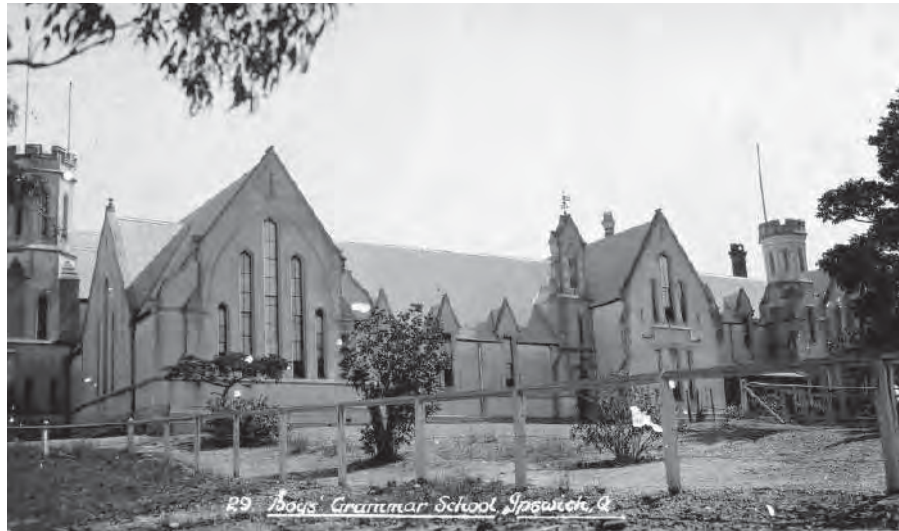
IGS c1950 showing render finish (Image obtained from IGS Archives)

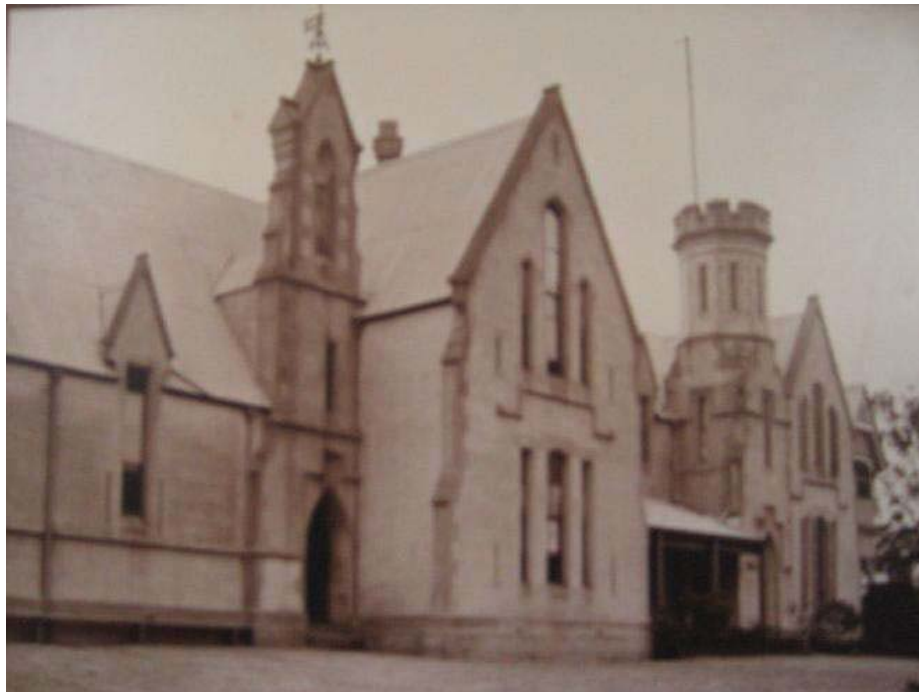
Image undated, the c1863 section with render, stone dressings and mouldings evident. (Image obtained from IGS Archives)

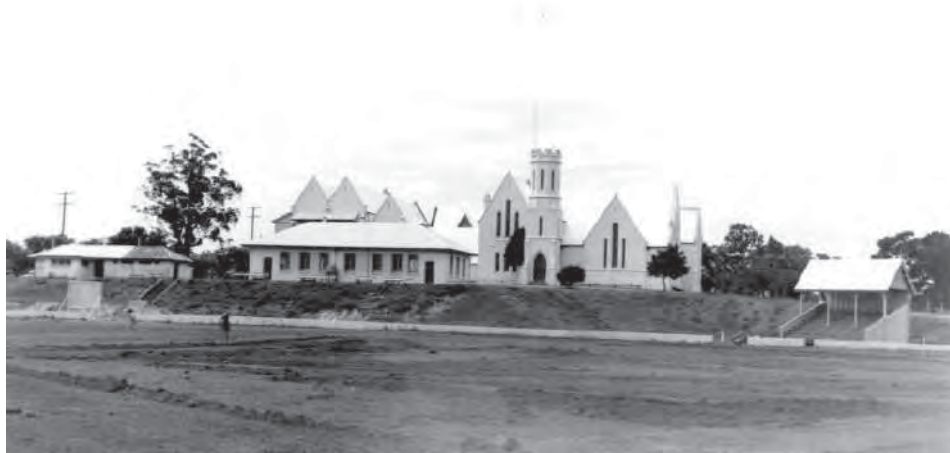
IGS c1960s showing an amenities building to the left, the 1913 Science Rooms central and Grandstand to the right overlooking the No.1 Oval (Image IGS Archives)

The new laboratories were built as a separate block overlooking the oval - a simple, one-storey rectangular building. They were funded by a government loan, community fundraising and the sale of land owned by the school.²¹

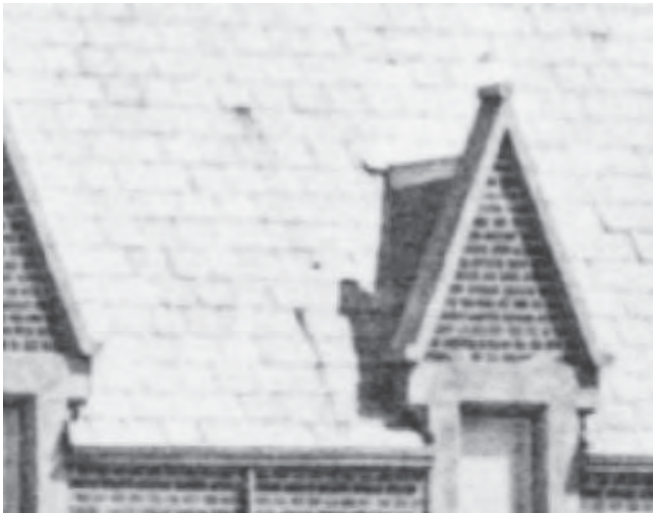
Area of roof showing slates (Detail from previous images)

The roof of the school was reportedly a repeated source of problems. By 1884, the slate roof was already proving to be troublesome, and it was recommended the roof be changed to shingles (which was originally proposed by Backhouse). The decision to change the roof to shingles was approved in 1884, though it is not clear to what extent the roof was shingled (CMP, 2010: 18). Some of the roof remained slated because complaints are said to have continued into the twentieth century, with severe wind lifting slates in 1902 (CMP, 2010: 19).

By 1899 however, a decision had been made to substitute galvanised iron for the troublesome slates. This was carried out progressively. Whenever extensive repairs were required for the roof, the slates were removed, and galvanised iron substituted. It is believed the school was re-roofed on several occasions in the early twentieth century (CMP, 2010: 19).

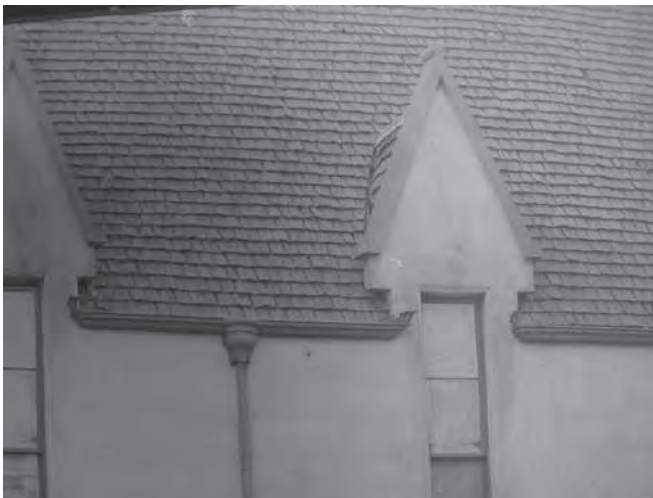
Similar area of roof showing timber shingles (Detail from previous images)

By 1884, the slates were proving troublesome and Samuel Shenton recommended changing them to shingles. In June, a tender was accepted from Worley and Whitehead for £229 for "shingling school with split shingles" and in December, an insurance company's endorsement noted the alteration from slate to shingle. However it is not clear to what extent the roof was shingled. The 1863 section was certainly shingled, as this is clearly shown in a jubilee photograph taken in 1913. The Gatekeeper's Lodge might also have been changed as an 1888 minute refers to repairing the Lodge with shingles.

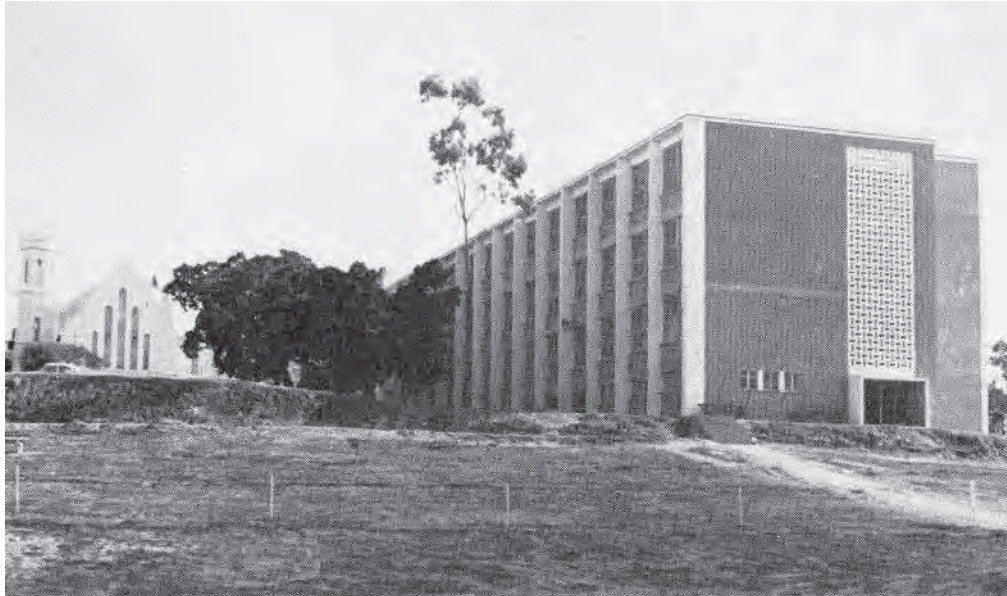
New building c 1960s designed by Karl Langer (Image obtained from IGS Archives)

Also in the 1960s, a large new building was designed by architect Karl Langer. This included 13 classrooms, 2 science demonstration rooms, 3 laboratories, offices, masters' rooms, wash room, and locker area. It was sited with little thought for historical context, and its scale and location made it an obtrusive element in the school grounds particularly when viewed from the town. It has now been absorbed into the modern building complex.

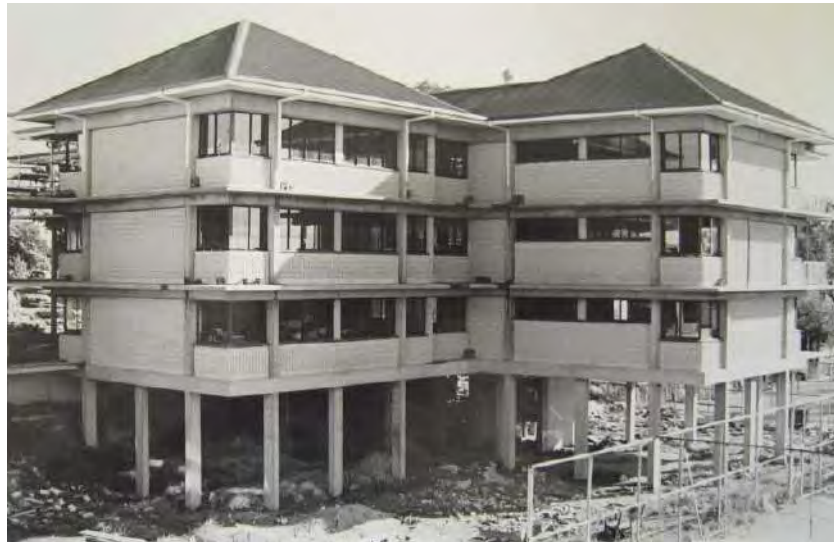
Wilson Building under construction (Image obtained from IGS Archives)

Bradfield House was refurbished and changed back into boarding accommodation by Buchanan Architects in 1982. In 1983, the three-storey Harry G. Wilson Science Building was completed. In 1985, the Murray Hancock Memorial Block built in 1947 was renovated by Buchanan Architects as an art studio and re-named the Murray Hancock Memorial Arts Centre. At the same time, the adjacent box room was converted into accommodation for masters

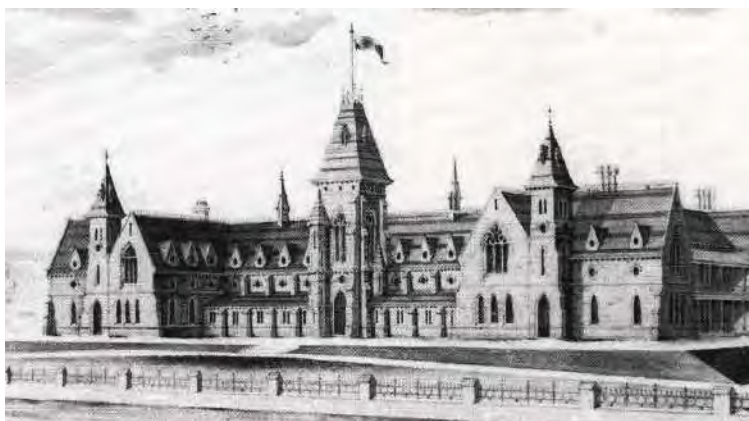
*The original
Backhouse design
proposal for Brisbane
Grammar School
1867. Photo from
Watson, McKay 1994,
pg 10*

In Brisbane, effort to construct a school for higher education was realised shortly after the Ipswich Grammar School was in operation. The original site of Brisbane Grammar School was in Roma Street, and the building in below left picture was constructed in 1868. The construction of the school in the image below left, is a much reduced or altered version of the original design drawing produced by Backhouse (bottom image). This un-built BGS design is more extensive than the Ipswich Grammar School design, however the design is similarly Victorian Free Gothic, without the crenulated towers (lower image).

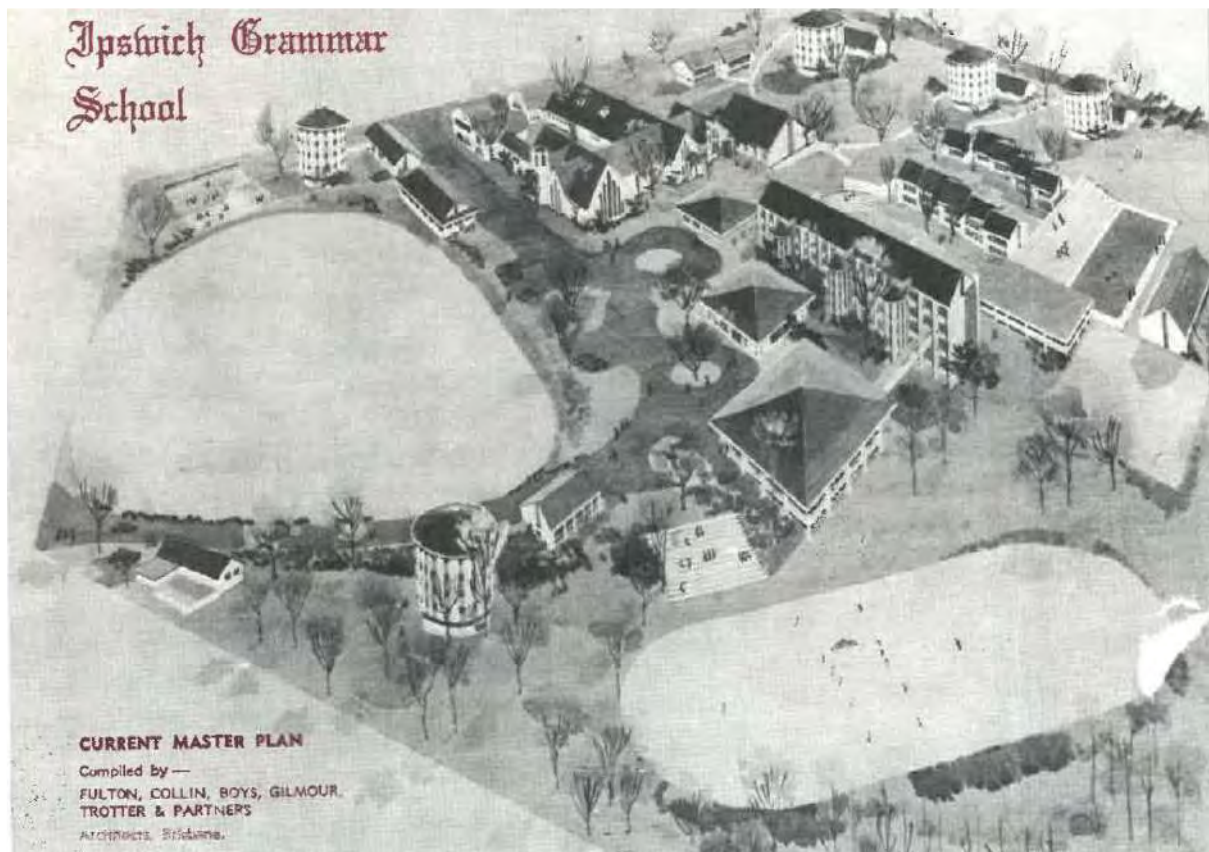
Figure 1: Master plan, 1972. Note that this image shows an addition of three dormitories that were initially proposed (top right) but never constructed. Also note the roof of the Langer Building is shown to be a gable roof (Image taken from Sophie Church, 2013: 41).

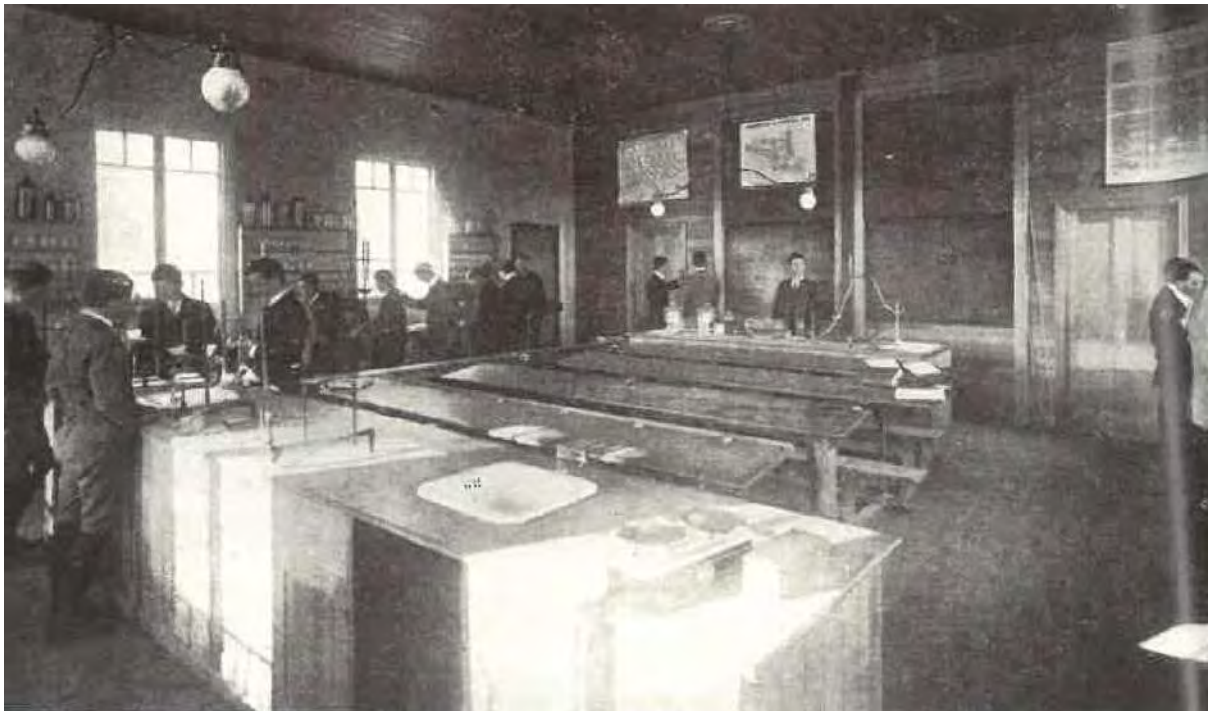
Figure 3: The 1912-13 Science Block, internally, 1913 (Image taken from Sophie Church, 2013: 115-116).

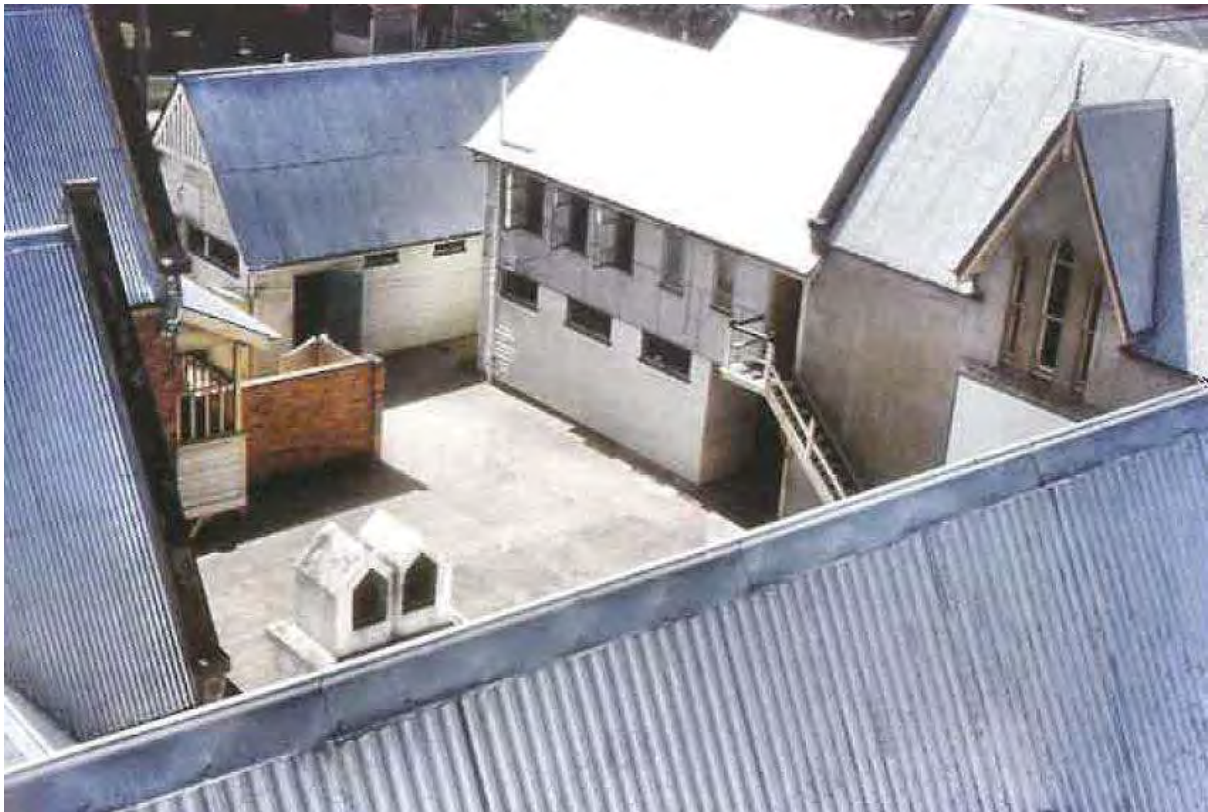
Figure 4: Courtyard area, 1961, showing connection between 1877 extension and the former Murray Hancock Memorial Building (Image taken from Sophie Church, 2013: 159).

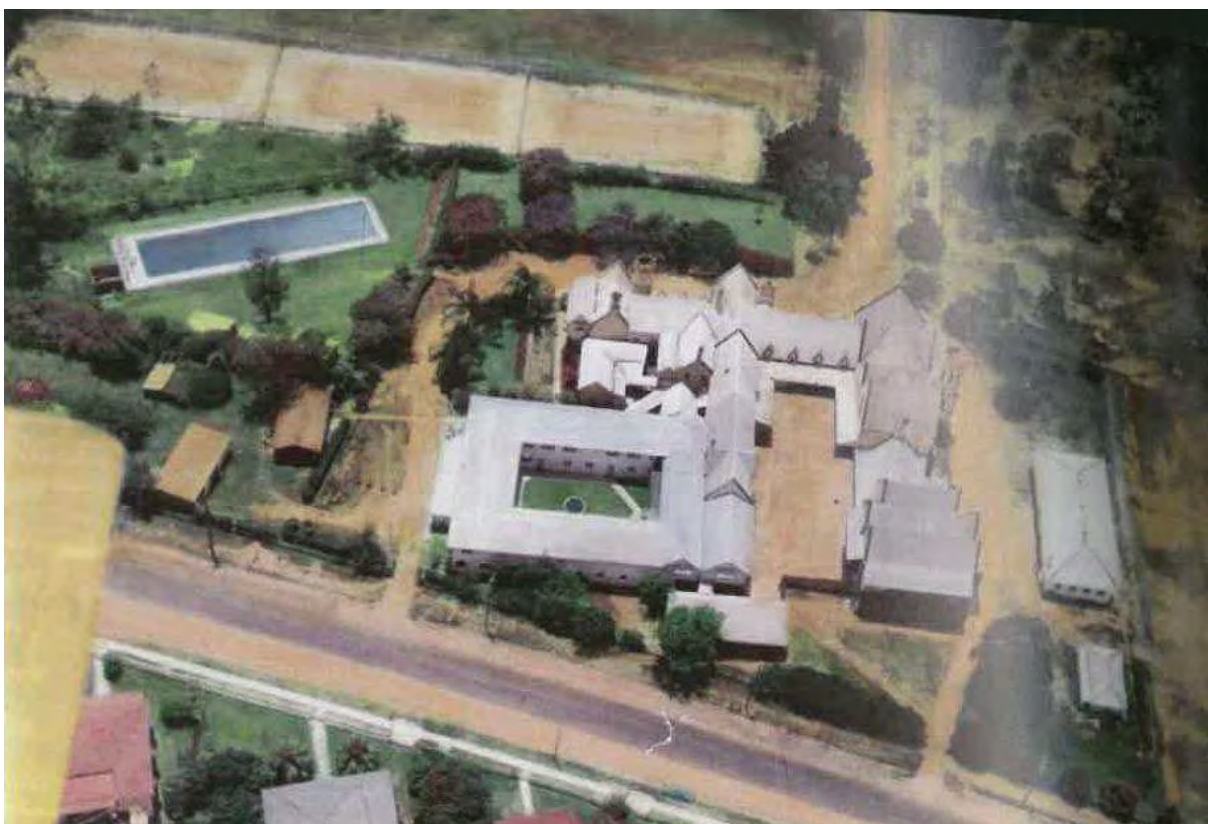
Figure 5: Aerial view of the school in 1951, prior to the Langer Building being constructed (Image taken from Sophie Church, 2013: 244).

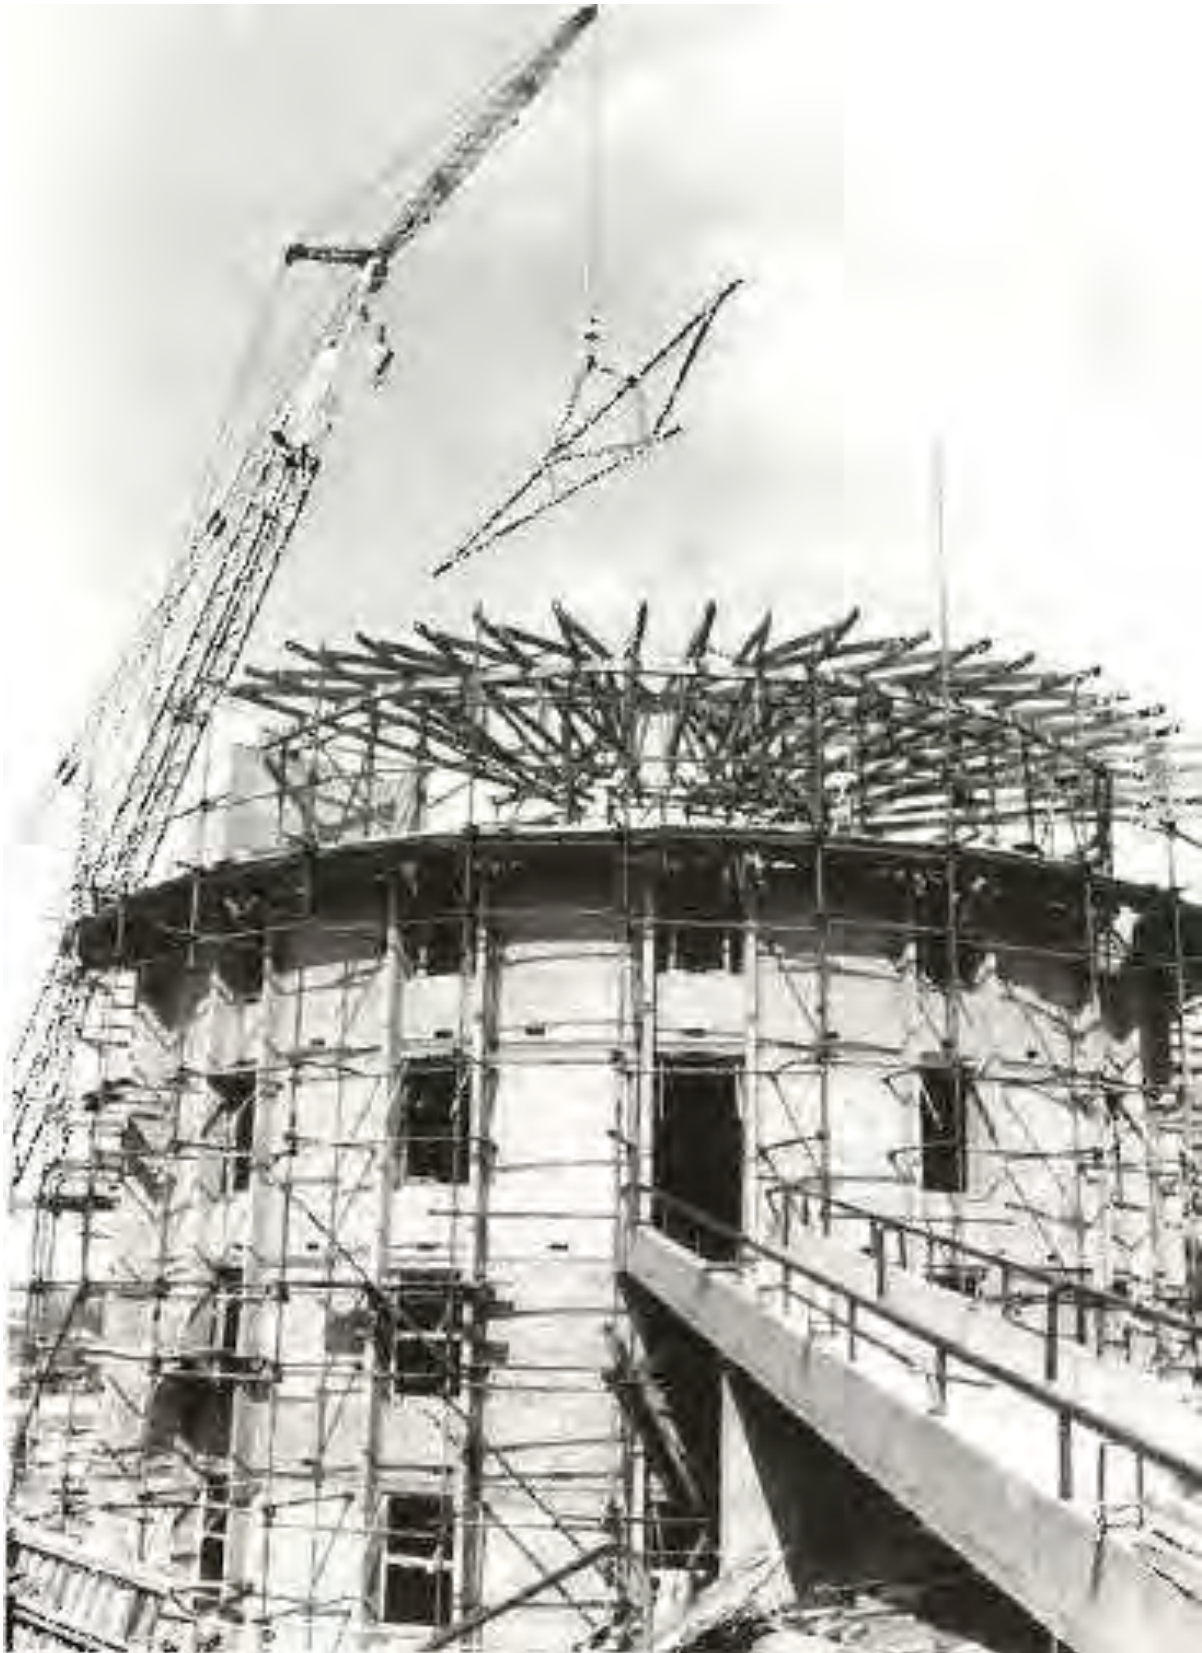
Figure 6: Construction of the Fox dormitory tower 1972 (Image taken from Sophie Church, 2013: 249).
