TECHNICAL NOTE

Conserving Roofs

Prepared by: Heritage Branch, Department of Environment and Heritage Protection

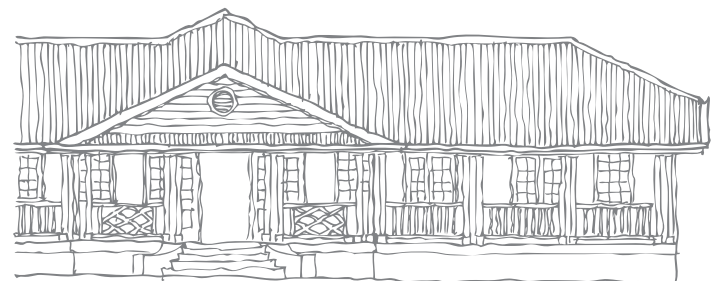
Decorative use of guttering—1930s

A plain building with a quad gutter taken all around the building, in front of the gable and following the pitch of the roof.

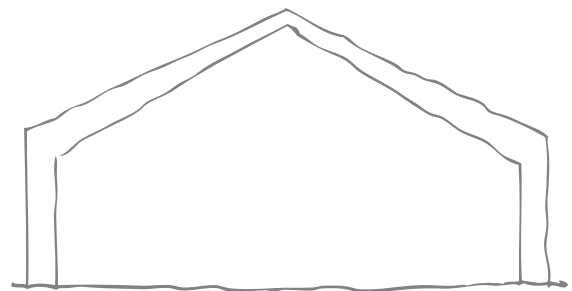
Typical portal frame—material could be timber (laminated or ply), steel or concrete

Portal frames are a comparatively recent form of construction where rafters and columns form part of the same frame. The rigid connection between rafter and column transfers some of the bending moments of the rafter to the column, allowing a larger span to be achieved. Portals are generally steel, precast concrete or laminated timber. The buildings are usually single bay and single storey.
