DIVE into history

SS Yongala (1911)

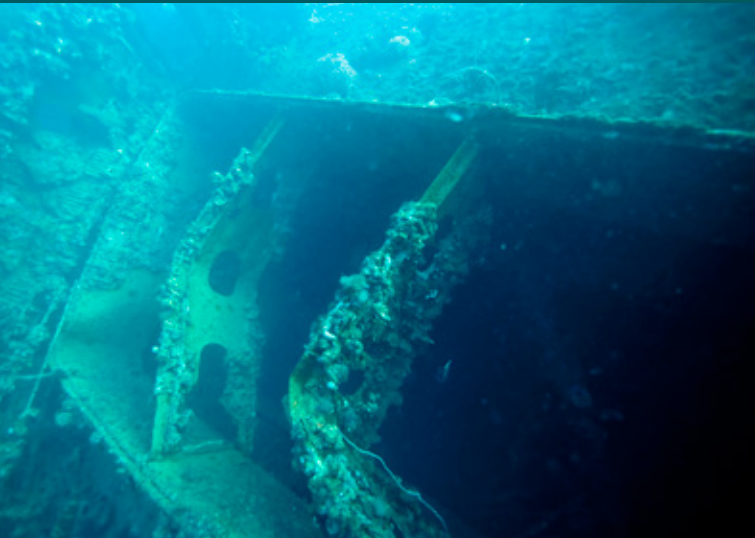
▼ The exposed engine

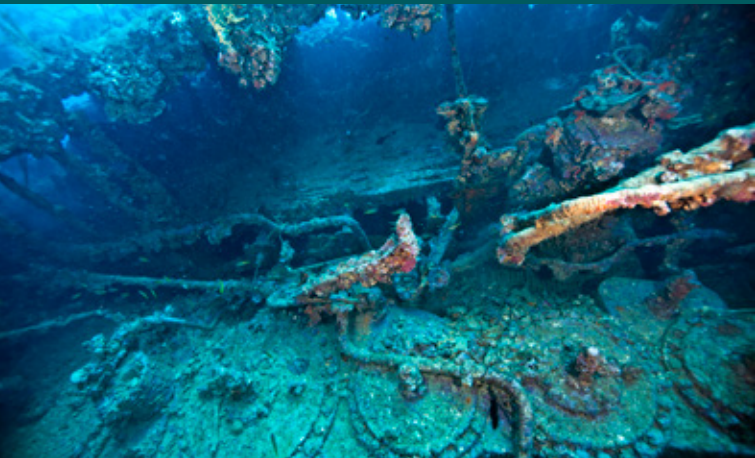
▼ The bow lying astern with anchors still fixed in place
