# Sandy Creek Sub-catchment Water Quality Monitoring Project

2015 – 2016

Science Division

Final 1.0

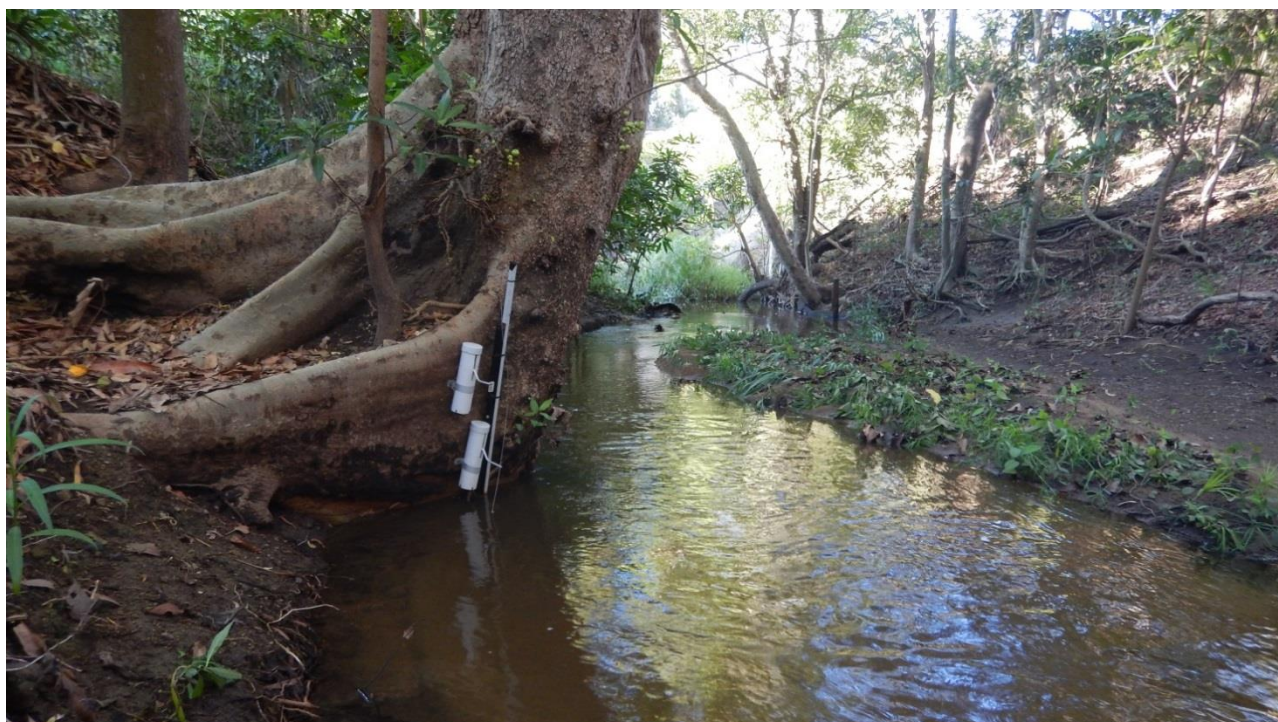
**Figure 2-4** Water depth logger and rising stage samplers installed in Sandy Creek South Branch on the downstream side of a tree.

Water depth loggers were mounted inside electrical conduit, fixed in place with a star picket and securely attached to a tree (Figure 2-4). Depth loggers were installed in positions which provided protection during high flow conditions, and co-located with rising stage samplers. The height records obtained from the depth loggers were used to determine the date and time the rising stage samplers filled.

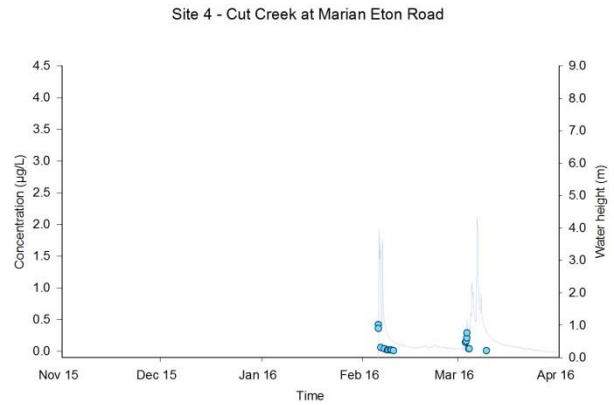
**Figure 7-5 Hydrographic plot of water level and concentration ( $\mu\text{gL}^{-1}$ ) of imidacloprid in Cut Creek.**

Figure 7-5 Hydrographic plot of water level and concentration ( $\mu\text{gL}^{-1}$ ) of imidacloprid in Cut Creek.	149
Figure 7-6 Hydrographic plot of water level and concentration ( $\mu\text{gL}^{-1}$ ) of imidacloprid in Sandy Creek at Eton.....	149
Figure 7-7 Hydrographic plot of water level and concentration ( $\mu\text{gL}^{-1}$ ) of imidacloprid in Draper Creek at Peak Downs Highway.....	150
Figure 7-8 Hydrographic plot of water level and concentration ( $\mu\text{gL}^{-1}$ ) of imidacloprid in Ross Creek at Barrie Lane. ....	150
Figure 7-9 Hydrographic plot of water level and concentration ( $\mu\text{gL}^{-1}$ ) of imidacloprid in Bagley Creek.....	150
Figure 7-10 Hydrographic plot of water level and concentration ( $\mu\text{gL}^{-1}$ ) of imidacloprid in Oak Creek.....	150
Figure 7-11 Hydrographic plot of water level and concentration ( $\mu\text{gL}^{-1}$ ) of imidacloprid in Sandy Creek at Homebush.....	150

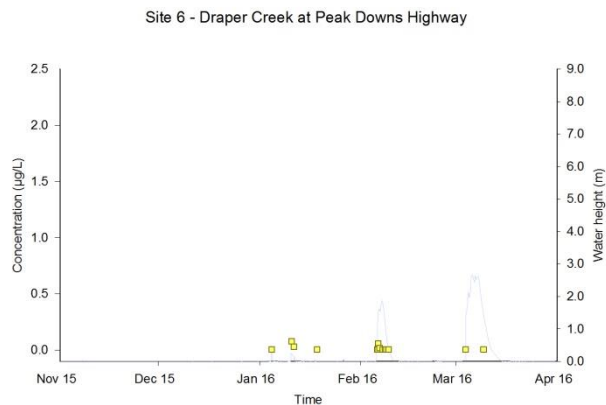
**Figure 7-175** Hydrographic plot of water level and concentration ( $\mu\text{gL}^{-1}$ ) of imazethapyr in Draper Creek at Peak Downs Highway.

Figure 7-175 Hydrographic plot of water level and concentration ( $\mu\text{gL}^{-1}$ ) of imazethapyr in Draper Creek at Peak Downs Highway.....	186
Figure 7-176 Hydrographic plot of water level and concentration ( $\mu\text{gL}^{-1}$ ) of imazethapyr in Ross Creek at Barrie Lane.....	186
Figure 7-177 Hydrographic plot of water level and concentration ( $\mu\text{gL}^{-1}$ ) of imazethapyr in Bagley Creek.....	186
Figure 7-178 Hydrographic plot of water level and concentration ( $\mu\text{gL}^{-1}$ ) of imazethapyr in Oaky Creek.....	186
Figure 7-179 Hydrographic plot of water level and concentration ( $\mu\text{gL}^{-1}$ ) of imazethapyr in Sandy Creek at Homebush.....	186
Figure 7-180 Hydrographic plot of water level and concentration ( $\mu\text{gL}^{-1}$ ) of imazethapyr in Frenchmans Creek.....	186
Figure 7-181 Hydrographic plot of water level and concentration ( $\mu\text{gL}^{-1}$ ) of imazethapyr in Sandy Creek at Bruce Highway.....	187
