LADY BOWEN

Sketch map of wreck site (key on reverse)

Lady Bowen (1894)

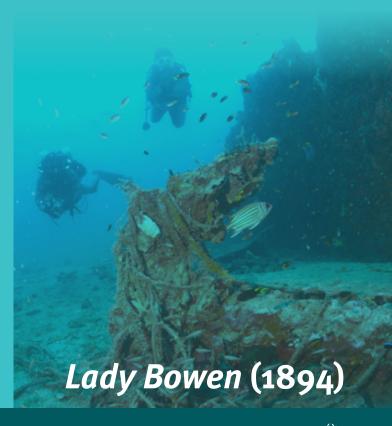
Site map of Lady Bowen

The wreck lies upright listing to starboard on a sandy bottom and can be partially covered by sand. Site features include an iron hull, ballast, broken planks, large anchor winch and anchor.

Lady Bowen map key

closed off smoke stack

broken planks

corroded object

rubble
