COLLINGWOOD PARK MINE REMEDIATION – Subsidence control using fly ash backfilling

Baotang Shen, Habib Alehossein, Brett Poulsen, Cameron Huddleston-Holmes, Binzhong Zhou, Xun Luo, Hongwei Wang, Johnny Qin, Joey Duan, Zak Jecny, Matt Van de Werken, David Williams¹

CSIRO Earth Science and Resource Engineering Report EP105068

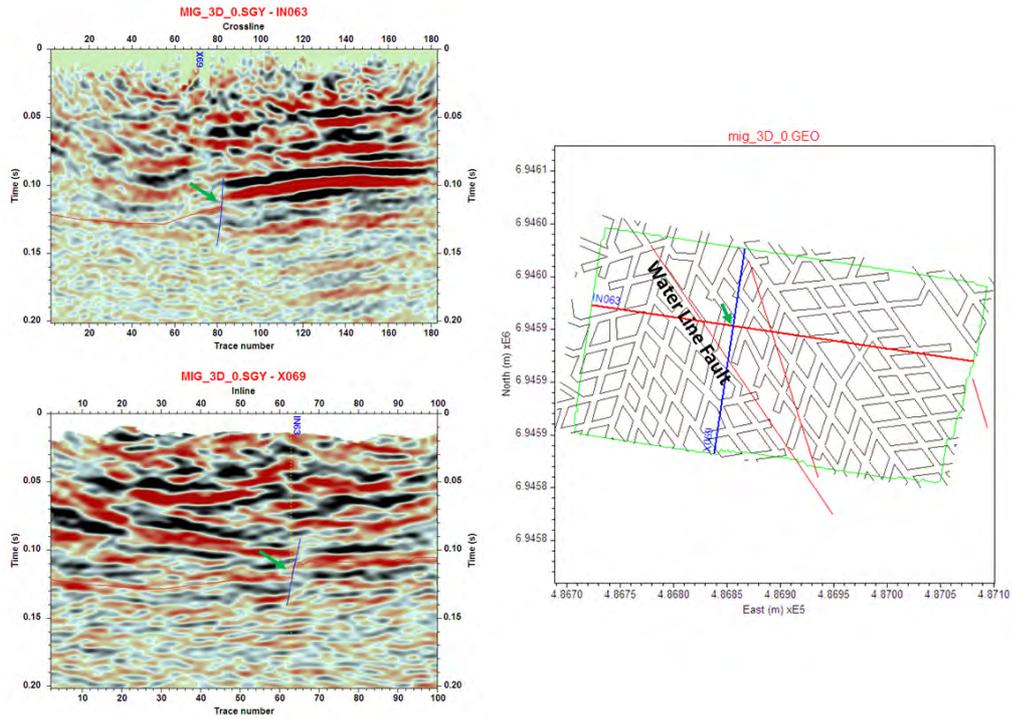
Figure 2-19. One fault identified from the inline IN063 and cross-line X069 as indicated by arrows. This fault is associated with the Waterline fault. The estimated fault displacement at this location is about 8-13 m based on the seismic data.

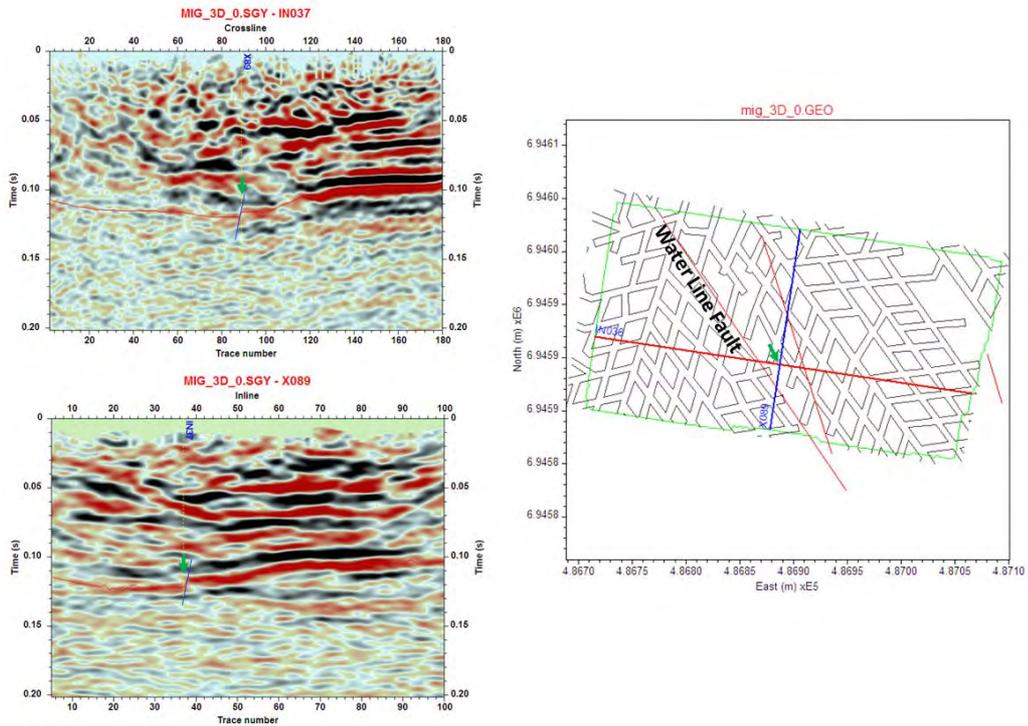
The up thrown side of the fault is on the right or East side of the fault. However, this fault could be a thrust fault with a fault plane dipping to the northeast as shown on the cross-line section X089 in Figure 2-20. However, because the area has been disturbed by subsidence, and the data quality is relatively poor, it is possible that the thrust fault appearance on section X089 is actually a reflection of the failure (or caving) boundary.

Figure 2-20. One fault identified from the inline IN037 and cross-line X089 as indicated by arrows. This fault is associated with the Waterline fault. The estimated fault displacement is about 3 - 5m.

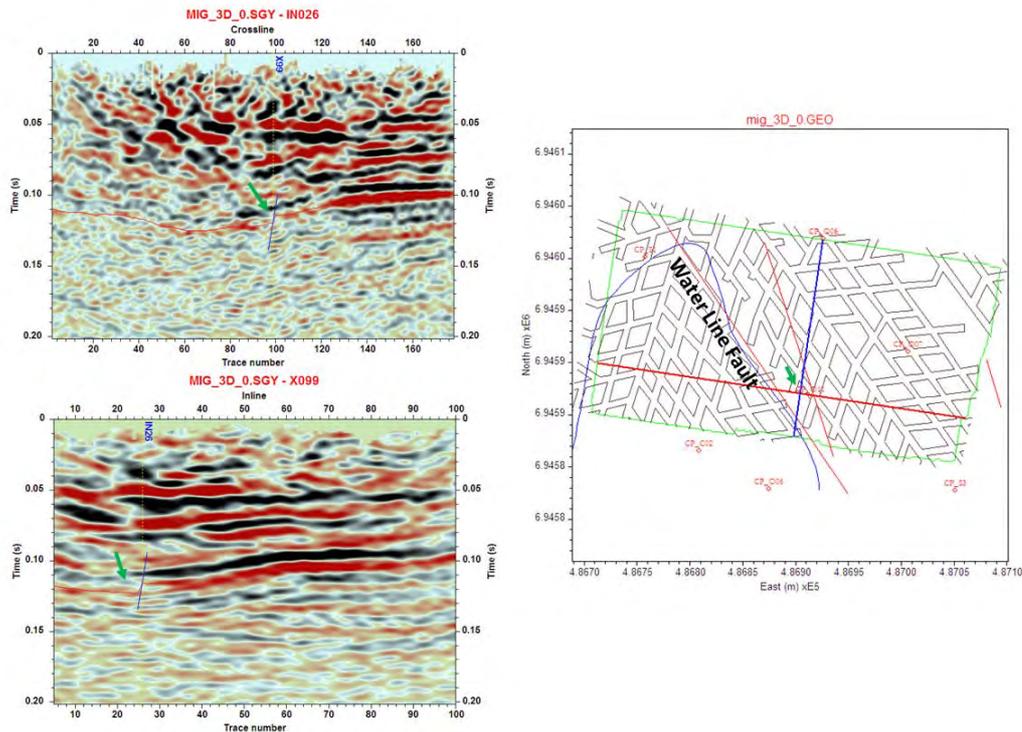
Figure 2-21. One fault identified from the inline IN026 and cross-line X099 as indicated by arrows. This fault is associated with the Waterline fault. The estimated fault displacement is about 3-6 m at this intersection location.

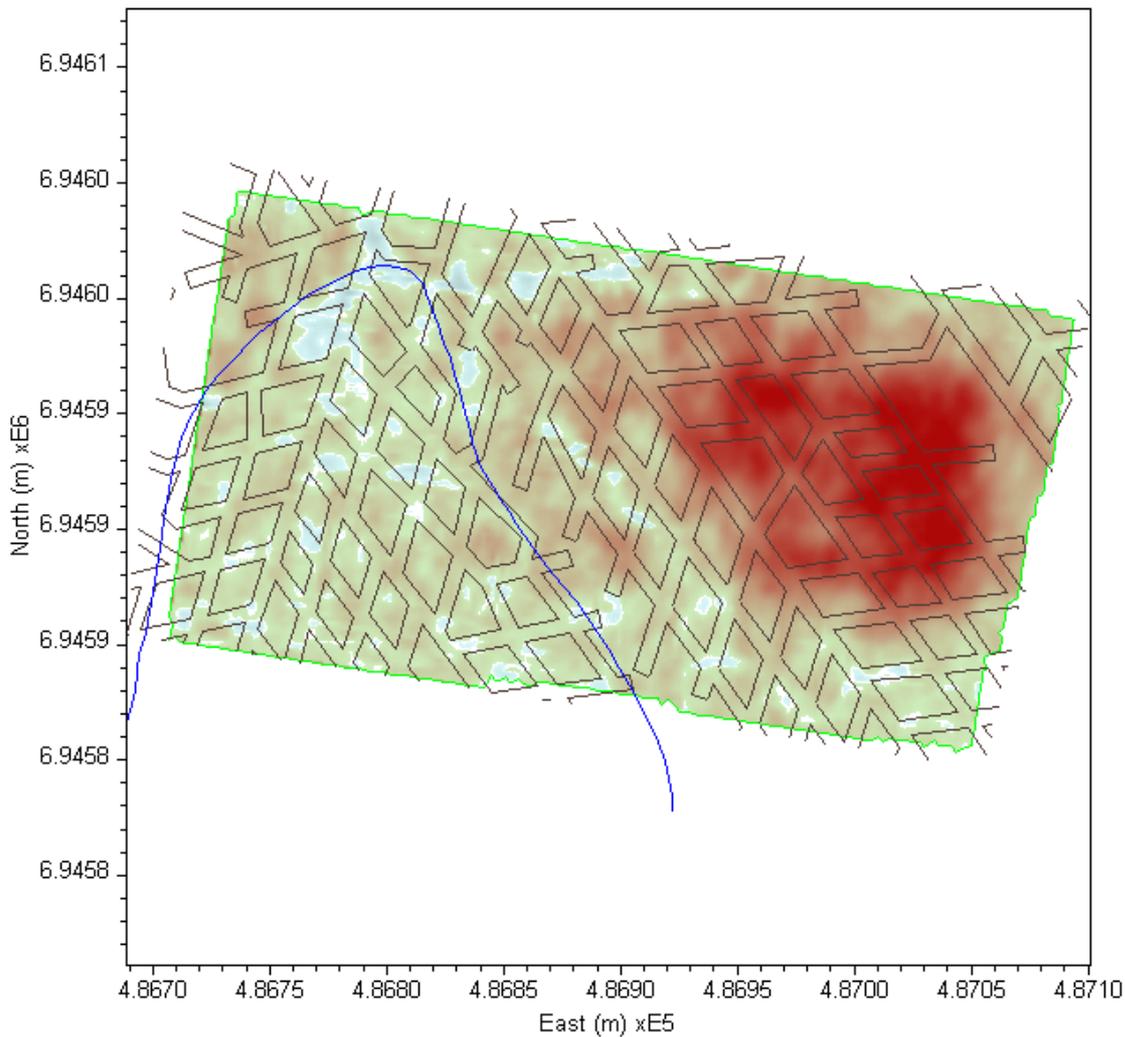
To improve the characteristics of true relative amplitudes the seismic data were reprocessed with true amplitude processing procedures and algorithms and the resulting amplitude distribution of the seam reflections is displayed in Figure 2-23. Unfortunately after this reprocessing we were still unable to map the underground workings. After excluding improper processing as the failure reason, other possible reasons for the failure can be:

- *Noise*: poor original data due to surface and traffic noise
- *Energy*: insufficient source energy generated by the weight-drop
- *Frequency*: the dominant frequency of the data (30 Hz) was not high enough
- *Width*: the working width (about 5m) was too small compared with the seismic wave length (about $86 \text{ m} = 2600 / 30$).

Figure 2-23. Seam reflection amplitude distribution extracted from true-amplitude processed volume is displayed with full-amplitude range. No workings can be identified from this amplitude map.

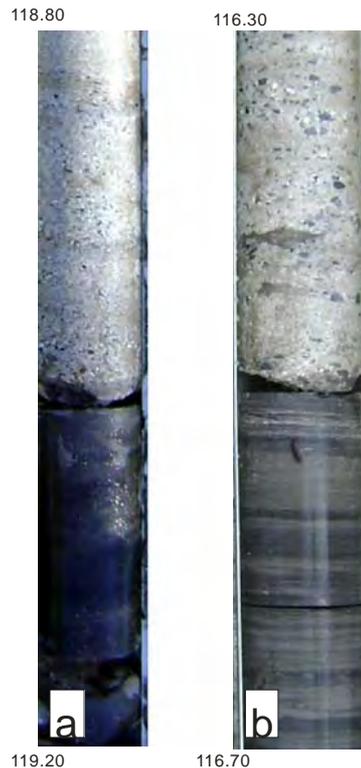
Figure 3-3. The base of the Aberdare Conglomerate and underlying Blackstone Formation in a) CP_C03 and b) CP_C04. In both cases the exact nature of this contact is obscured due to damage to the core as a result of drilling.

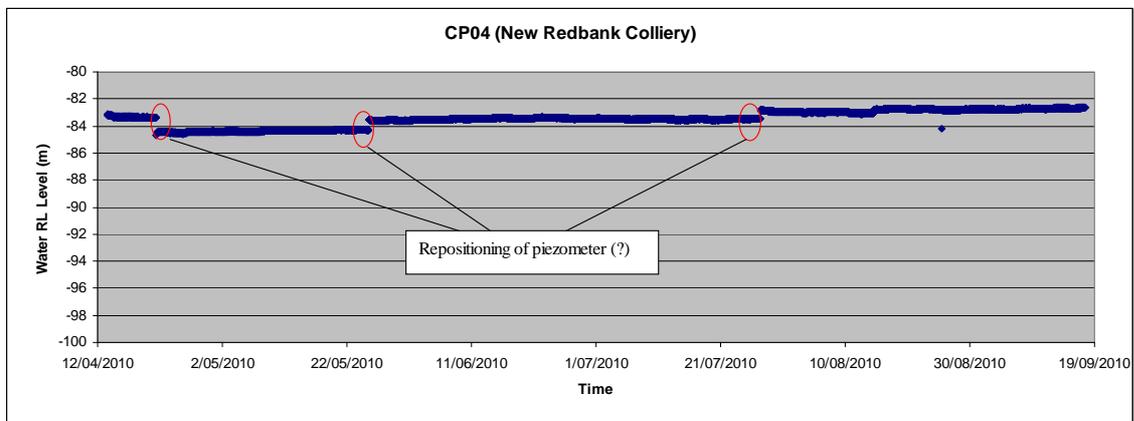
Figure 3-9. Recorded water level in Hole CP_C04, New Redbank Colliery – The water level is more or less stable at about 83m below sea level. The sudden change in the water level data is likely due to the removal and re-installation of the piezometer for water sampling.

In the New Redbank Colliery, the current water level is at RL= -83m, and it has remained stable so far. The sudden changes in the plot of Figure 3-10 were likely to be caused by the relocation of the piezometer which was removed and re-installed during water sampling. The removal of the piezometer is necessary as this hole was drilled at a smaller diameter (100 mm) than the other piezometer holes.

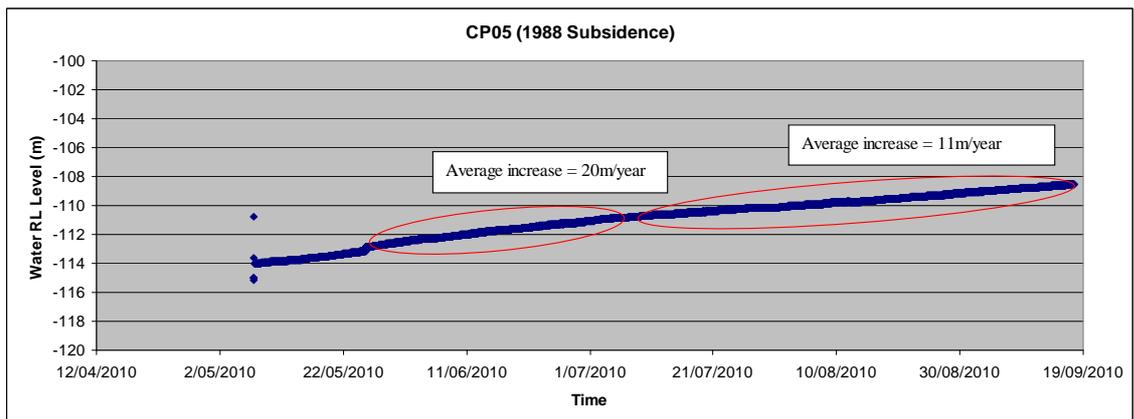
Figure 3-10. Recorded water level in Hole CP_C05, Westfalen No. 3 – The water level is increasing at a rate of about 20m/year during May to June but at a reduced rate of 11m/year during July to September.

The monitoring data up to 17 September 2010 indicate that the water level in Westfalen No. 3 Colliery was increasing at an estimated rate of 20-21m/year in May and June 2010 but that the rate was reduced to 11-12m/year during July to September. The water level on 17 September 2010 was at RL = -108m, which implies that the southern 1/3 of Westfalen No. 3 Colliery within the Collingwood Park investigation region is flooded. More detailed analysis of the water levels is given in later sections.

It is noticed from Mills' results that, during September 2009 – February 2010, the water level in Westfalen No. 3 Colliery was increasing steadily at a rate of about 3.5m/year. The rate significantly increased in April 2010 (Figure 3-12). Based on this study, the rate peaked at about 20m/year in May - June 2010 (Figure 3-10 and Figure 3-11), before reducing to 11-12m/year in July - September 2010.

The initial change of water level increase rate coincided with the drilling activities at Collingwood Park. It is possible that the new drill holes led to water leakage from perched aquifers in the overburden to the underground workings which caused a faster increase in the water level. With time however, the water flow into the drill holes may have reduced as the aquifers around them were drained. This would reduce the rate of water level change as observed during July to September 2010.

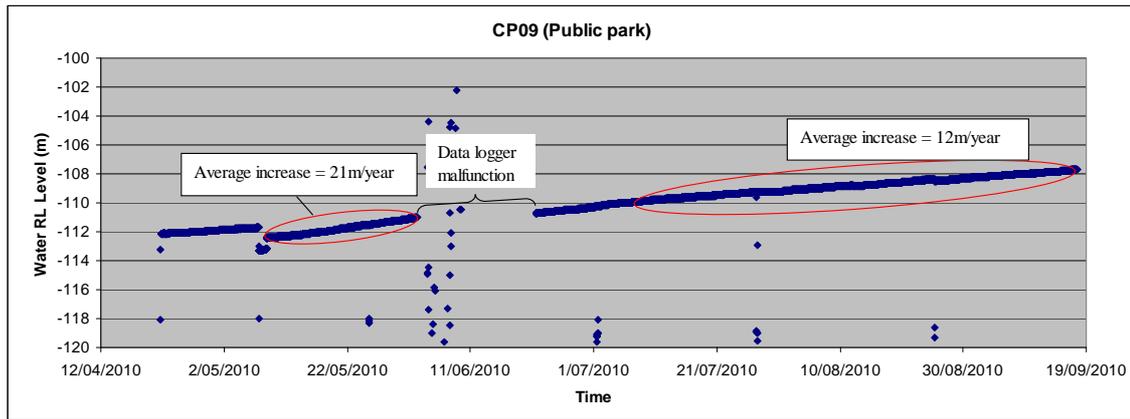
Figure 3-11. Recorded water level in Hole CP_C09, Westfalen No. 3. – about 21m/year during May to June but at a reduced rate of 12m/year during July to September.

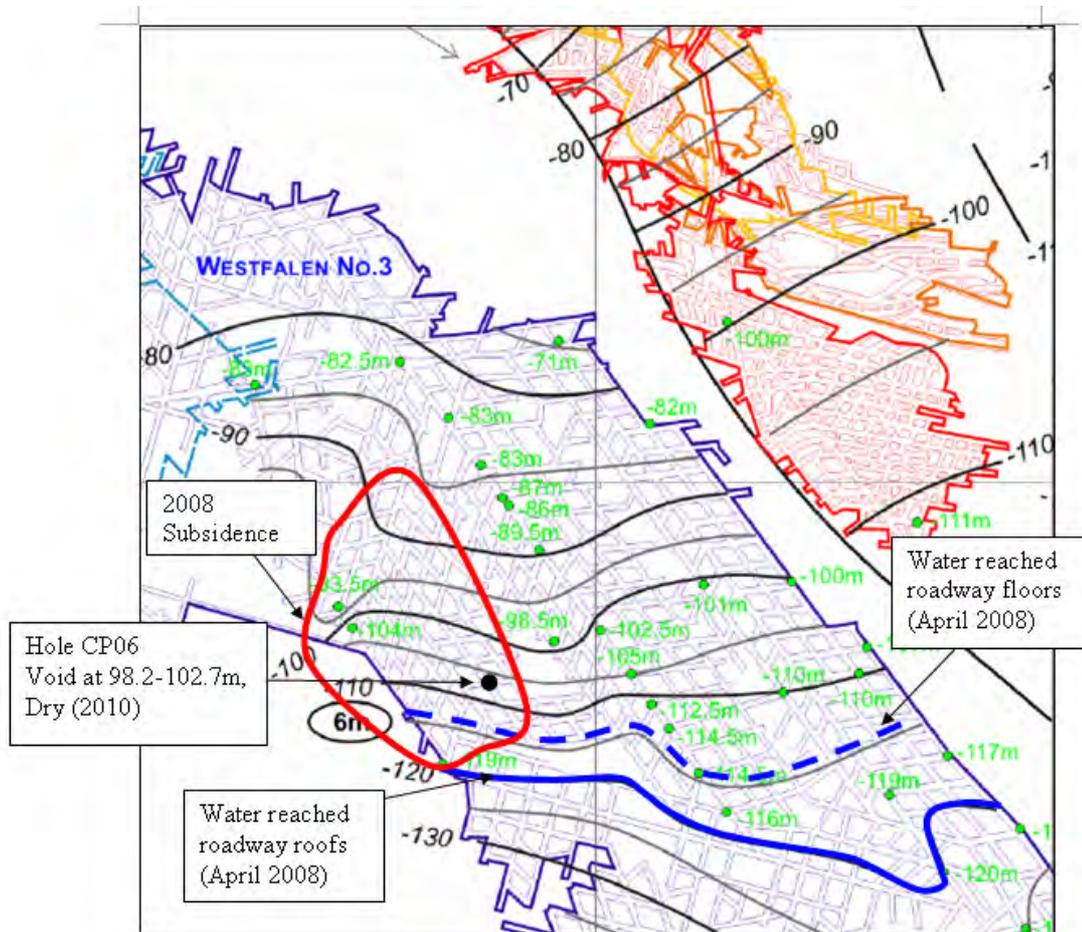
Using the seam floor contour map provided by Mills (2009) based on underground survey data, at this mine water level (RL=-120m), most of the pillars in the 2008 subsided area should be above the water table with exceptions of some pillars which might have started to experience just becoming wet at the floor level, as shown in Figure 3-13.

Figure 3-13. Predicted water level in Westfalen No. 3 Colliery at the time of the 2008 subsidence events based on data from Mills (2009).

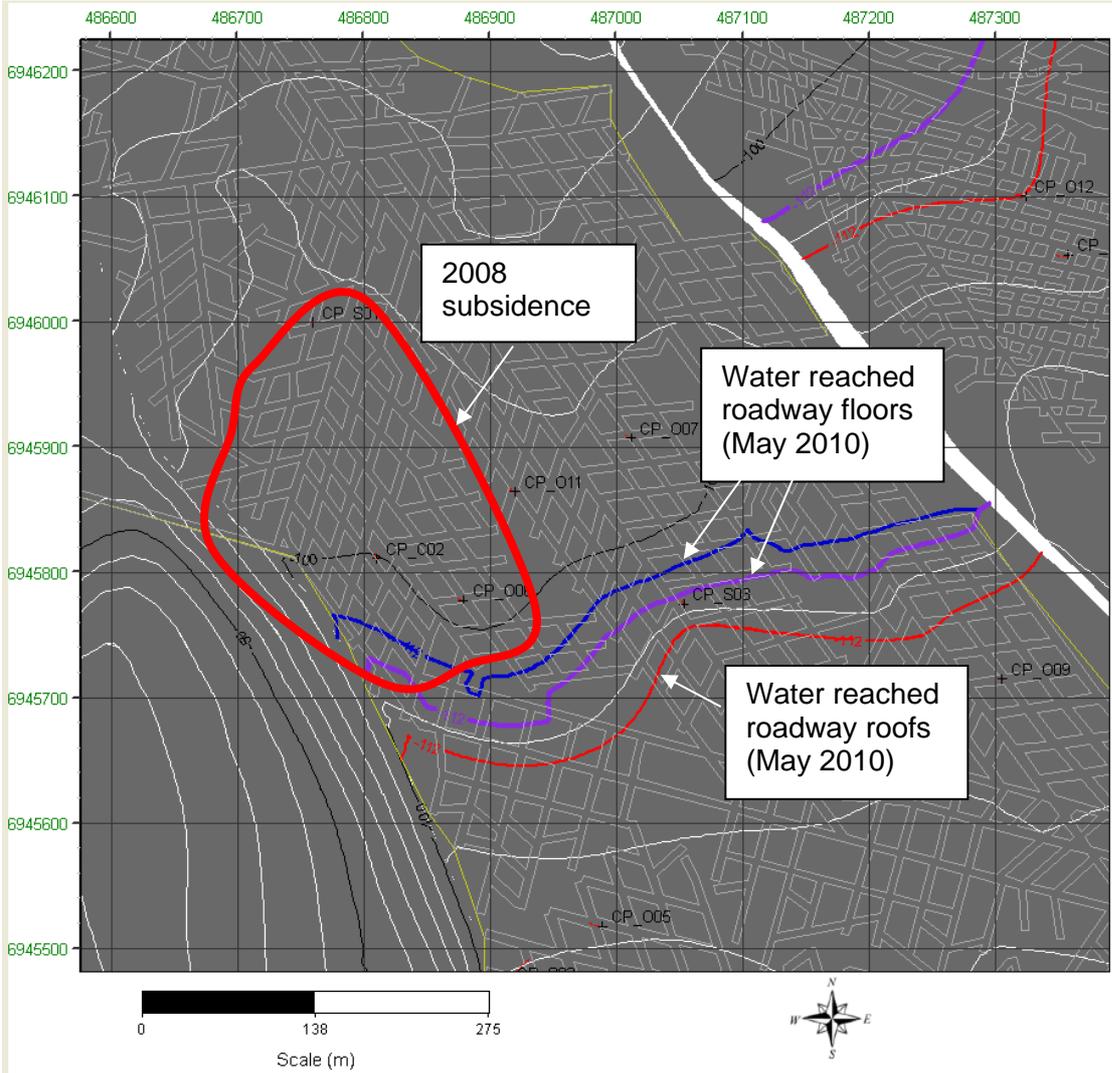
The seam floor contours derived from the previous and new drill hole data are different from those based on the underground survey data (Figure 3-14). Overall, the drill hole data suggest that the floor level in the 2008 subsidence area is about 10m-14m higher than the survey data suggest. Some doubts about the survey data accuracy were also expressed by the previous mine managers during an interview.

Figure 3-14. Depth contours (RL level) of seam roof and predicted water level in Westfalen No. 3 Colliery as at May 2010, based on recent drill hole data. The blue and purple lines provide the estimated water level at the roadway floor, based on the mining height ranges presented in Figure 6-3.

Based on the drill hole roof contours, the extents of water level in May 2010 is shown in Figure 3-14. This result suggests that all pillars in the 2008 subsidence area were basically above the water table at the time of the subsidence event if the water levels have not decreased, which is considered highly unlikely.

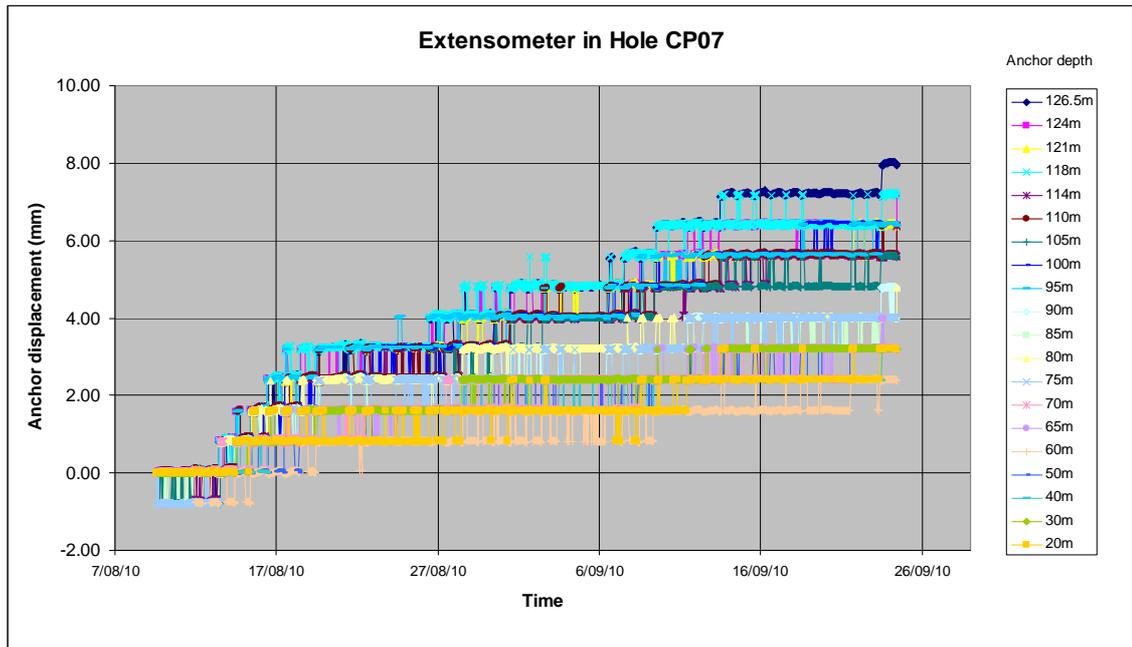
The extensometer monitoring results at Collingwood Park are shown in Figure 3-15 and Figure 3-16. During the monitored period of 9 August to 24 September 2010, the extensometer results showed a maximum displacement of 8mm between the seam roof and the ground surface (Figure 3-15). The movement has been increasing at approximately 1mm per week. The displacement occurred mostly in the depth zones of 0-20m and 60-100m.

Figure 3-15. Extensometer readings during 8 August – 24 September 2010.

Although the monitored strata movement is still small, the trend of the data clearly suggests that the overburden strata are “expanding”, ie the strata close to the seam are moving downward relative to the ground surface which may also be moving. This kind of movement is often observed in the early stage of a panel failure when strata

The extensometer data need to be closely monitored and interpreted. If the strata deformation continues to increase, we recommend the following actions:

- Install two additional extensometers close to either ends of the Central Panel to determine the size of the area with movement
- Install one additional geophone station close to CP_O07 to help detect and locate small seismic events in the Central Panel
- Increase the data analysis frequency (both extensometer and microseismic data) to minimum twice a week if significant increase in the rate of displacement and seismicity is observed
- DEEDI considers developing a response plan for any potential mine subsidence events.

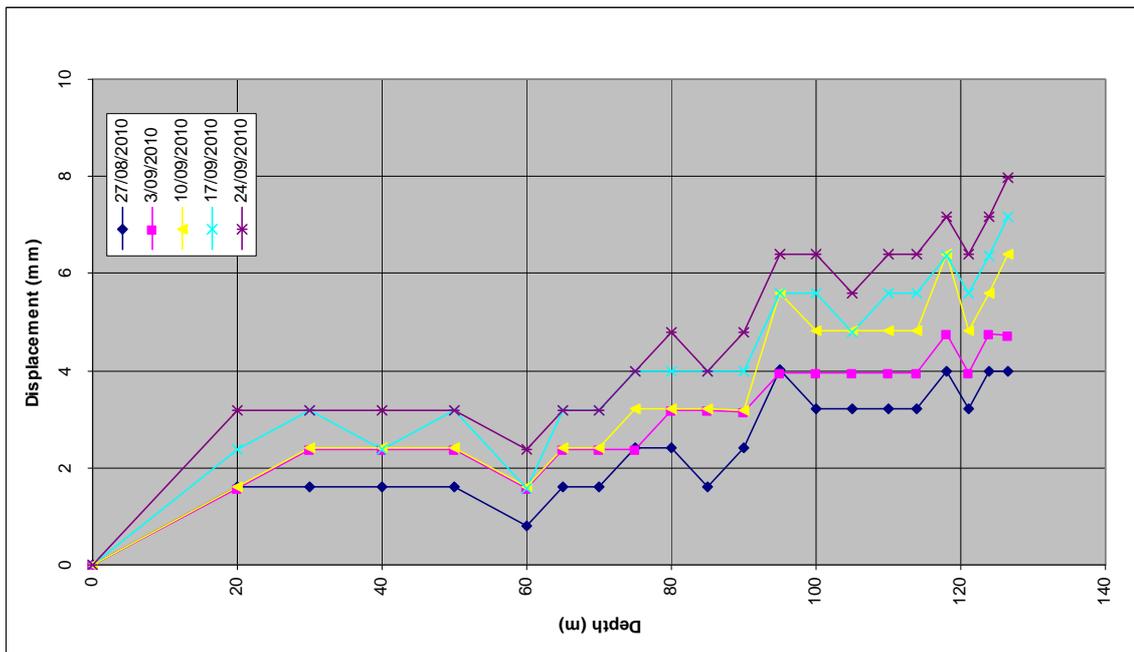
Figure 3-16. Profile of strata movement in overburden strata recoded in CP_O07 during August – September 2010.

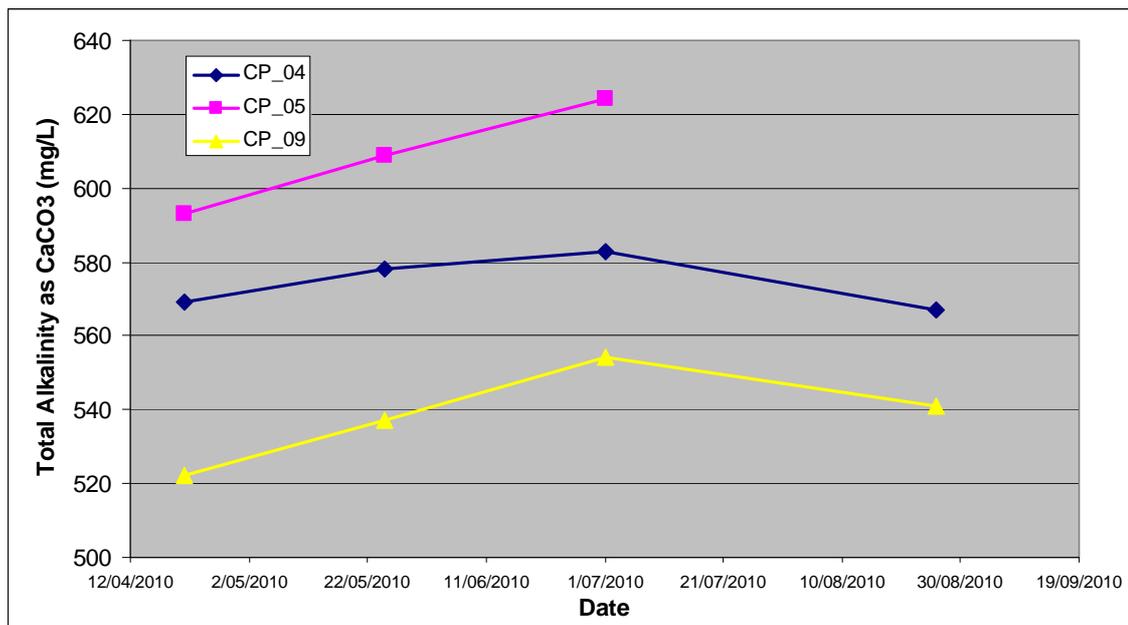
- The piezometer readings taken over the three month period indicate that there has been an increase in water level at Westfalen Colliery. At the end of four month period, an increase in height of about 5 m was noticed at CP_05 and about 4 m at CP_09. However, there was not much variation in water level after three months at New Redbank Colliery, represented by borehole CP_04.
- Over the four month period, the total Alkalinity of water from both collieries showed an increasing trend during April – June 2010 but a decreasing trend during July – August 2010. It is inconclusive on what caused this change. One possible scenario is that some fresh water may find its way into the mine workings in July and August, and hence reduced the total Alkalinity.

Figure 3-17. Alkalinity change in water samples from New Redbank Colliery (CP_04) and Westfalen No. 3 Colliery (CP_05 and CP_09)

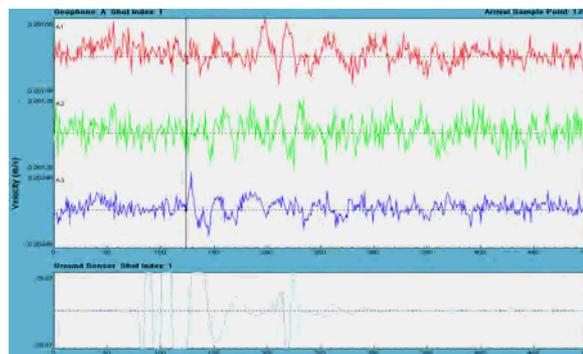
The results showed that the weight drops did not provide the energy required to orient the geophones. Figure 4-4 shows typical seismic waveforms recorded on the three components of one of the triaxial geophone in S2. The signal to noise ratio is too poor to determine the orientation.

Figure 4-4. Typical seismic waveforms from the weight drop trial at a distance of 35m recorded at the S2 station. The red line is for the east component, green for the north and blue for the vertical. The bottom waveform is captured by the reference geophone near the weight drop testing point.

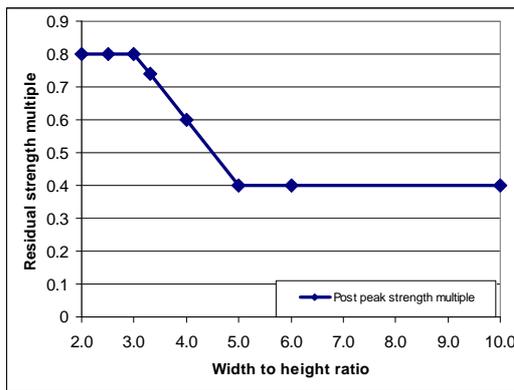
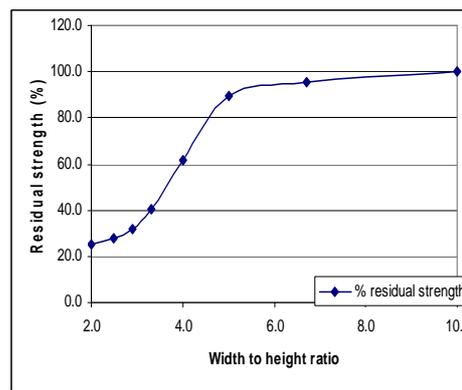
The total vertical stress shed by failed pillars is a function of the width-to-height ratio. The quantity of shed stress is based on observations by Das (1986) in Indian mines and numerical modelling results with a square pillar of 20m width, see Table 6-1 and Figure 6-1 and Figure 6-2. Full details are presented in the Appendix I.

Figure 6-2. Stress multiple as function of w/h ratio(a). Value of 1 means all pillar stress is shed to pillars within influence region. Values approximate (b) which in tern is derived from Fig 1-1(b) at 4% strain.

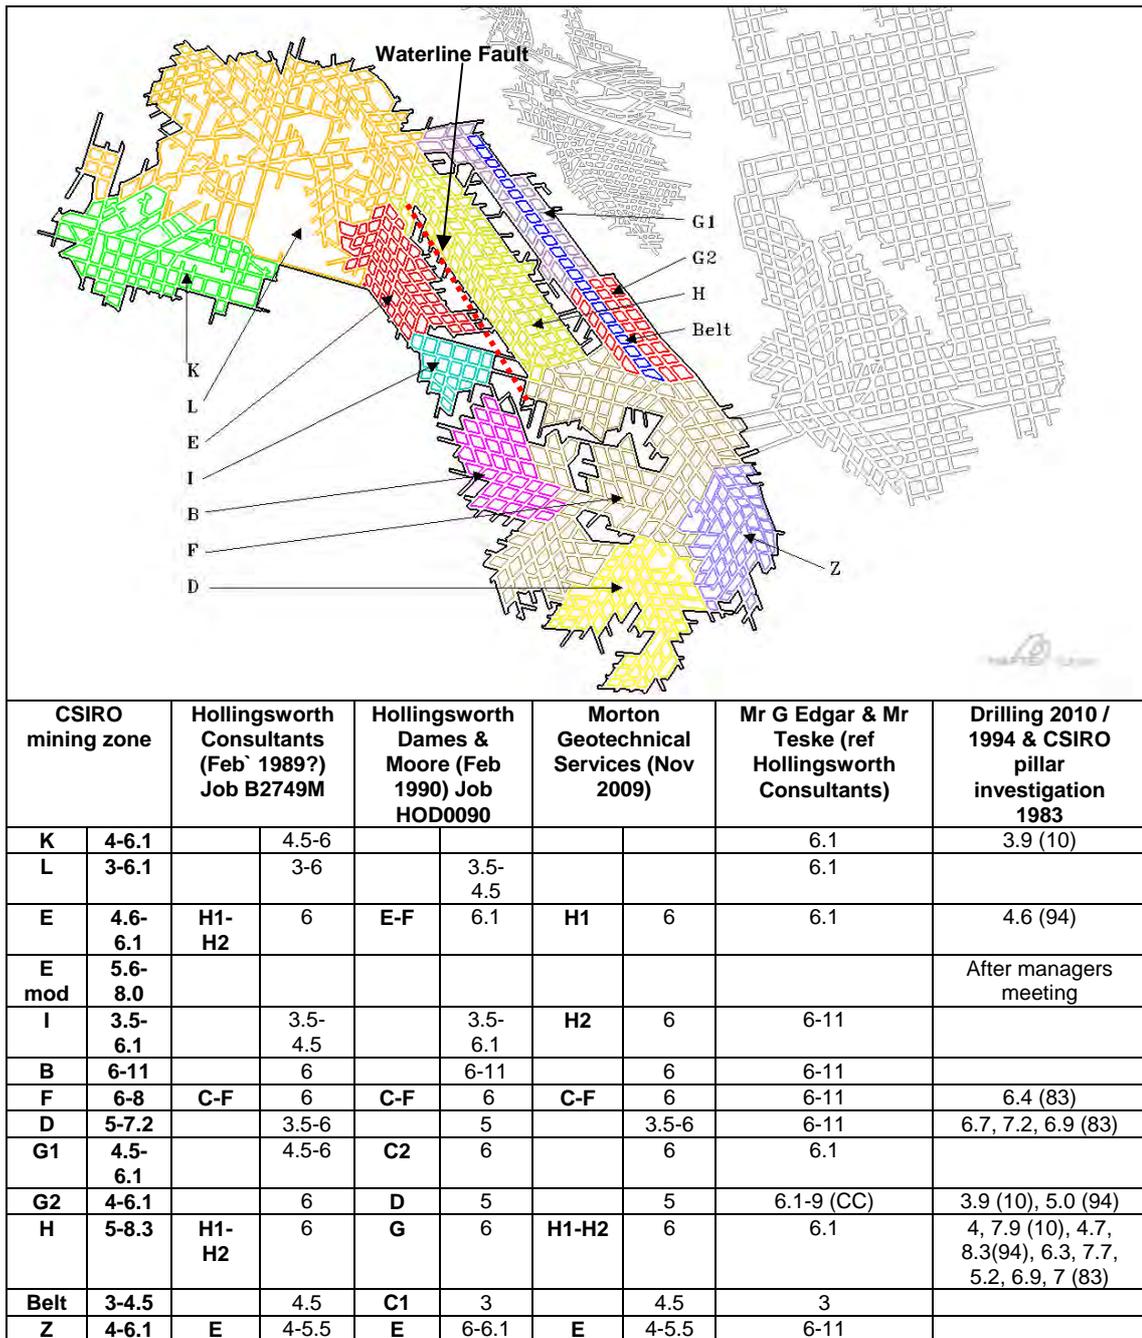
Figure 6-3. Mining zones with mining heights for Westfalen No. 3 Colliery. Note modified mining heights for Duncan St region after interviews with Mr Evans and Mr Martin who state there was no systematic variation in heights west and east of the Waterline Fault.

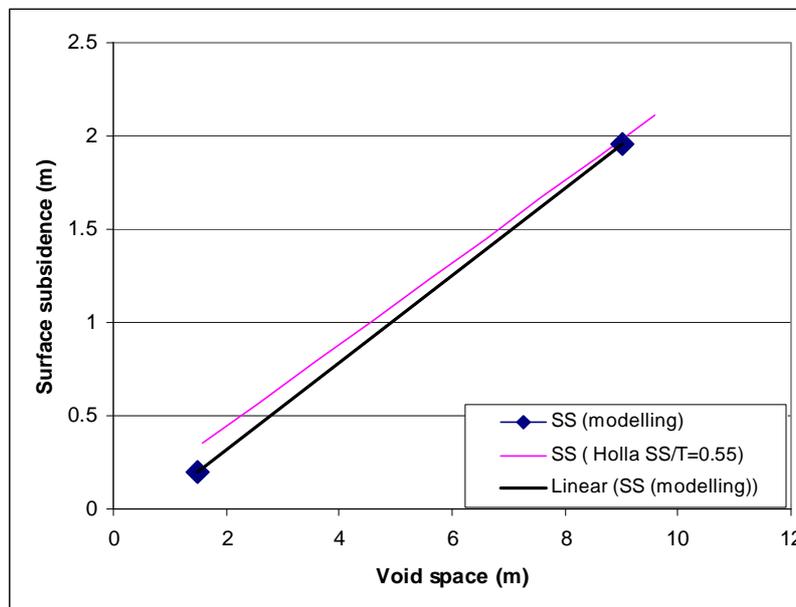
Holla estimates the multiplier  $K_1$  as 0.65 for longwall mining situation. However  $K_1 = 0.55$  has been found to be a better fit to the observed subsidence and the corresponding numerical results at Collingwood Park.

Figure 6-10. Comparison between surface subsidence predicted by two numerical models of Westfalen No. 3 and that predicted by Holla with  $S_{\max}/T=0.55$  and extraction ratio=40%.

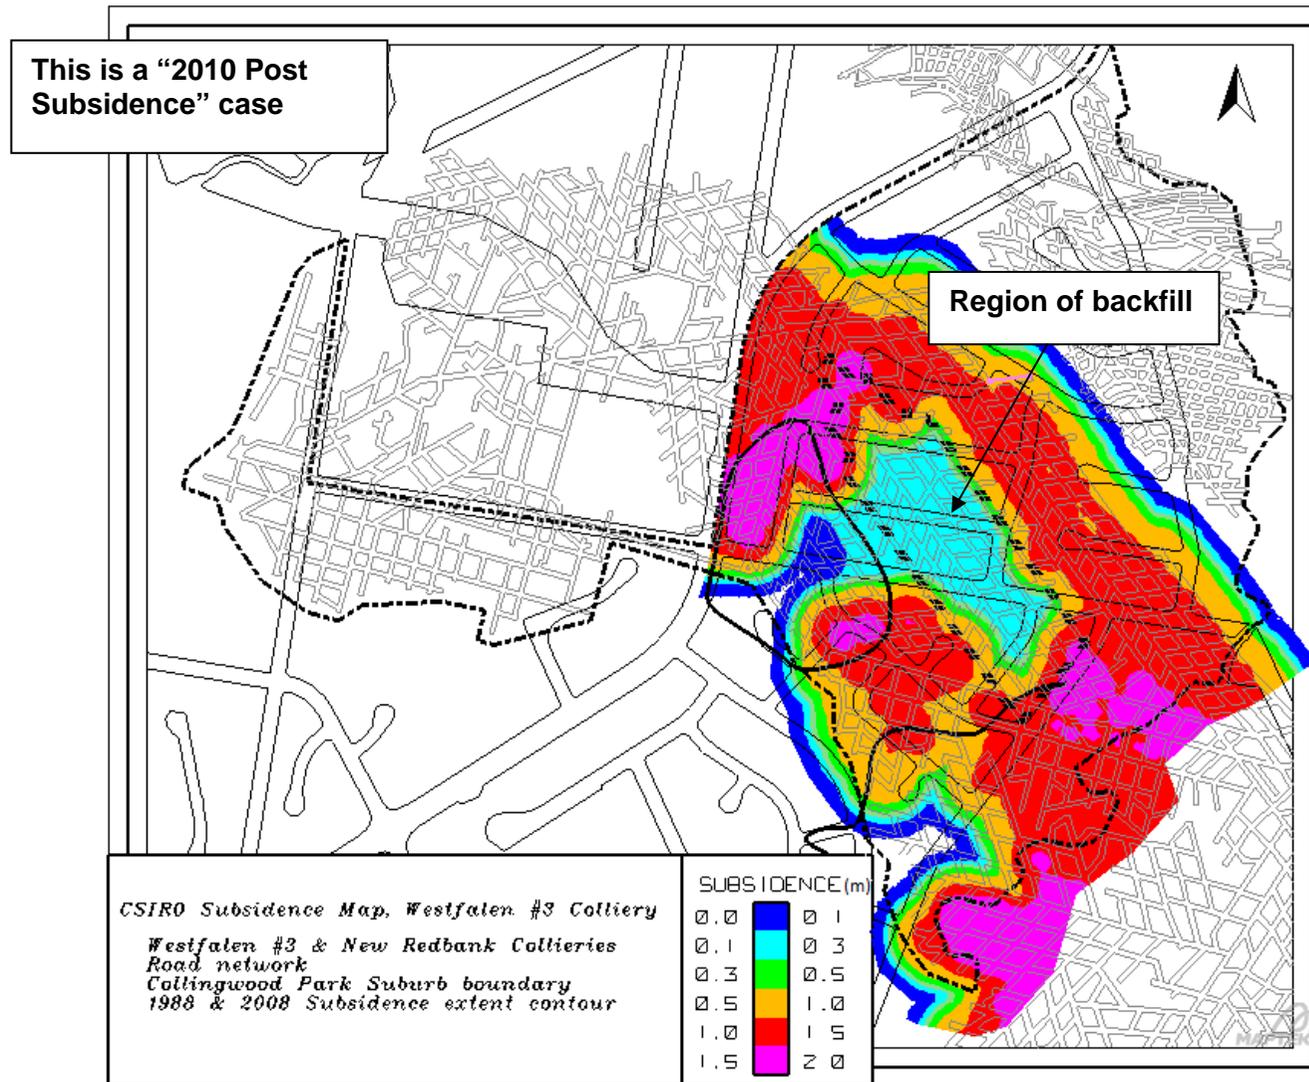
Figure 6-14. Estimated surface subsidence assuming ALL pillars fail after backfilling with 90% roadway fill. Assumes height equal to 90% of the maximum reported height for each mining zone. Backfill only in the central region.

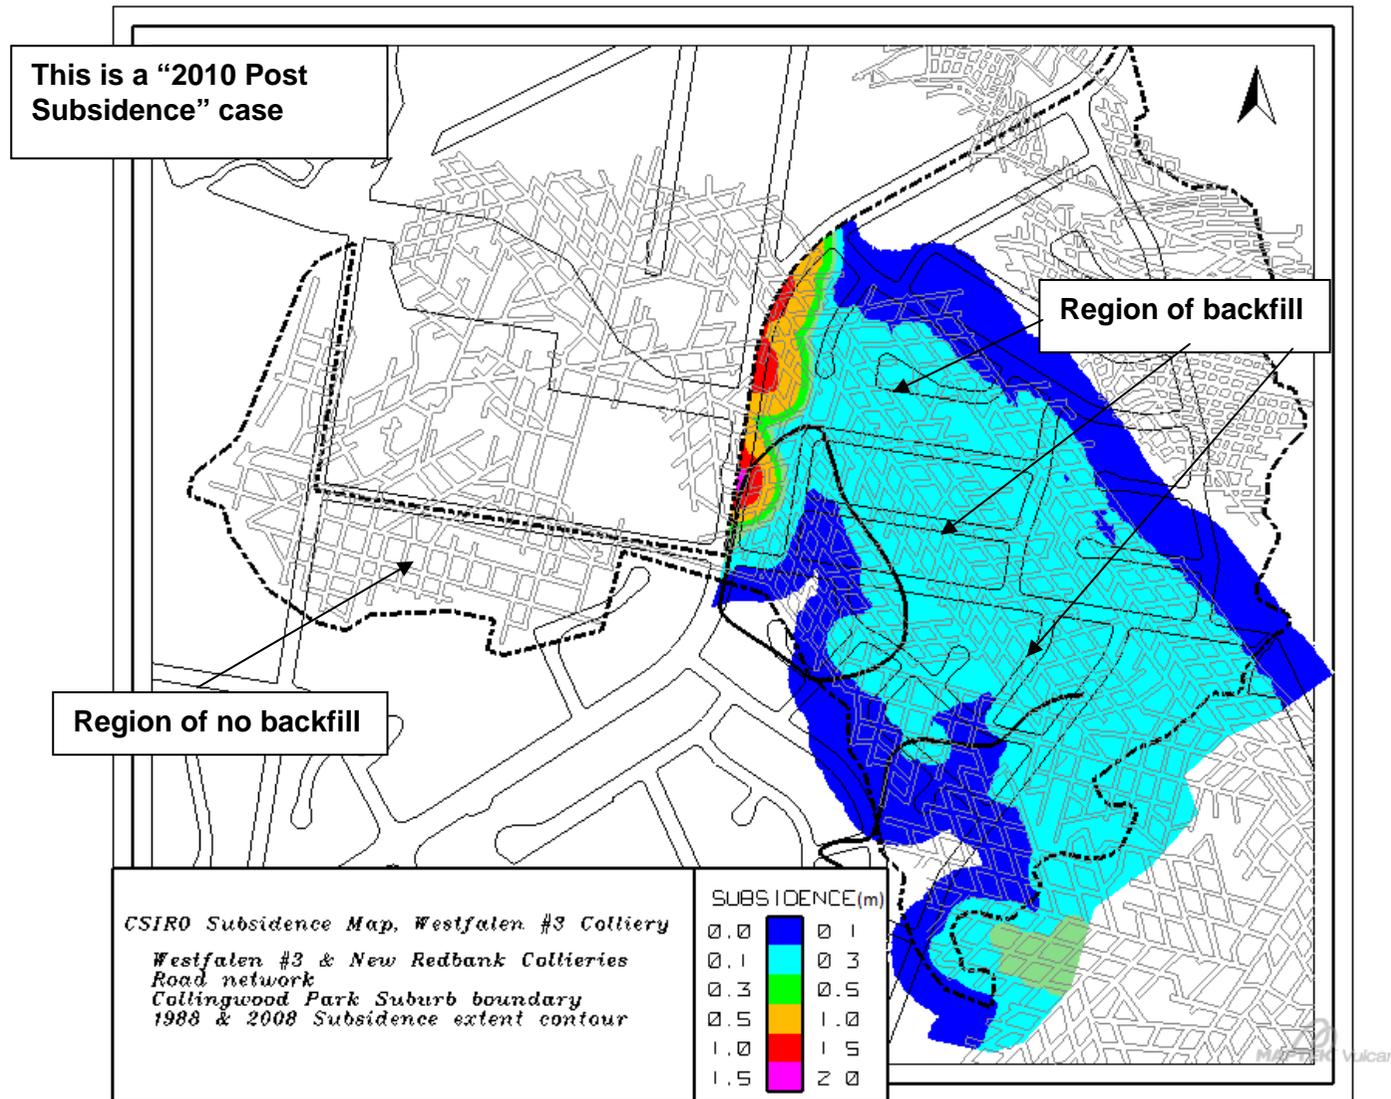
Figure 6-15. Estimated surface subsidence assuming ALL pillars fail after backfilling with 90% roadway fill (including cohesive or non-cohesive backfill). Assumes height equal to 90% of the maximum reported height for each mining zone. All roadways except those on the western side of Collingwood Drive are backfilled.

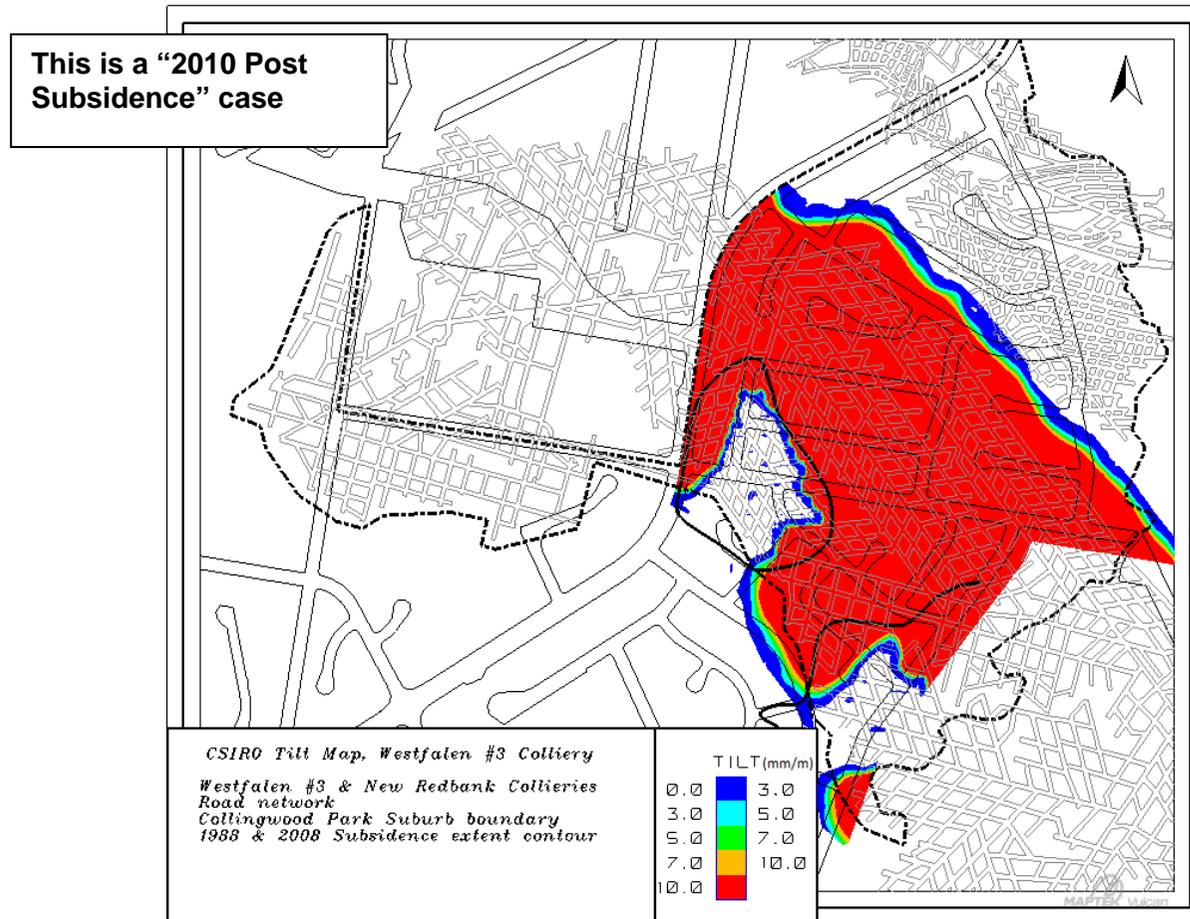
Figure 6-17. Estimated surface tilt assuming ALL pillars fail with NO backfilling. Assumes height equal to 90% of the maximum reported height for each mining zone.

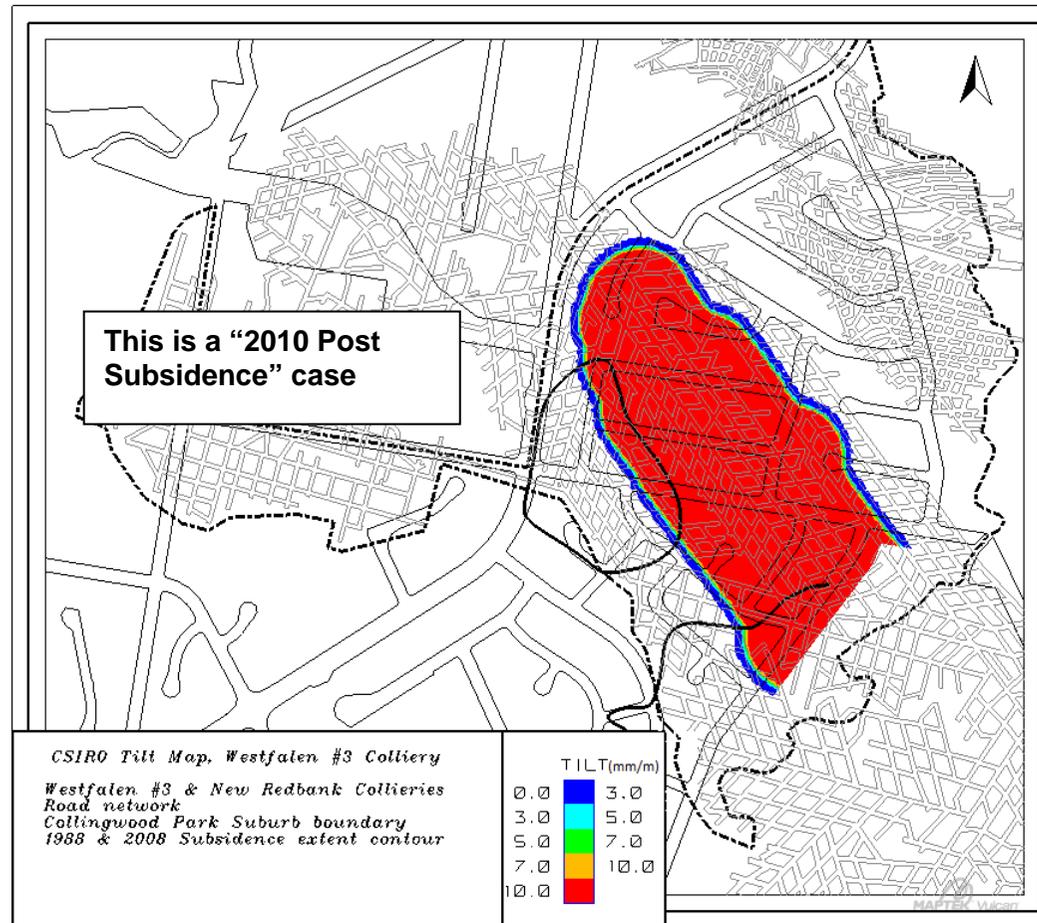
Figure 6-18. Estimated surface tilt assuming central pillars fail with NO backfilling. This central region includes pillars of similar size and extends further south than the proposed targeted backfilled region. Assumes height equal to 90% of the maximum reported height for each mining zone.

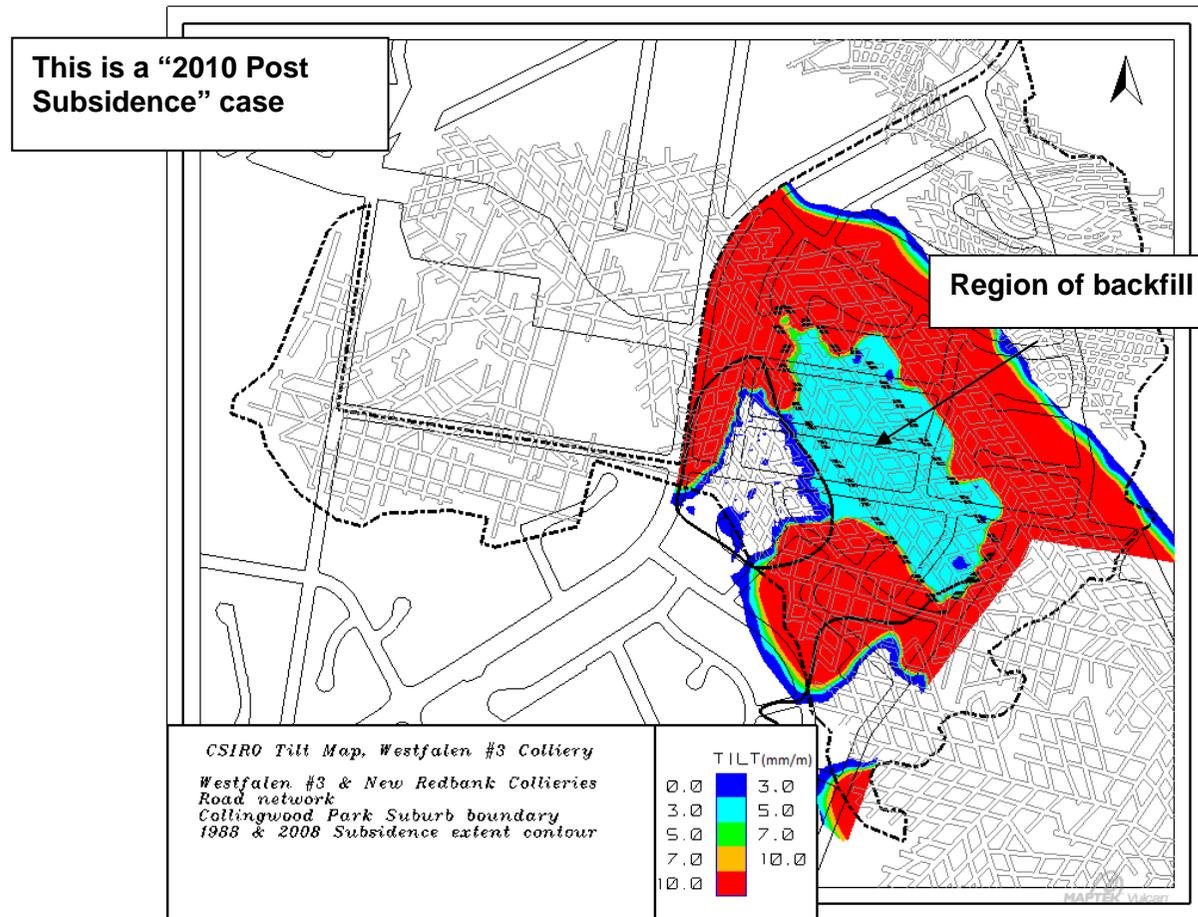
Figure 6-19. Estimated surface tilt assuming ALL pillars fail after backfilling with 90% roadway fill. Assumes height equal to 90% of the maximum reported height for each mining zone.

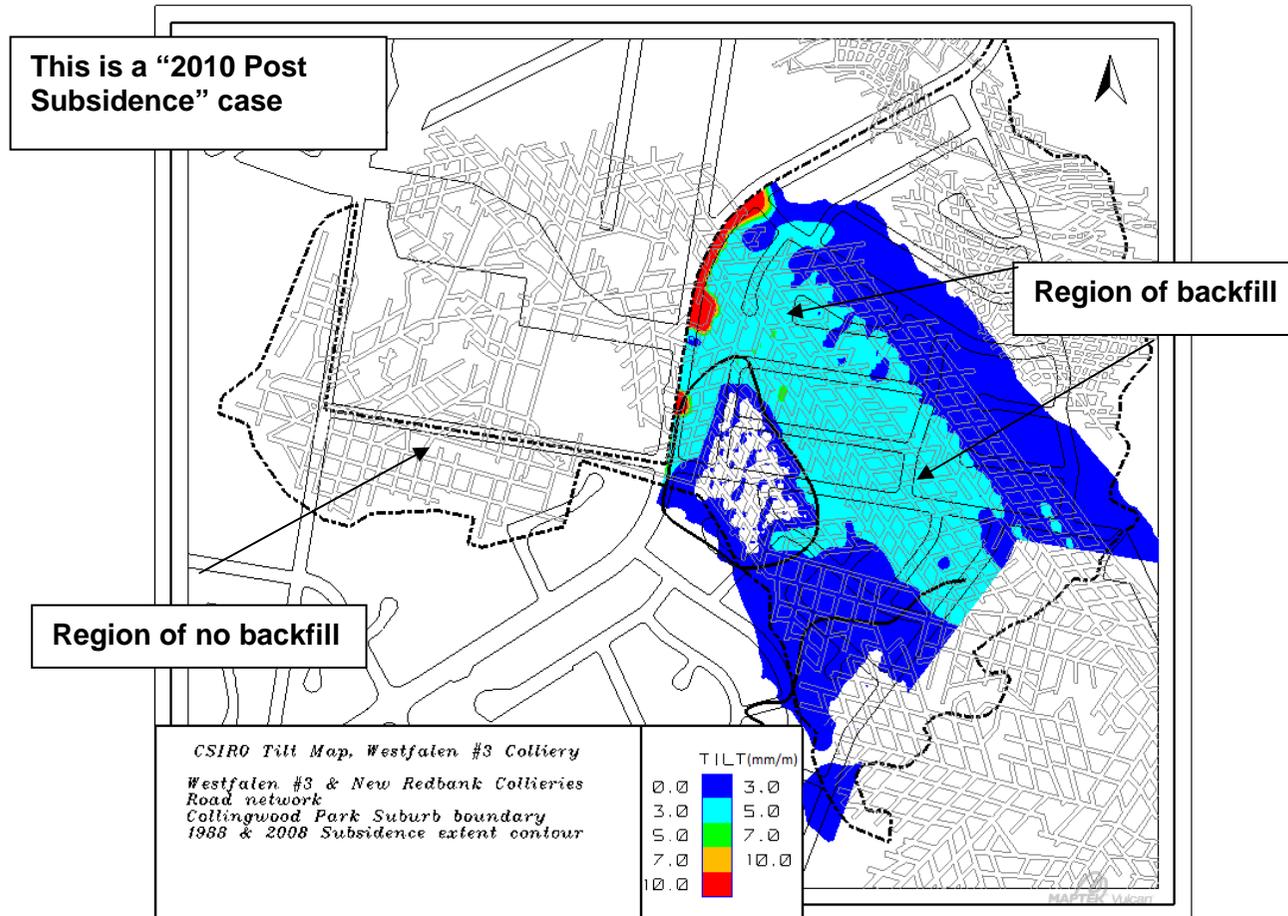
Figure 6-20. Estimated surface tilt assuming ALL pillars fail after backfilling with 90% roadway fill (including cohesive or non-cohesive backfill). Assumes height equal to 90% of the maximum reported height for each mining zone. All roadways except those on the western side of Collingwood Drive are backfilled.
