COLLINGWOOD PARK MINE REMEDIATION – Subsidence control using fly ash backfilling

Baotang Shen, Habib Alehossein, Brett Poulsen, Cameron Huddleston-Holmes, Binzhong Zhou, Xun Luo, Hongwei Wang, Johnny Qin, Joey Duan, Zak Jecny, Matt Van de Werken, David Williams¹

CSIRO Earth Science and Resource Engineering Report EP105068

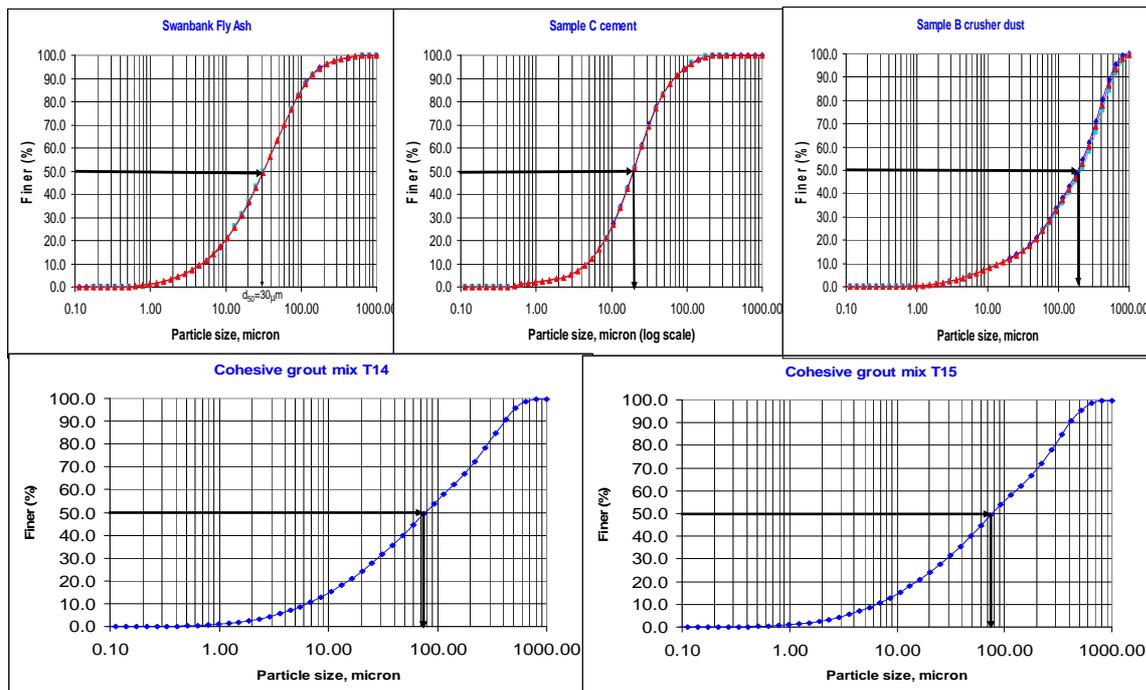
From laser grain size analysis, the median size ( $d_{50}$ ) of fly ash particles was measured to be about 30-40  $\mu\text{m}$ . Hydrometer analysis of grain size for the same sample conducted by UQ showed a  $d_{50} = 15 \mu\text{m}$ . The difference in the two measurement techniques suggests a multi-modal size distribution, rather than a single S curve size distribution. The finer the slurry particles are, the less effort is normally required to pump such slurries through the pipeline and/or small holes and voids and gaps of the rock mass. See **Appendix B** for more details.

Figure 7-1. Size distribution of solid particles of fly ash, crush dust, cement and cohesive mixtures

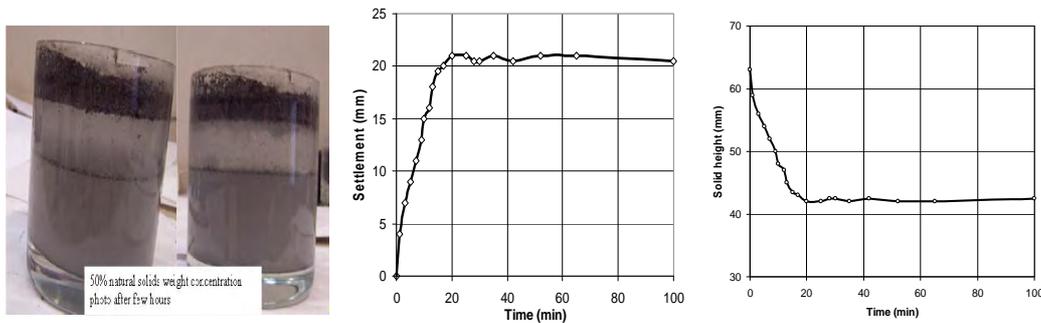
glass beakers and graded buret (UQ) to measure the rate of sedimentation or settlement of separately moving submerged solid particles in slurry at low or zero flow velocities, or whenever separation and deposition of fly ash solid particles is possible. As shown in the figure the maximum rate of settlement occurs during the initial 20 minutes. More results are discussed in **Appendix B**.

Figure 7-2. Deposition time and velocity of floating particles

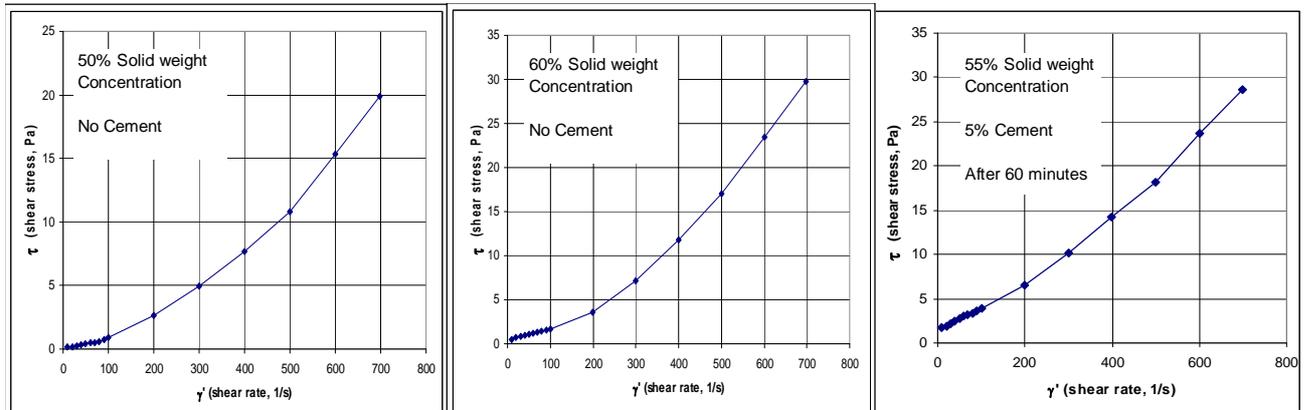
The viscosity increases dramatically at concentrations > 75%, where the mix becomes more like a paste than a slurry. A practical range of solid concentration for all grout handling, transporting and backfill operations is in the range of 50% to 60%. Therefore, the selection of a pump meeting all the pump pressure and power requirements should

Figure 7-3. Viscosity measurements of non-cohesive slurry at solid by weight concentrations of 50% and 60% and cohesive slurry at solid concentration of 55% and 5% cement after one hour.

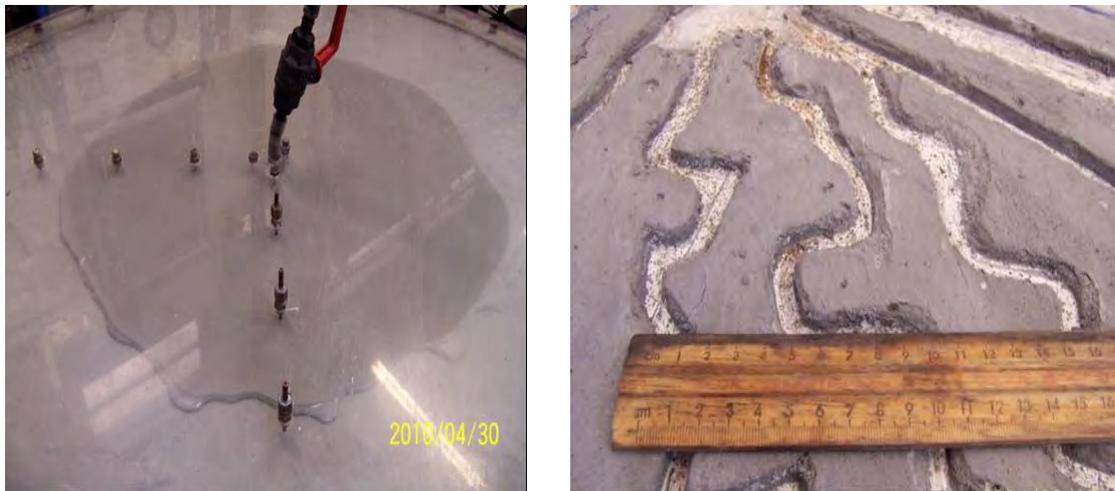
A series of disc grout tests were conducted on Swanbank Power Station fly ash both with and without cement at different solid weight concentrations. The testing gear consists of a disc of 1m diameter with an adjustable gap thickness, simulating a rock fracture opening, and a vertical pipe line at its centre, simulating an injection borehole. Left Figure 7-4 shows how a 60% solid weight concentration flows or disperses from the narrow central tube into a 4mm disc gap, while the right figure shows preparation of a curly narrow path, in which the same slurry flew successfully. See **Appendix B** for more details.

Figure 7-4. Disc grout flow experiments for measuring grout backfilling behaviour. Left: a 60% solid weight fly ash slurry flowing and dispersing through the 4mm gap of the disc. Right: a curly narrow path on a cemented deposit in the same disc installed to test if fly ash slurries can flow through the path.

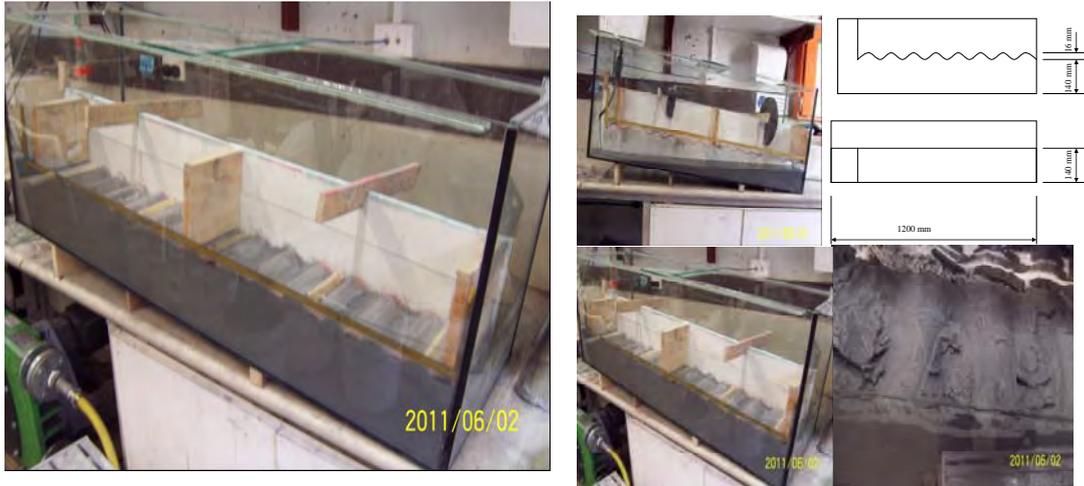
A series of slurry flow tests for both cohesive (5% cement + 55% solids weight concentration) and non-cohesive (solid weight concentrations 50-60%) were conducted in a rectangular glass tank of 1.2m length, 400mm width and 600mm height. The tanks long axis could also be placed on a 5 degree slope to simulate the dip of the workings in the mine. The roof of the workings was replicated with a piece of corrugated plastic to simulate undulations in the roof. The grout flow rate was in the range of 10-30 litres per hour from a 12mm hose placed at the up-dip end of the tank under simple gravity. These tests showed that backfilling with non-cohesive slurry from boreholes spaced at large distances (100 m or so) is not a problem and is practically achievable. These tests also showed that more than 90% of the void space was filled. See **Appendix B** for more results.

Figure 7-5. Experiment of fly ash flow and deposition in a confined roadway

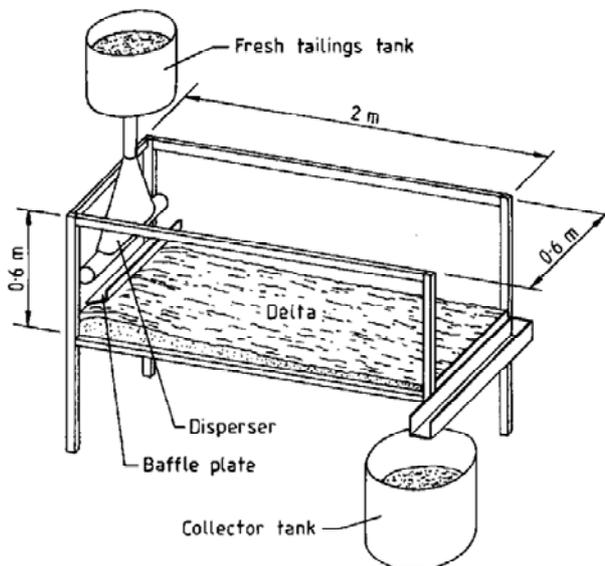
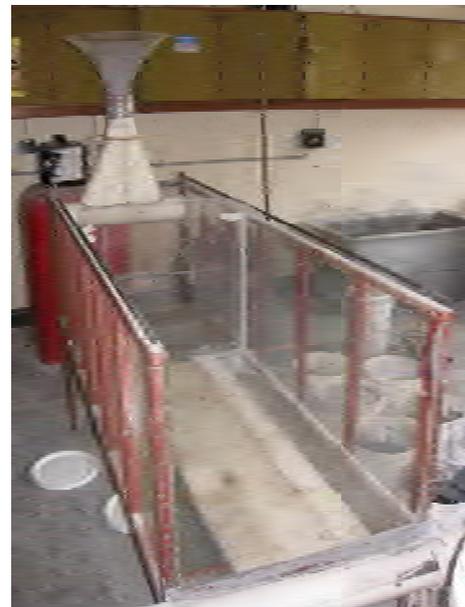
Figure 7-6. UQ laboratory beaching flume for simulation of fly ash slurry flow, deposition and erosion

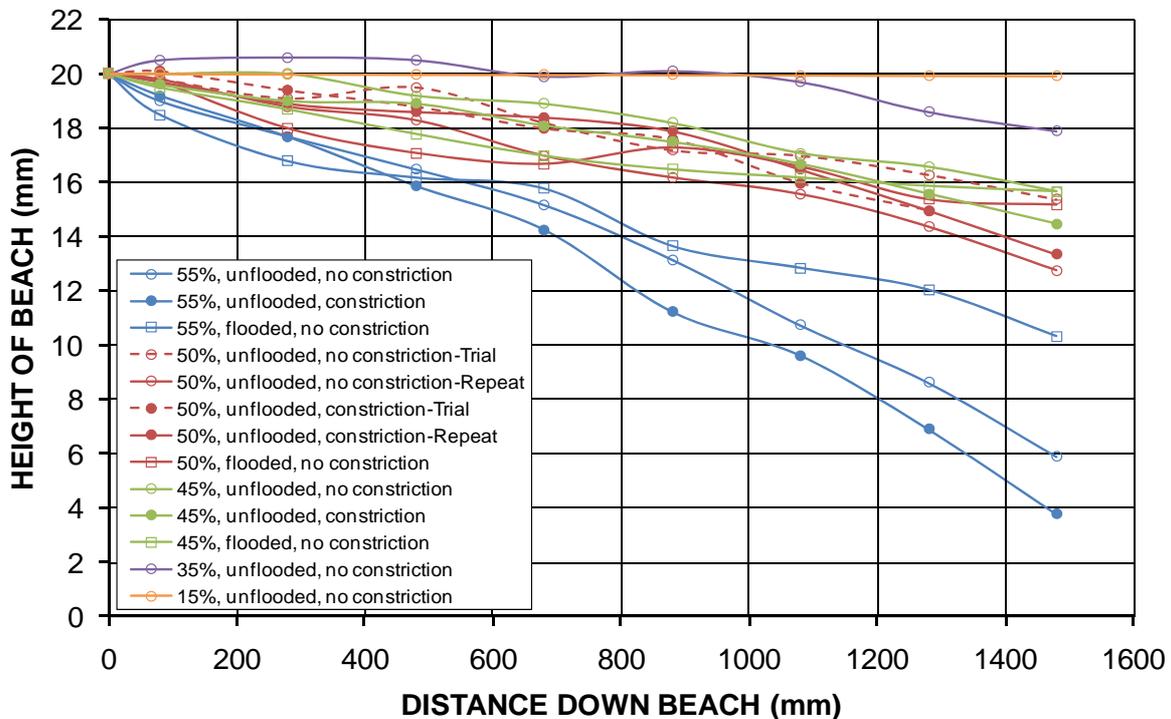
solids, the steeper the beach profile, with  $\leq 35\%$  solids producing an almost flat beach. Notice the maximum measured beach angle is about 1%. Figure 7-8 shows the settled slurry profile resulting from flooded deposition of Swanbank slurry initially at 60% solids, under a high slurry head into a closed-ended constriction. Figure 7-9 compares the average laboratory and field beach slopes obtained for Swanbank fly ash at different initial % solids, which highlights that for unflooded, unconstricted beaching the average beach slope is highest (at about 1%) for an initial % solids of 55%, lower but insensitive over the intermediate range of initial % solids, and flat for an initial % solids of 15%. The average field beach slope of 0.014% is similar to that obtained in the laboratory for an initial % solids of 15% (similar to the field initial % solids), and the non-dimensional beach profile is similar to that for the field profile.

Figure 7-7. Summary of open-ended laboratory flume beach profiles for Swanbank fly ash

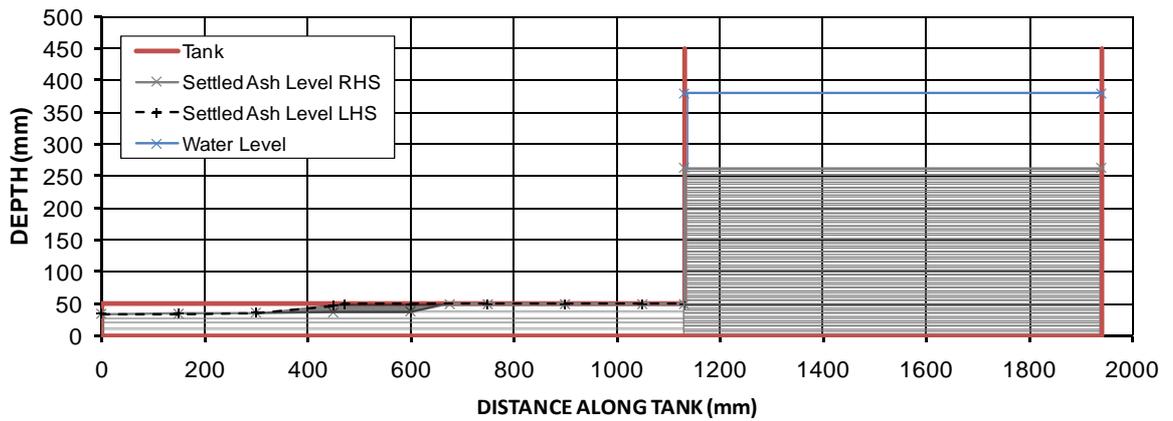
Figure 7-8. Constricted backfilling, under water and a high head of Swanbank fly ash slurry, initially at 60% solids

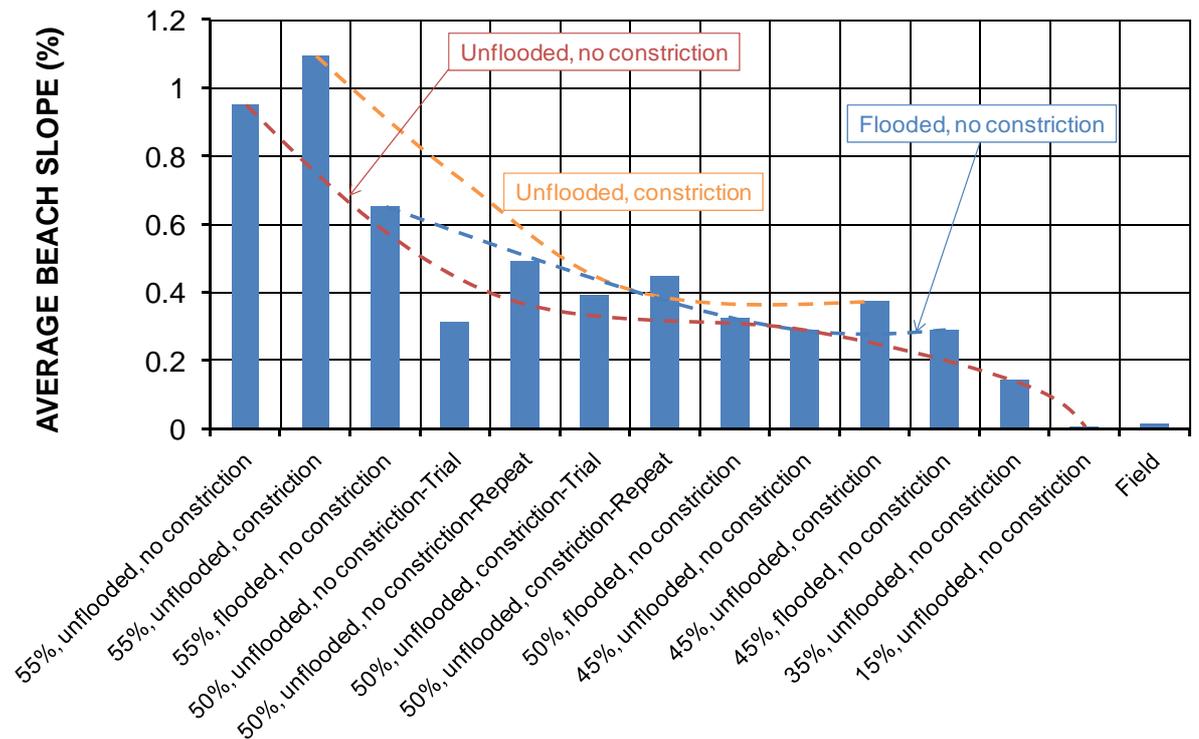
Figure 7-9. Comparison of average beach slopes of laboratory and field beach profiles for Swanbank fly ash.

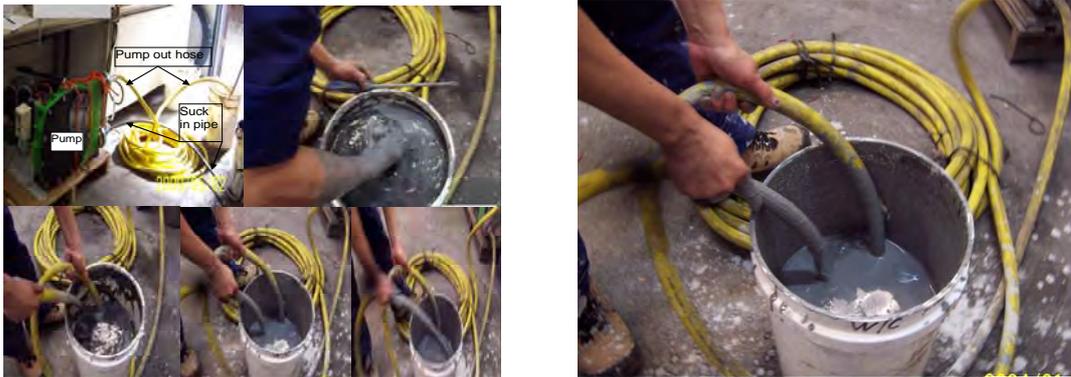
whenever the speed of suspended particles drops below a critical threshold velocity. In this case, even injection of pure water, boosted by high pump pressures, may still be inadequate to remove blockages and to reactivate the flow in a long pipe or at a sharp bend. Therefore, the transportation characteristics of a slurry need to be determined before any field injection trials. We used flexible rubber pipes of 20mm diameter for experiments on Swanbank fly ash, as shown in Figure 7-10. The loop test results revealed the fact that fly ash slurry could successfully be pumped at all solids weight concentrations up to 75% without problems.

Figure 7-10. Pipeline transport tests on a range of fly ash slurries and paste from 50-70% solids weight concentration

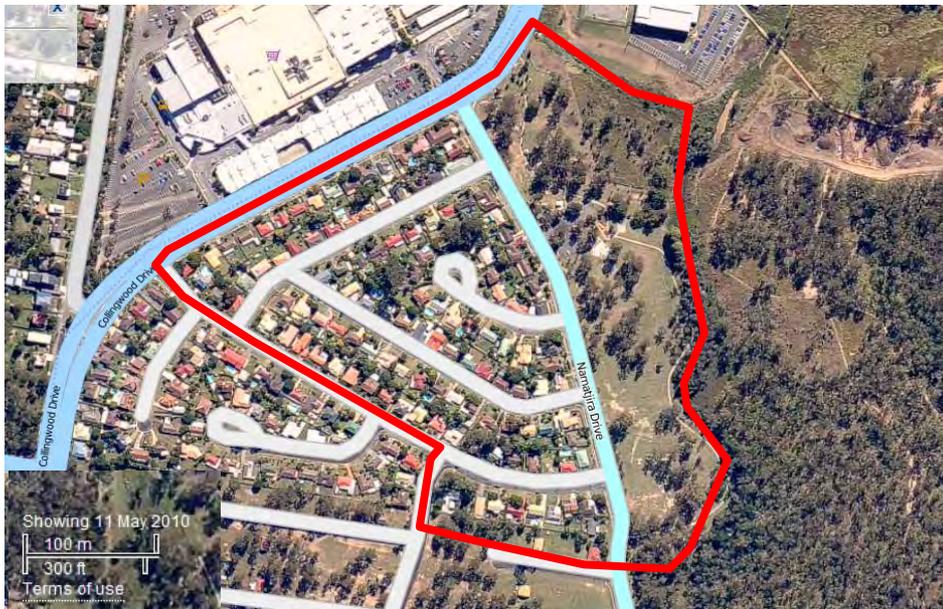
Figure 8-1. Recommended area of 3D seismic survey at New Redbank Colliery.

The suggested area of the 3D seismic survey is shown in Figure 8-1. This area is about twice the area of the survey at Duncan Street. Because a large portion of the survey would be in an area with a higher density of residential properties, the difficulties for the 3D seismic survey will also increase.

It is expected the cost for this study will be in the range of \$150K-\$200K.
