Paradise Dam Preparedness Review

Report 1: 2019-20

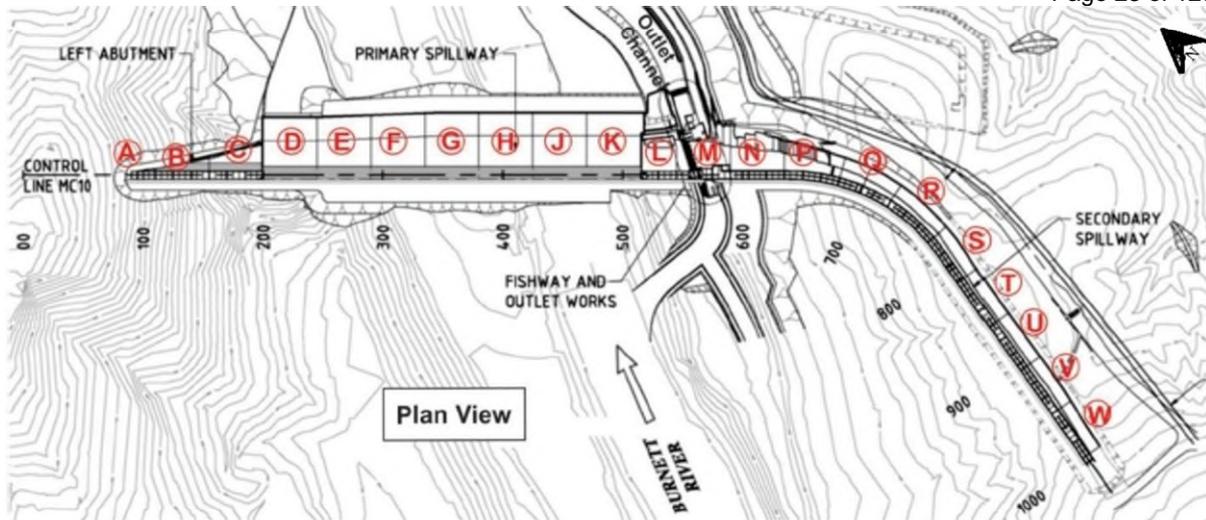
The Paradise Dam spillway is a concrete gravity structure; the primary construction material is roller compacted concrete. The roller compacted concrete technique became popular in the 1970's. It allowed dams to be built in a timelier and more cost-effective way than conventional structure concrete dams. This technique is now commonly used for mass gravity dam applications. Roller compacted concrete dams are constructed using a series of horizontal continuous shallow layers of compacted concrete, called lifts. Construction of the Paradise Dam consists of a primary and secondary spillway. These are divided into sections of roller compacted monoliths, identified in the colour red in the following diagram. For the purpose of this report both spillways are referred to as "the spillway".

Diagram of the Paradise Dam spillways from above showing the monoliths.

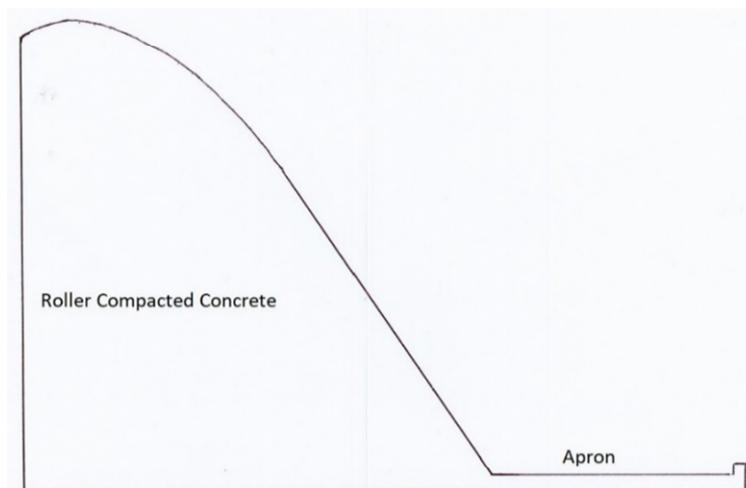
Along the base of the primary spillway is a 20-metre-long spillway apron. This is intended to protect the toe of the spillway from impact of overtopping floodwaters and to reduce the energy flow onto the exposed rock and the river bed downstream.

Cross section of spillway showing the spillway apron.

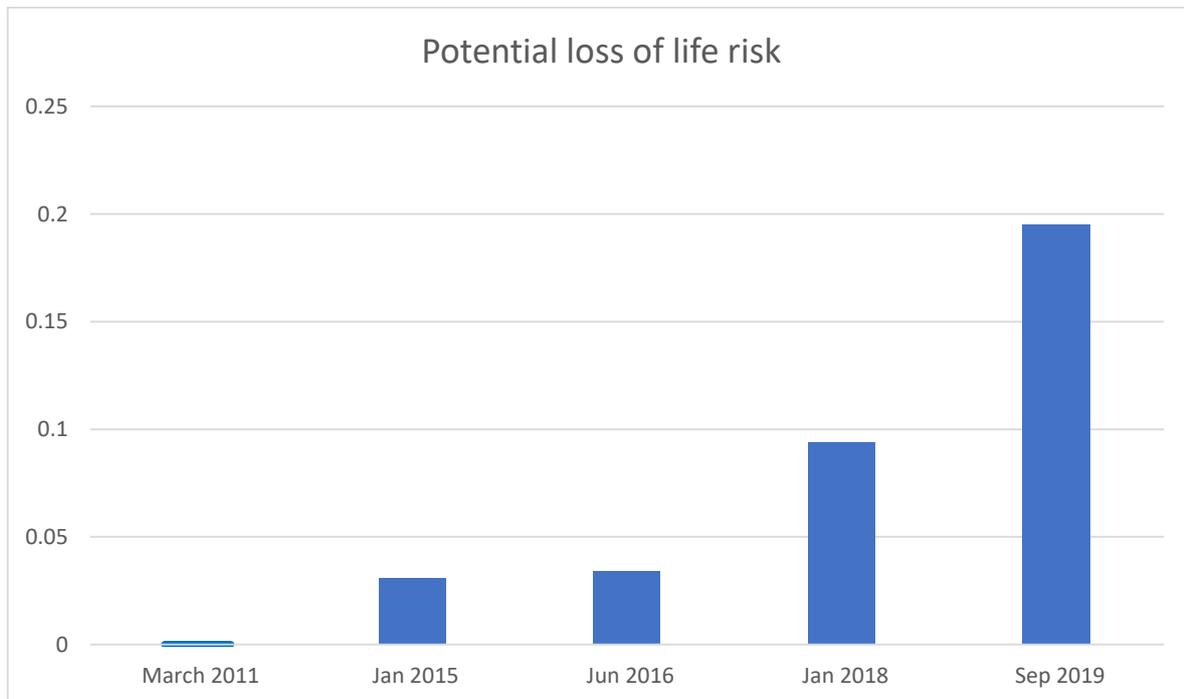
This information has been calculated by the dam operator for this particular dam, but is not available to disaster management planners. When these figures are graphed (see Figure 1),

the calculated risk to life has grown significantly, 6-fold between January 2015 and September 2019 and 1500-fold between March 2011 and September 2019.

Figure 1: Graph showing the change of potential loss of life probability over time

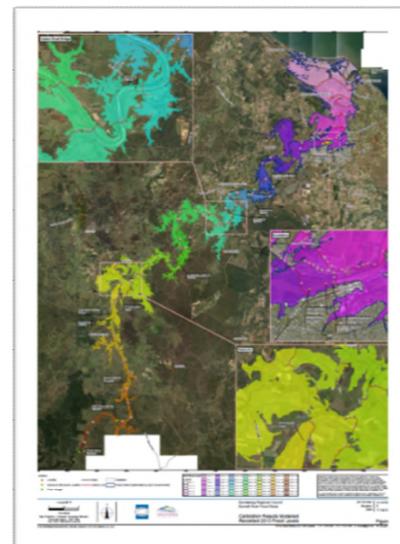
Figure 2

An in-depth explanation and demonstration of BRC's flood modelling tools and plans were provided to the review team. This provided a strong level of confidence in BRC's knowledge and capability to manage riverine flooding in the Bundaberg area. A copy of one of these flood modelling maps is provided in Figure 2.

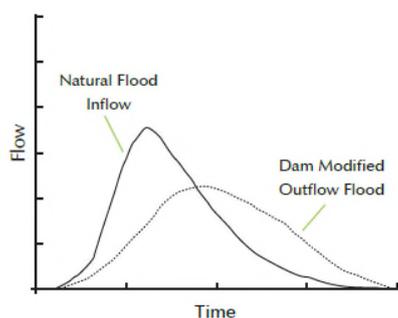
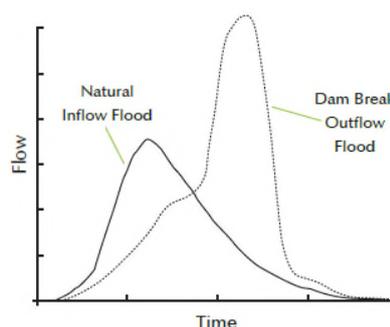
Dams may also have the potential to fail and the subsequent dam-break floods can cause substantial damage downstream. The effect of dam failure on flood flows is illustrated in Figure 3b. Dam-failure floods involving a risk to life are rare events, but failure usually causes extremely rapid rises in downstream flood levels and often these rises occur with little or no effective warning especially if the population at risk is close to the dam.⁷⁰
